### DIVISION OF WATER RIGHTS - DAM SAFETY SECTION

### DAM INSPECTION REPORT – 2009

| Dam Name/Number: | <b>Tibble Fork – UT00299</b> | | |

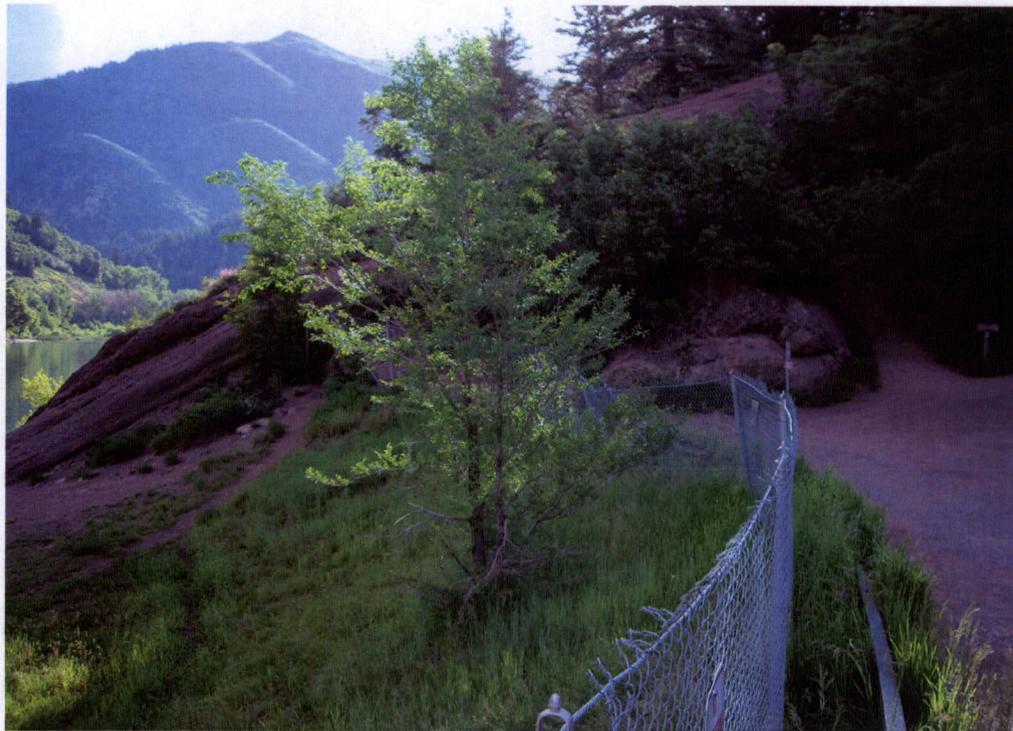
| US Slope: | Willows near the spillway and the tree on the left side need to be removed. |

Photo 1: Tree on upstream slope should be removed

1. Remove woody vegetation (willows, trees, & sagebrush) from the upstream and downstream slopes.
1. Exterminate burrowing rodents.
2. Submit video recording of drain line inspection.
3. Operate the control gate annually through its full range.
4. Repair concrete spalling on right spillway wingwall.

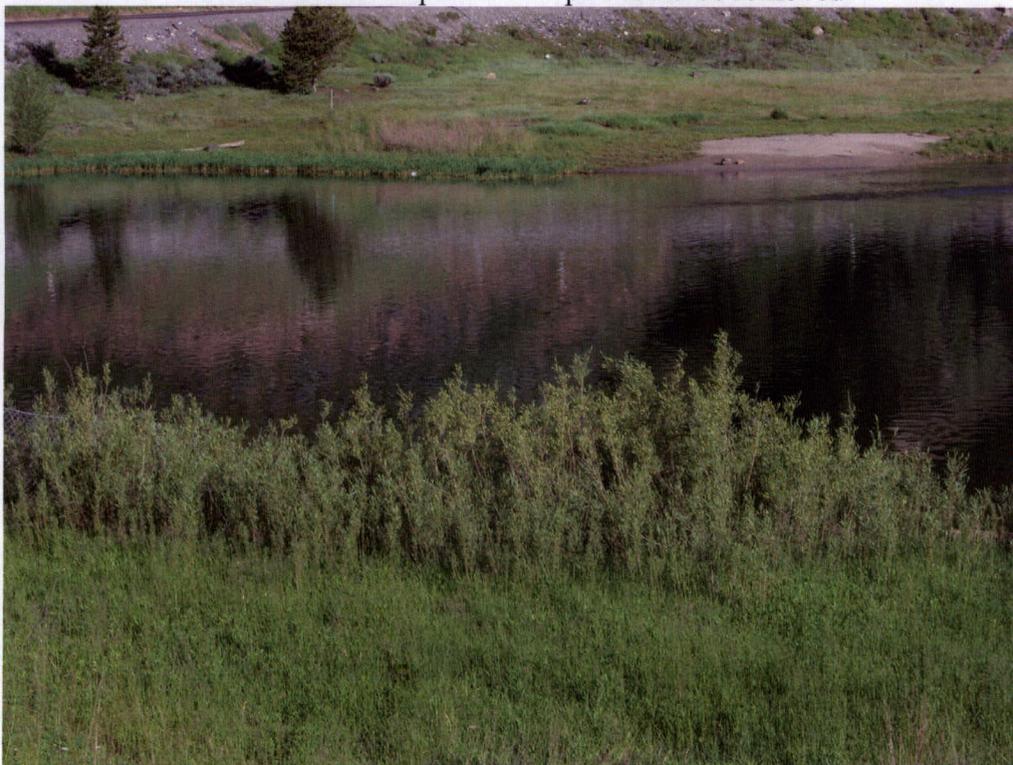
Photo 2: Remove willows from the upstream slope

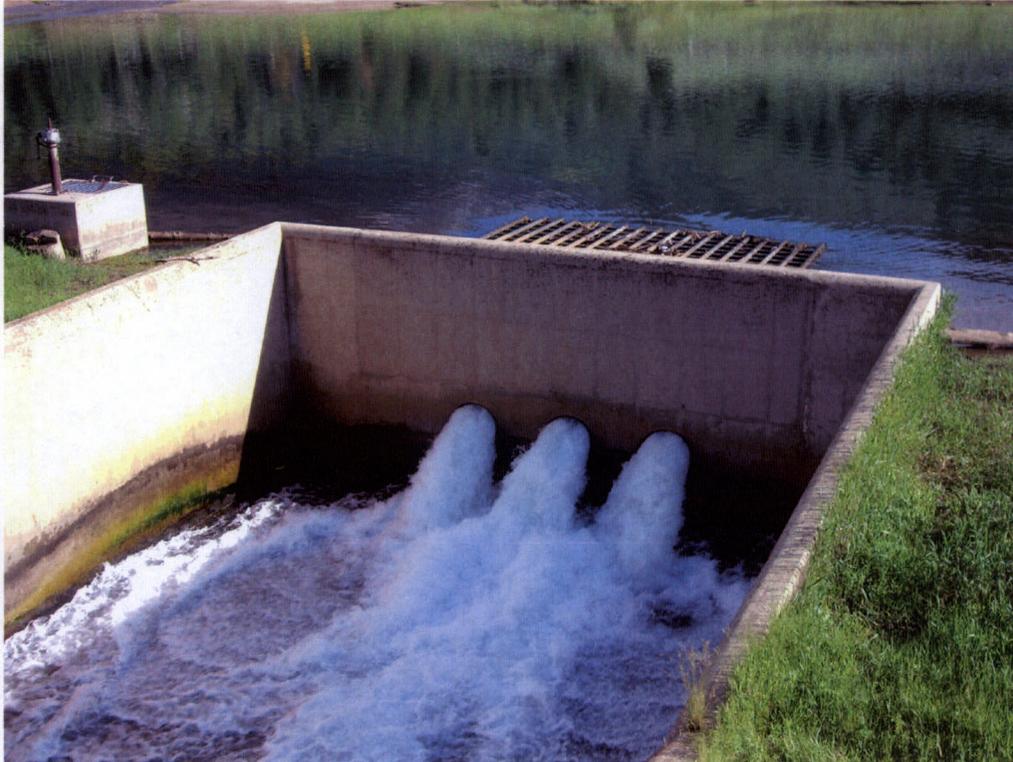
| Freeboard: | The principal spillway is spilling approximately 3'. There is 11 ½ feet of freeboard between the principal spillway crest and dam crest. |

Photo 3: Spillway Flow

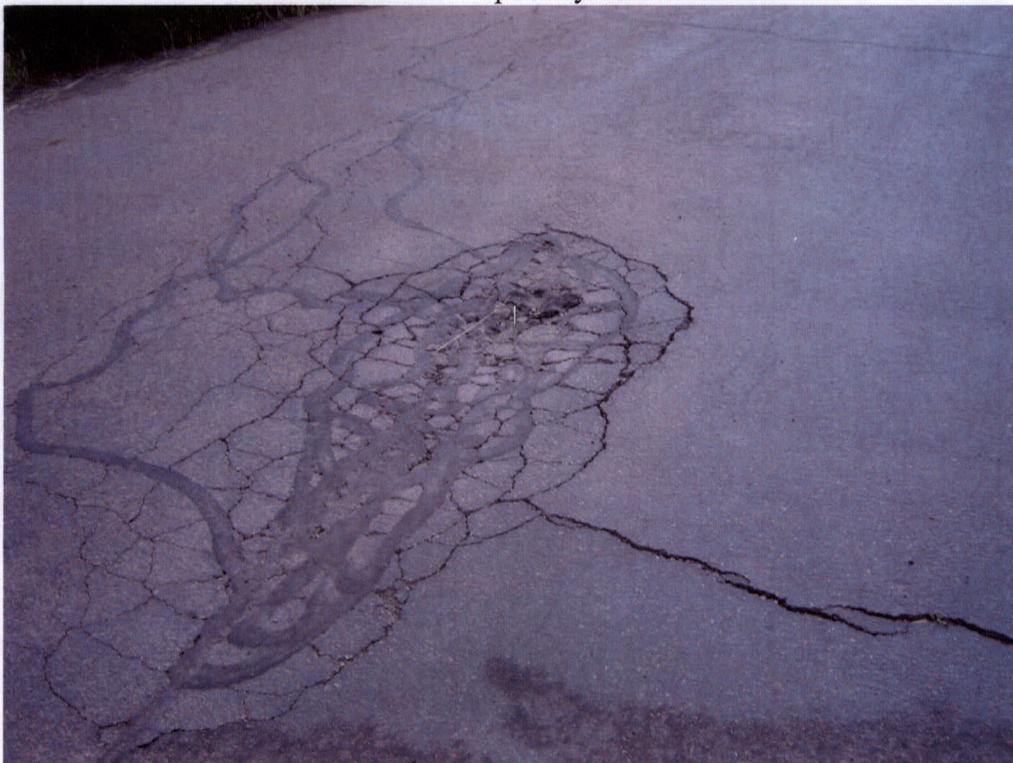
| Crest: | The pavement is in fair condition. Cracks have been sealed. Some potholes are developing. |

Photo 4: Pot Hole Developing on the Crest

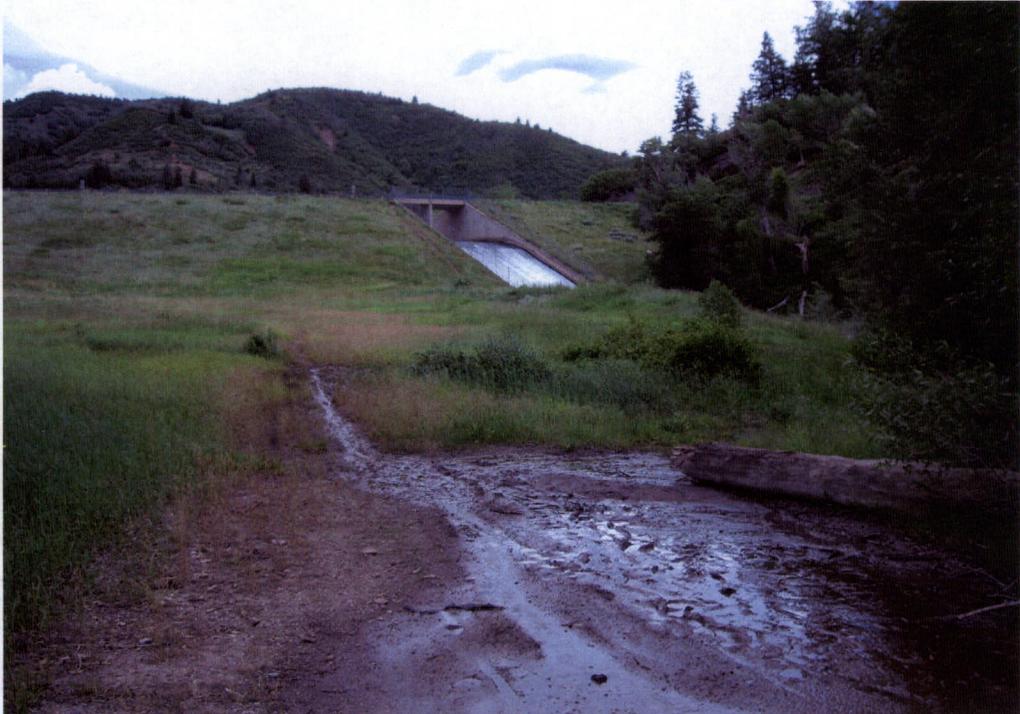
| DS Toe: | In good condition. There is seepage about 200 feet down from the toe of the dam. This may be from a clogged drainpipe in the area. The owner is planning on videoing the drain outfalls in the near future to determine if this is the cause. The seepage is clear. |

Photo 5: Seepage Approximately 200 ft Downstream of the Dam.

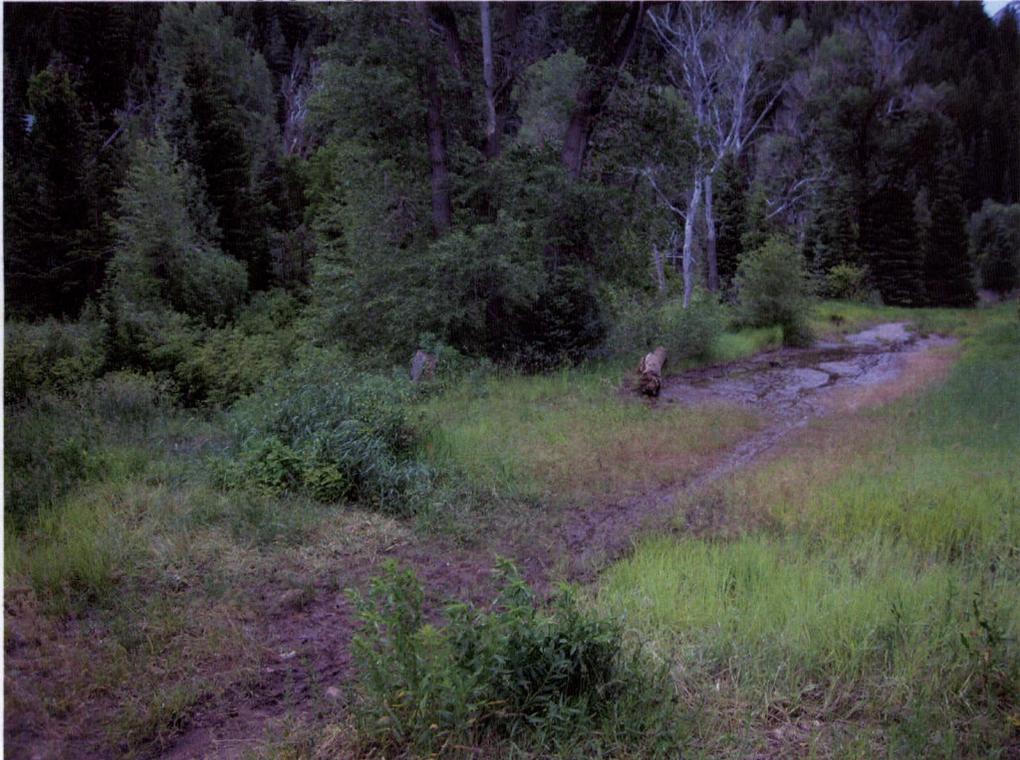
Photo 6: Seepage Looking Downstream.

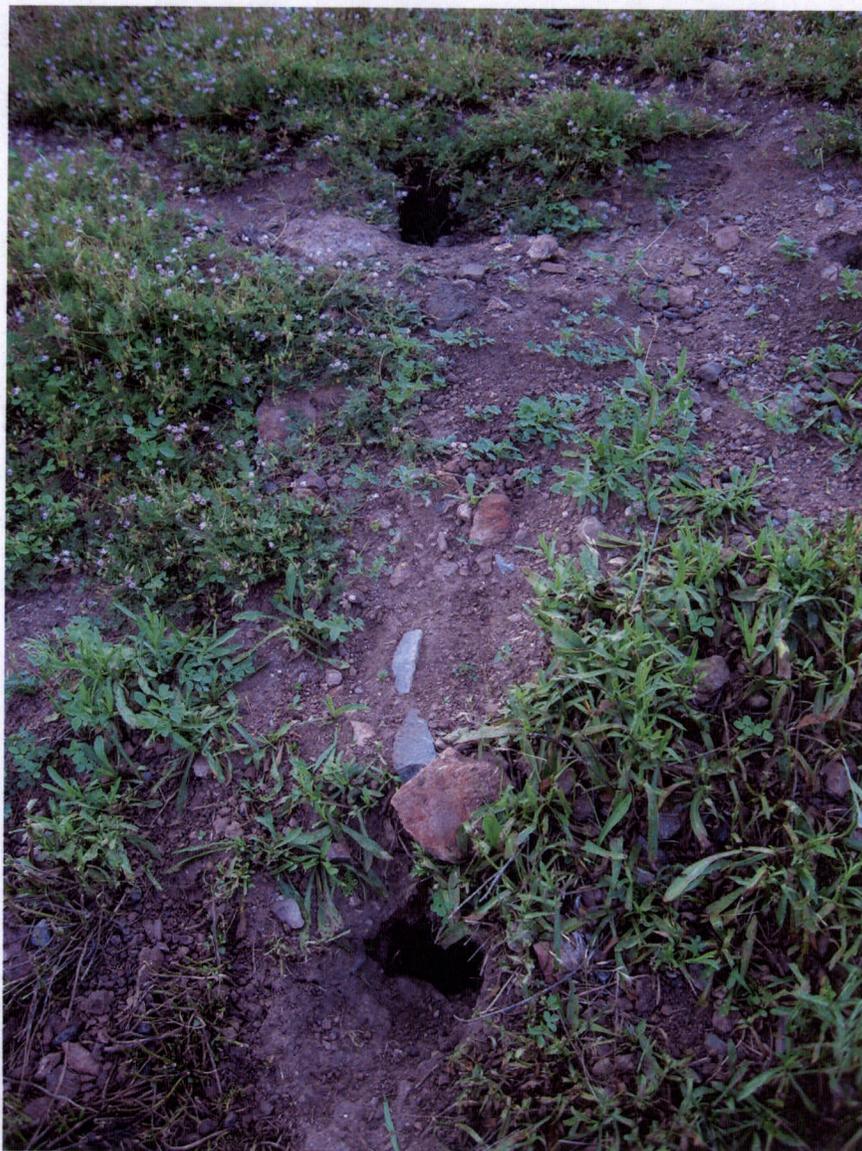
| DS Slope: | Exterminate burrowing rodents. Remove woody vegetation near the left groin. |

Photo 7: Rodent Holes on Downstream Face
