DEPARTMENT OF NATURAL RESOURCES

DIVISION OF WATER RIGHTS

RE: EAST FORK OF VIRGIN RIVER

Possible Repair of Chamberlain Spring

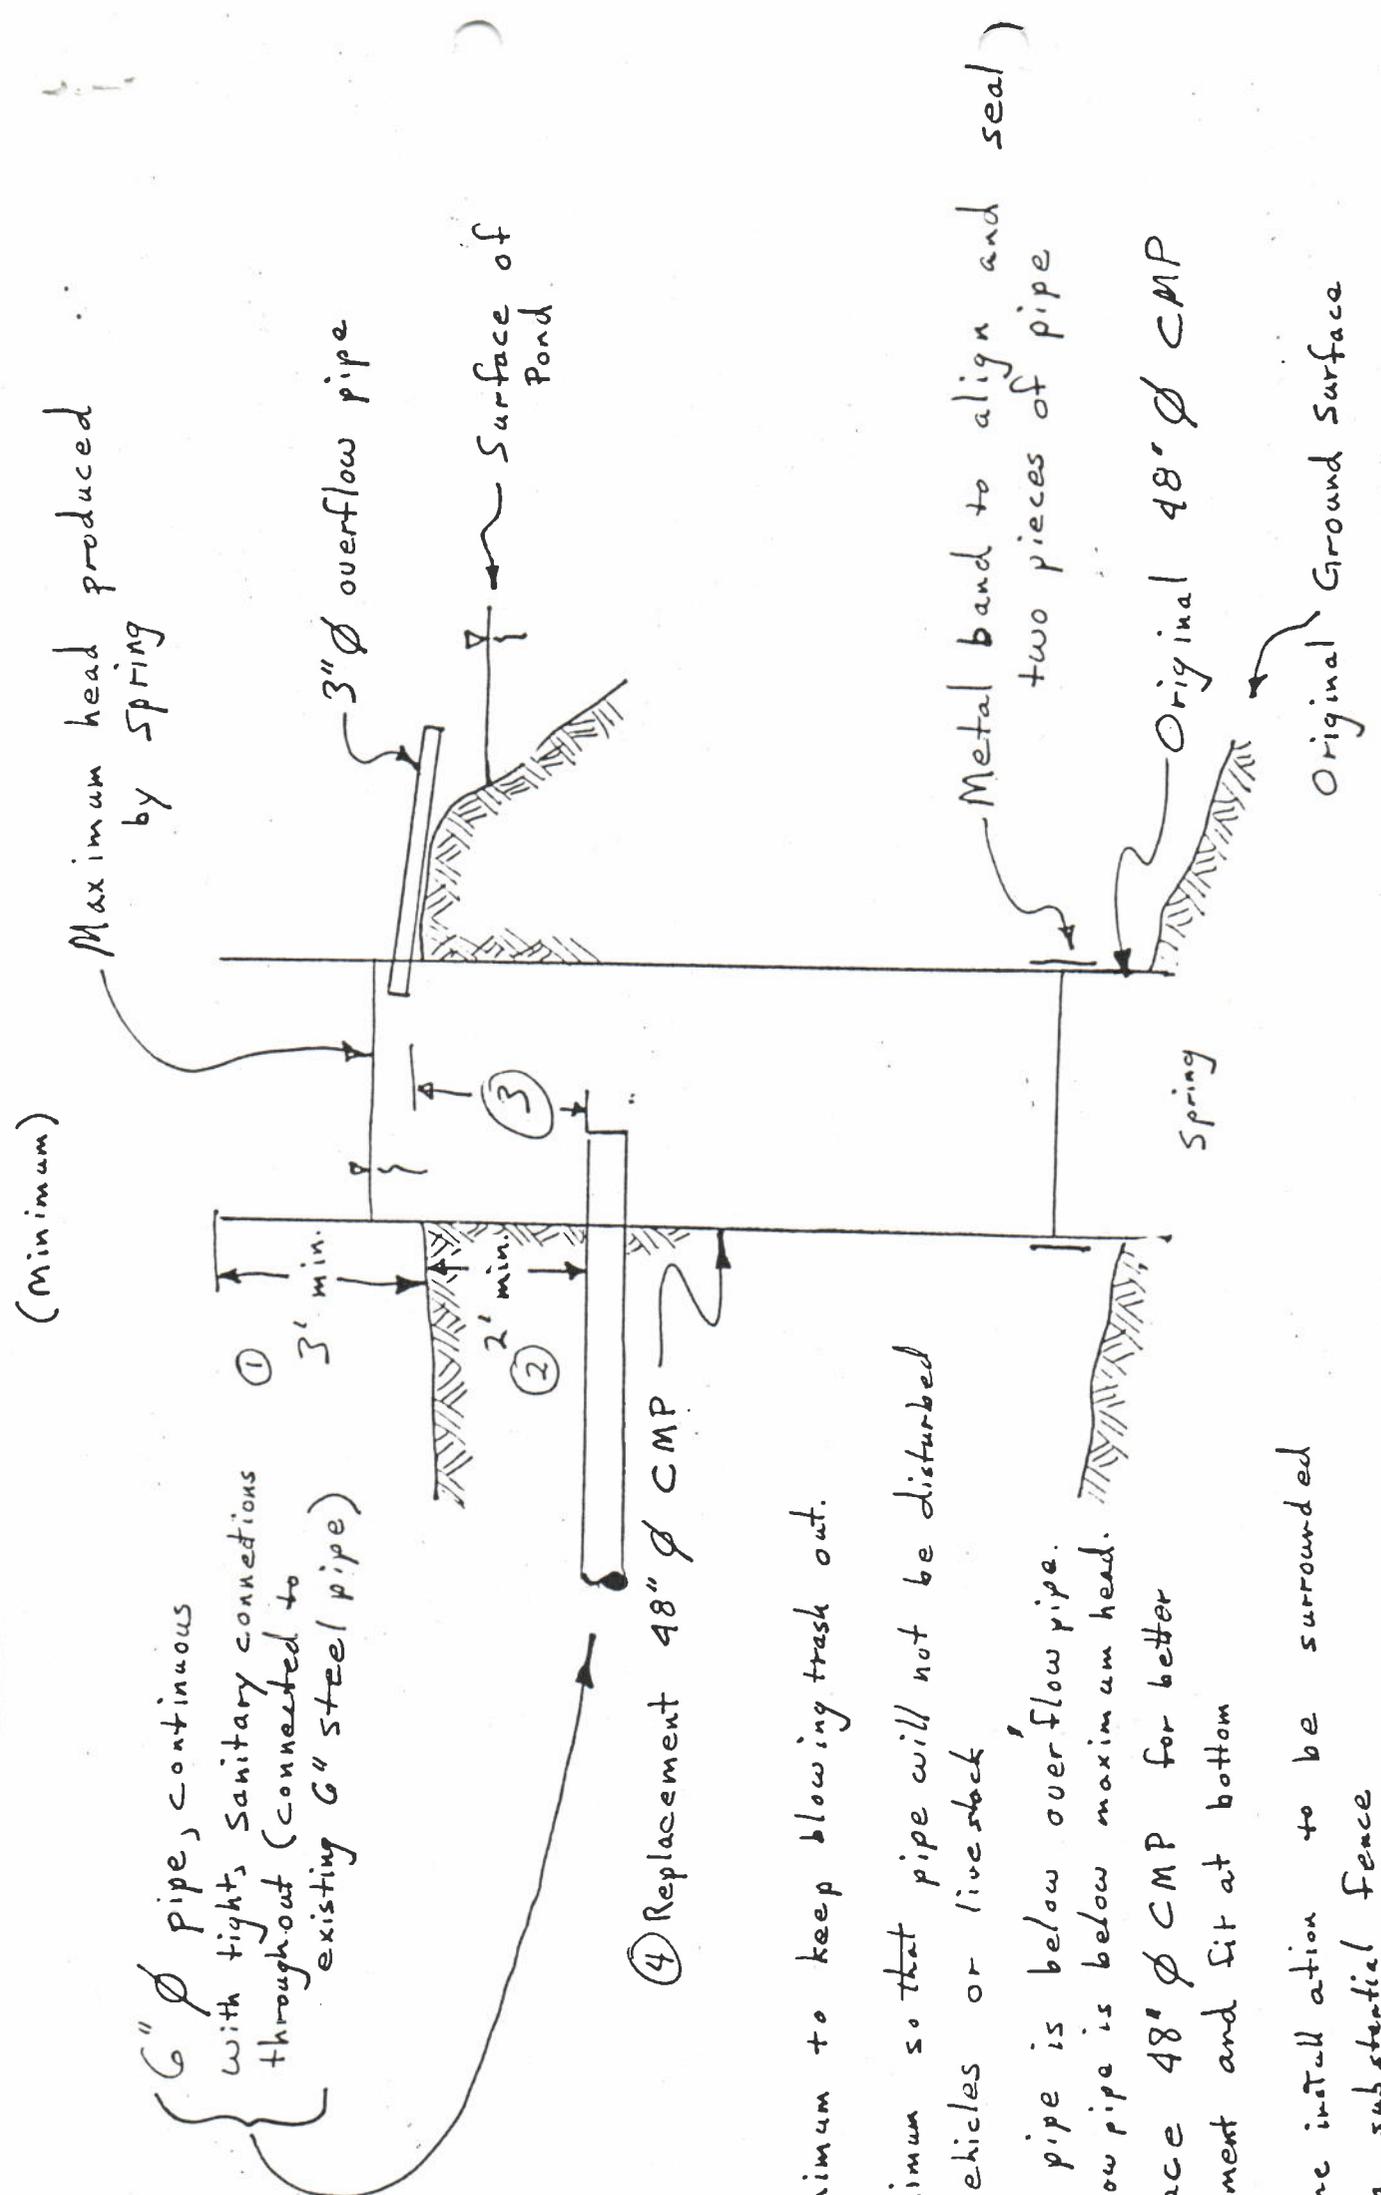
The Chamberlain's complaint is that when you built a certain small dam in Lydias Canyon you severed their waterline from the above mentioned spring to their home and that the water impounded behind the dam has inundated the spring. Remedial measures taken on your part to restore the flow to Chamberlain's home are not satisfactory to them or to this office. Gerald Stoker, Area Engineer, believes that you and Mr. Chamberlain have had sufficient time to correct this problem and that further delay is not in the best interest of those water users at the Chamberlain Ranch.

You are hereby ordered by the State Engineer to complete the repairs to the water system described above. The minimum that will be acceptable is a closed system that will prevent contamination of the Chamberlain's domestic water supply.

Enclosed is a sketch of one possibility that would meet our requirements. We will allow you thirty (30) days or until Jan. 10, 1979 to have these repairs and construction completed. If you choose not to comply with this order, we will take legal action to have the offending dam removed and the water system restored to preconstruction conditions.

- ① 3' minimum to keep blowing trash out.
- ② 2' minimum so that pipe will not be disturbed by vehicles or livestock
- ③ Inlet pipe is below overflow pipe. Overflow pipe is below maximum head.
- ④ Replace 48" \varnothing CMP for better alignment and fit at bottom
- ⑤ Entire installation to be surrounded by a substantial fence
- ⑥ CMP = Corrugated Metal Pipe = culvert
 \varnothing = diameter (ID or OD)
