ROSENBERG ASSOCIATES

August 13, 1990

**SUBJECT: SANTA CLARA RIVER DISTRIBUTION SYSTEM,
UTAH POWER & LIGHT CO. CANAL EVALUATION**

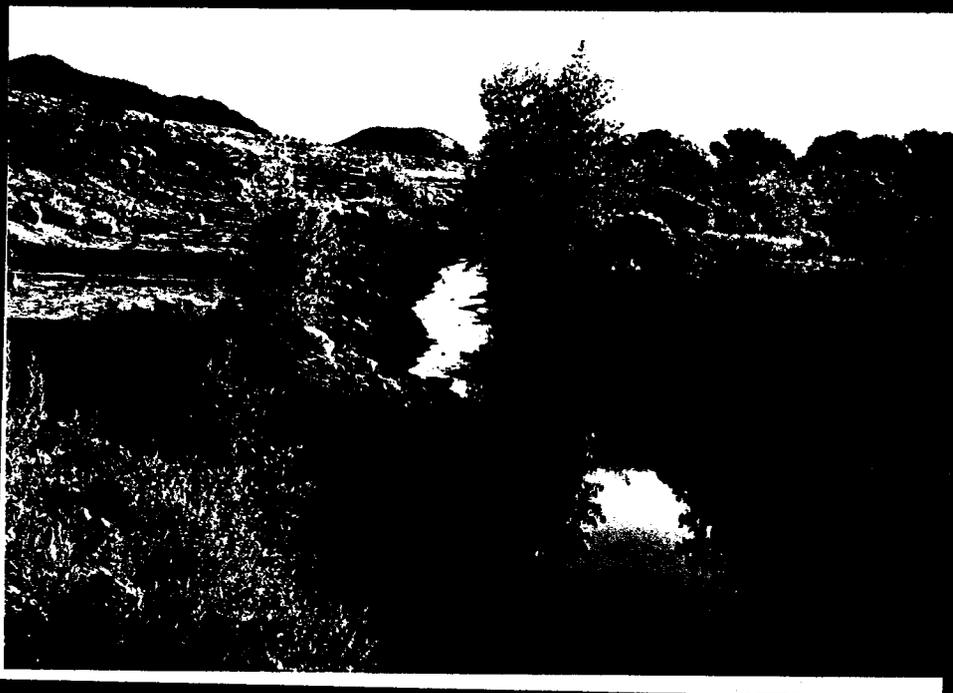
Figure 8. Canal above Veyo Plant Penstock intake -
Note vegetation above ditch compared to
vegetation below ditch (8/8/90)

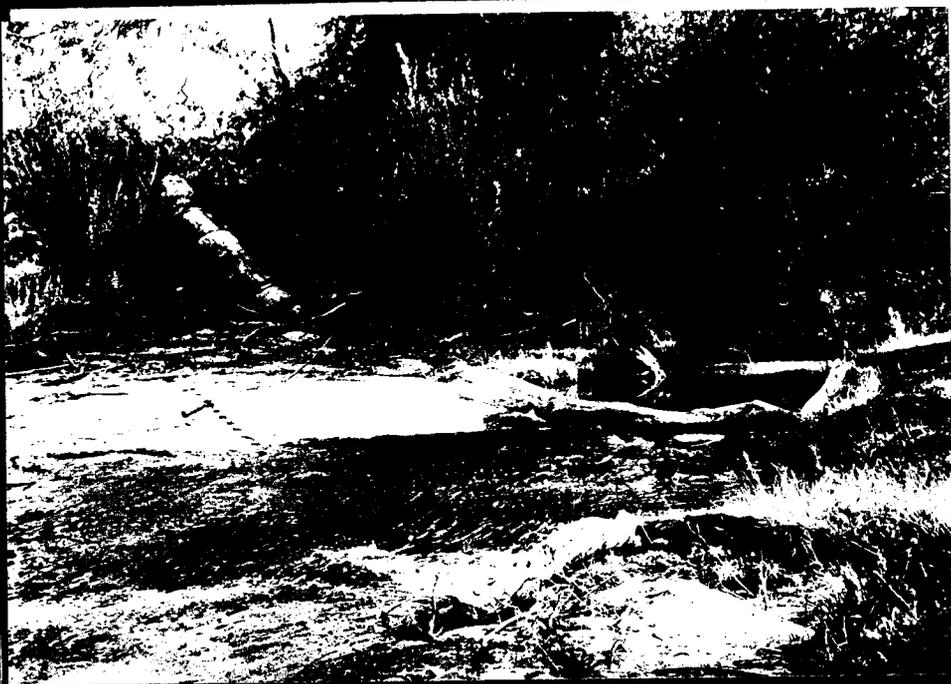
Figure 15. Siphon line at Santa Clara River - note flow in river caused by springs and canal leaks in \approx 5000' of stream (8/8/90)

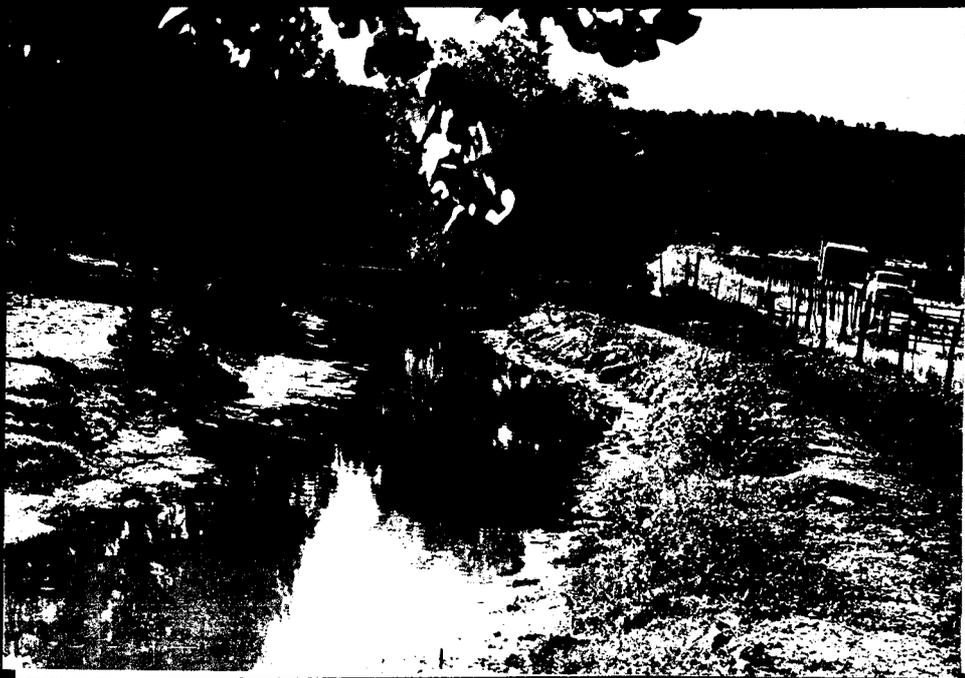
Figure 19. Canal near Bailin property. Leaking diversion is feeding green alfalfa field in background. (8/8/90)

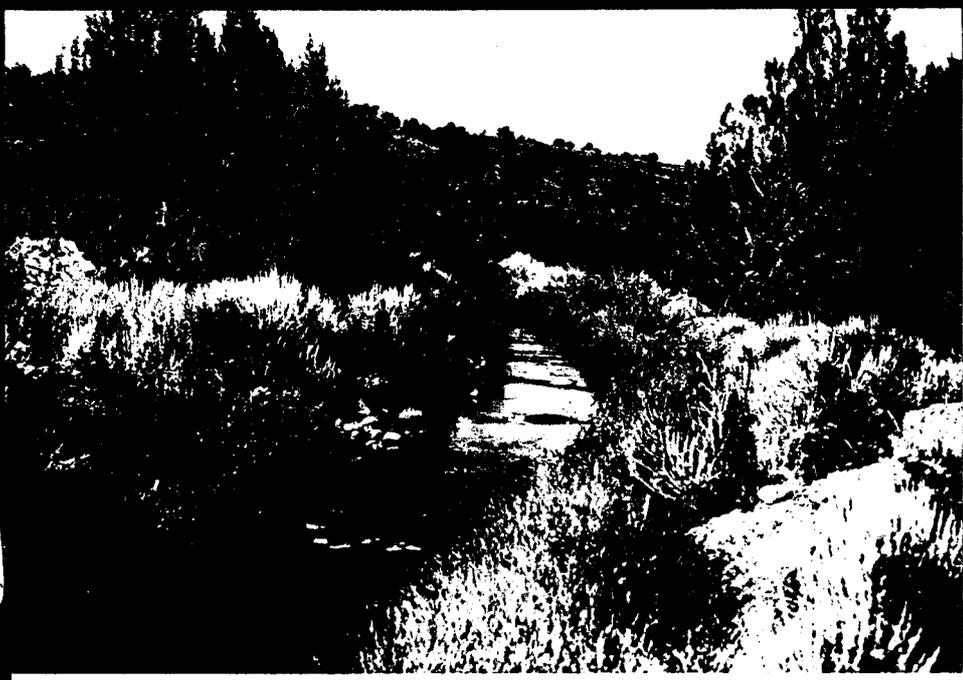
Figure 20. Canal south of Bailin property. Maintenance has been completed in past years (8/8/90)

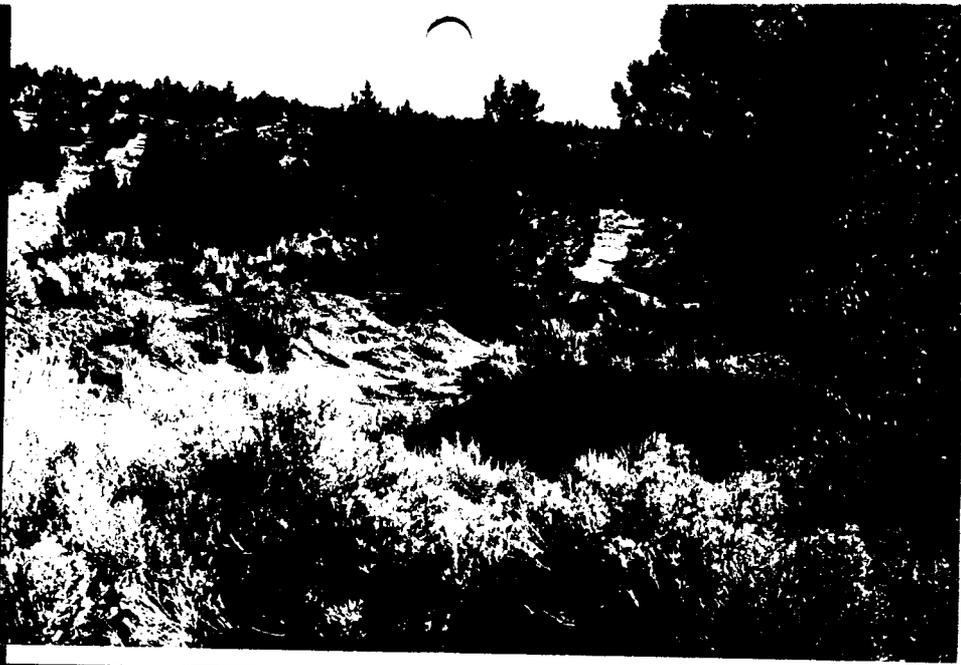
Figure 21. Upstream from leaking canal crossing of dry wash Southeast of Bailin property (8/8/90)

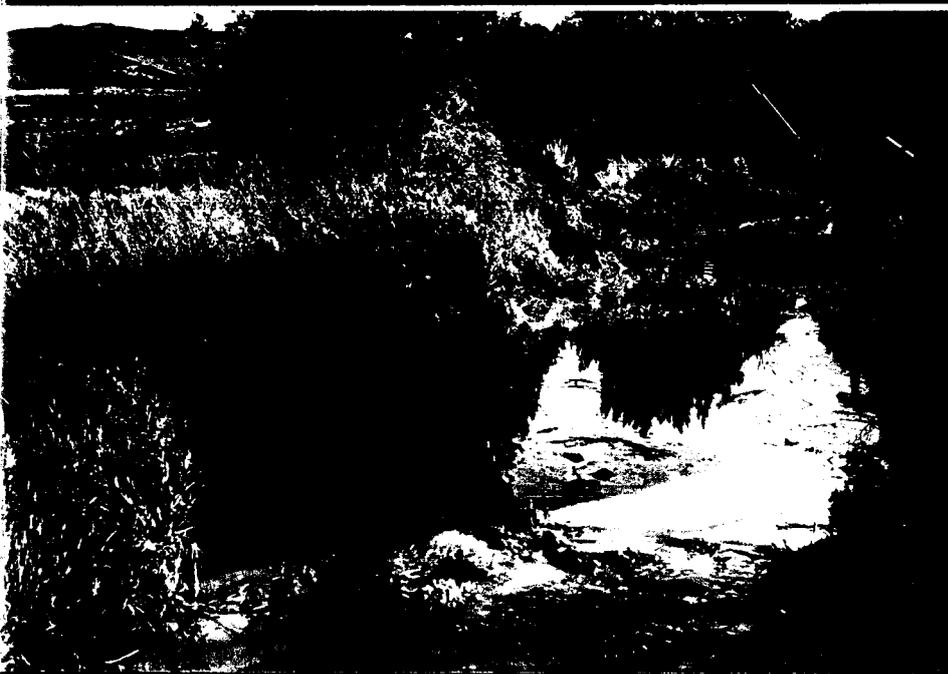
Figure 24. UP & L personnel cleaning ditch west of Highway 18 - notice difference between before and after conditions (8/8/90)

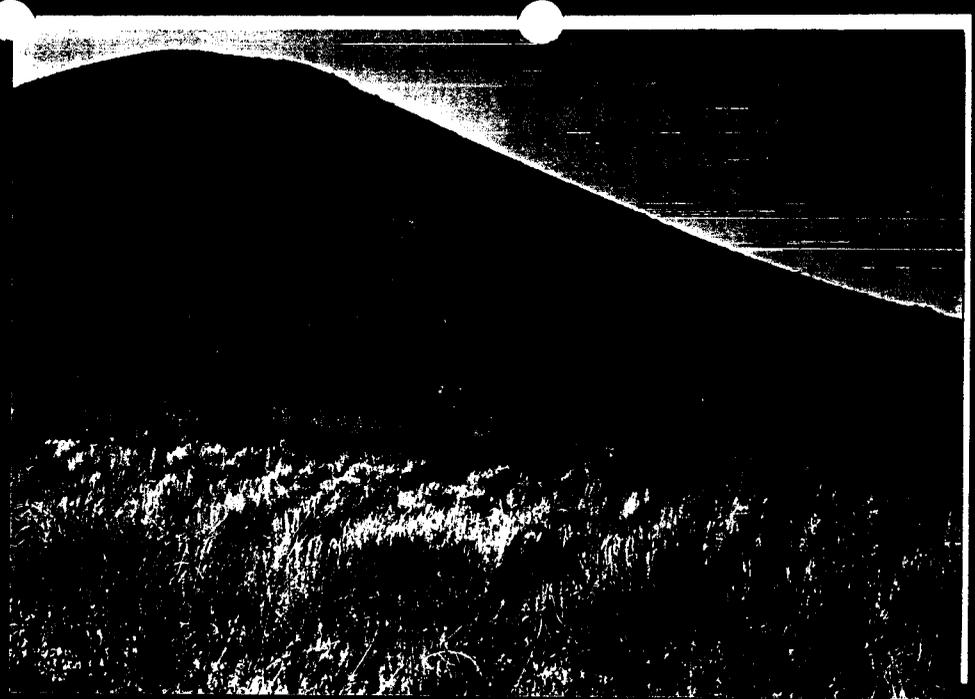
Figure 25. Vegetation along canal on north slope of volcano (8/8/90)
