\* M E M O R A N D U M \*

TO: File  
FROM: Richard B. Hall, P. E., Distribution Engineer  
SUBJECT: Field Review of the East Fork of the Virgin River Distribution System  
DATE: November 10, 1984

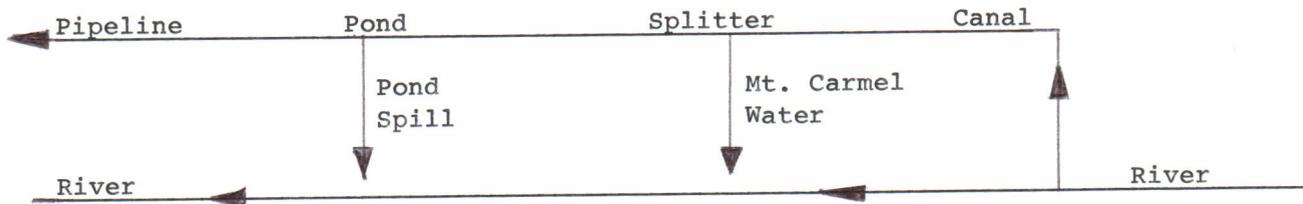
- 1) Mt. Carmel Diversion - This has a splitter to an East and West Ditch both of which have Parshall Flumes, which are adequate. The flume in the West Ditch has deteriorated concrete, which needs repairing.
- 2) Orderville Diversion - This diversion has been a problem for some time. The following diagram represents the system.

The pipe has apparently become blocked, which requires more head, which in turn requires addition flashboards in the Mt. Carmel side of the splitter, which causes bad readings. The spill from the pond is regulated by an Armco Gate and has no measuring device. (We need to get the plans of the system from Water Resources and talk to them about the problem.)
