I
IMPACT REPORT
NORTH FORK DUCHESNE RIVER

Glenn M. Davis, Regional Fishery Biologist
Utah State Department of Fish and Game

June, 1963

This report concerns flood damages to the fishery resource of the Duchesne River, incurred June 16, 1963, when Little Deer Creek Reservoir broke. A preliminary survey of the drainage indicated that channel damage on the main river was not too severe; therefore, efforts were concentrated on the North Fork.

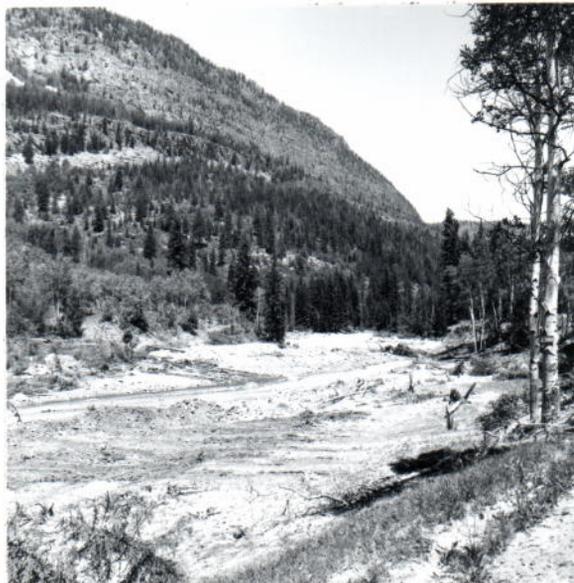
"L" Station 99 - This is a shot upstream from Iron Springs Campground. Iron Springs is the starting point of the survey, it is also the first part of the North Fork drainage, where the flood had a chance to widen out. Little Deer Creek Reservoir was located approximately 5 miles above this point.

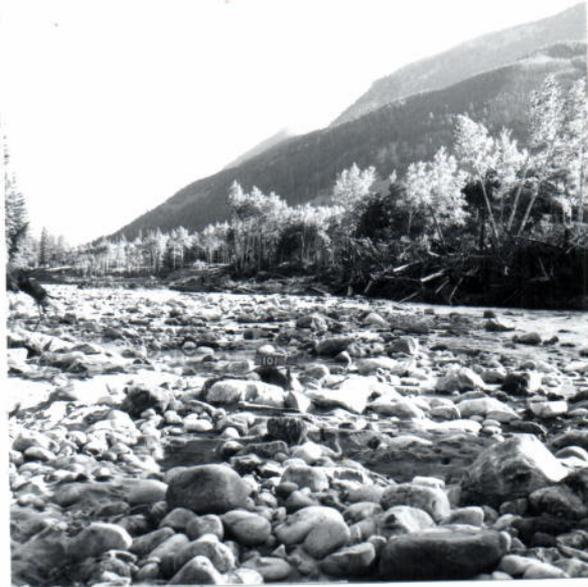
"T" Station 101 - Is photographed from the center of the channel which is approximately 120' wide. Stream is split into two sections, with most of the water on the left side. Banks are rocky and fairly stable. The main impact is debris along the banks and separation of the stream.

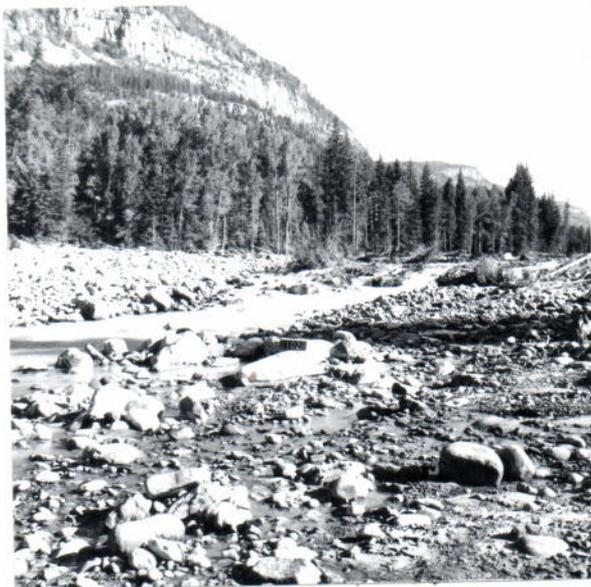
"T" Station 102 - The channel width was left denuded of all bottom types except boulders and rubble. The center of the channel, where the stream flows is gouged in some areas and heaved up in others. The overall impact is complete loss of streamside vegetation, and an increase in gradient.

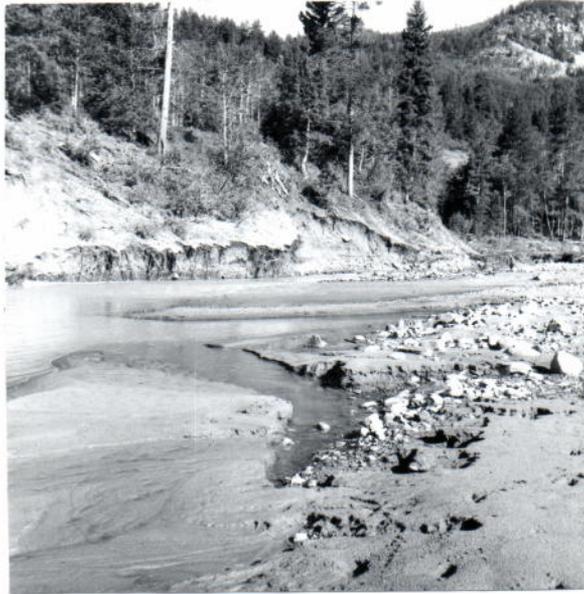
"L" Station 103 - Is located downstream approximately 200' from station 102. The right bank is high cut and needs protection. All streamside vegetation along the left bank is gone. Here again the channel was widened. It is suggested that an anchored, cut tree revetment be installed along the right bank to prevent erosion, and encourage regrowth of vegetation.

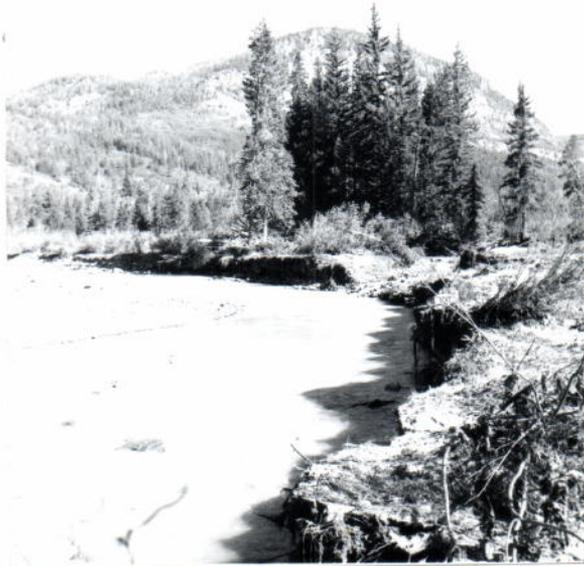
"T" Station 104 - The flood widened out to 300' to 400' here. Debris is scattered throughout the area, and willow bunches are severely damaged. The left bank was left quite unstable, but should re-establish itself with the regrowth of vegetation. The stream is scattered in several small channels throughout the area. Some are original channels, some probably new.

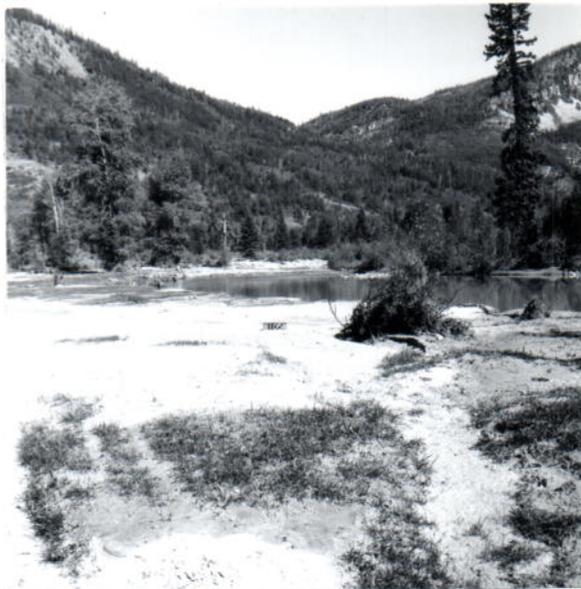
"T" Station 105 - Typical shot of denuded stream banks in the willow bunch meadow above Defa's Dude Ranch. Good chance for regrowth of vegetation in some areas, other questionable because most of the soil is gone.

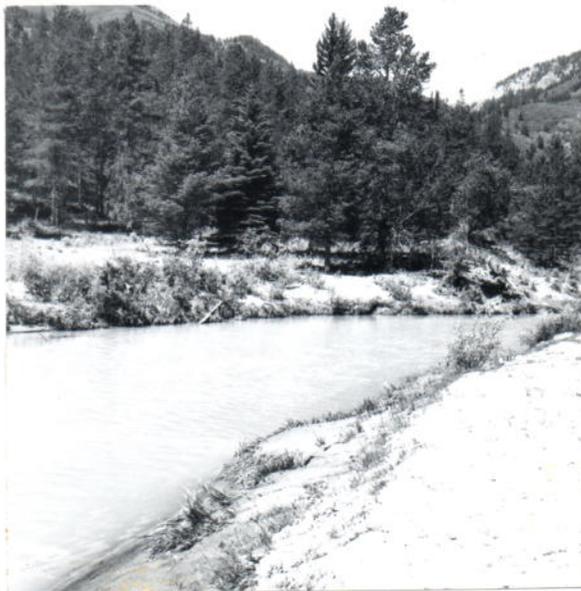
"T" Station 216 - Is located within the boundaries of the Defa's Dude Ranch. This stillwater area did not receive extensive, permanent damage because the flood widened out, and did not follow the channel. Good chance for regrowth of vegetation to re-stabilize banks.

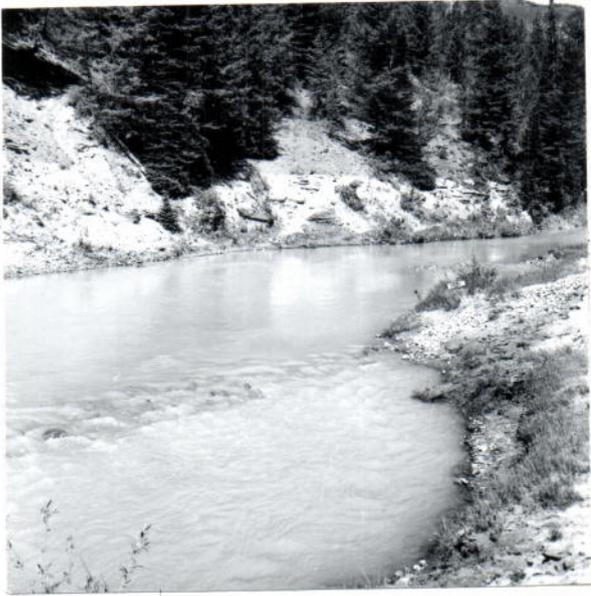
"T" Station 217 - The stream is still in good condition in the section of stillwater area, just upstream from where Hades Creek enters. Flood also widened out in this area resulting in considerable damage to Hades Camp Ground. Note high waterline on right bank.

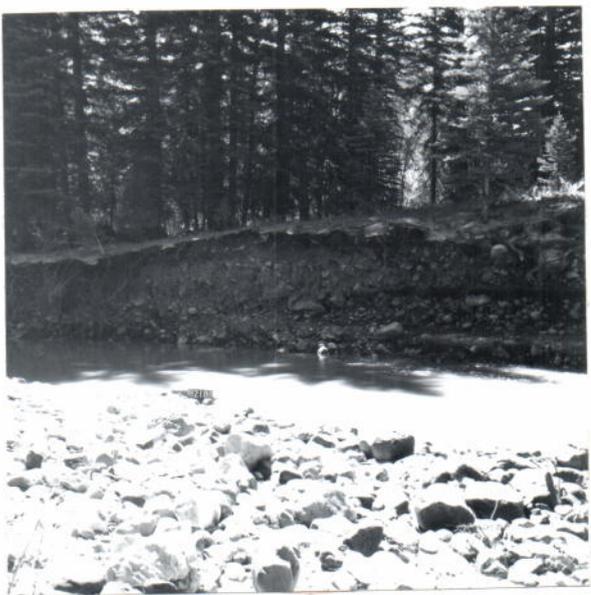
"L" Station 218 - High cut right bank just downstream from where Hades Creek enters. This bank is rocky and would probably sluff off and stabilize itself; however, placement of an anchored, cut tree revetment might hold enough soil for regrowth of vegetation.

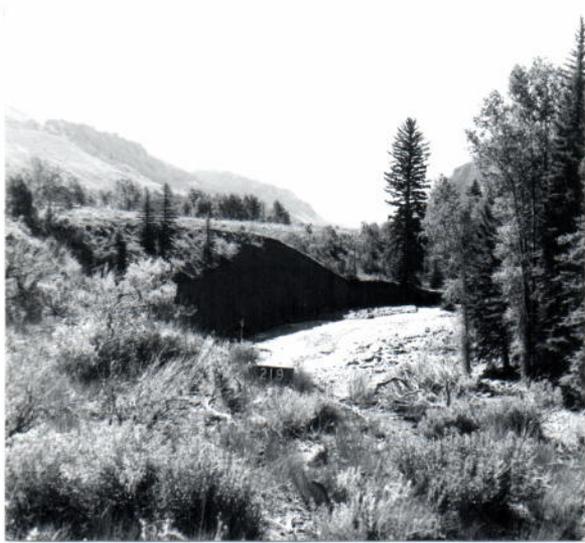
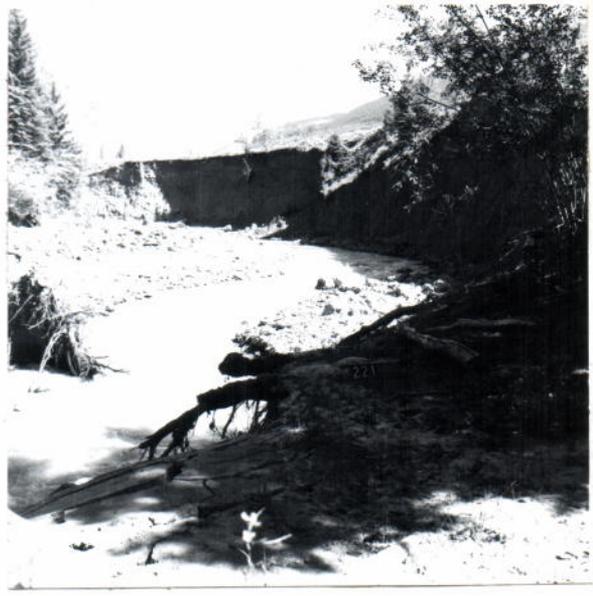
"L" Station 219 - Shear cut left bank approximately 18' high. Stream has moved 30' to 40' to the left leaving a very hazardous bank. Measures should be taken to prevent further erosion and encourage regrowth of streamside vegetation. Two views of this station.

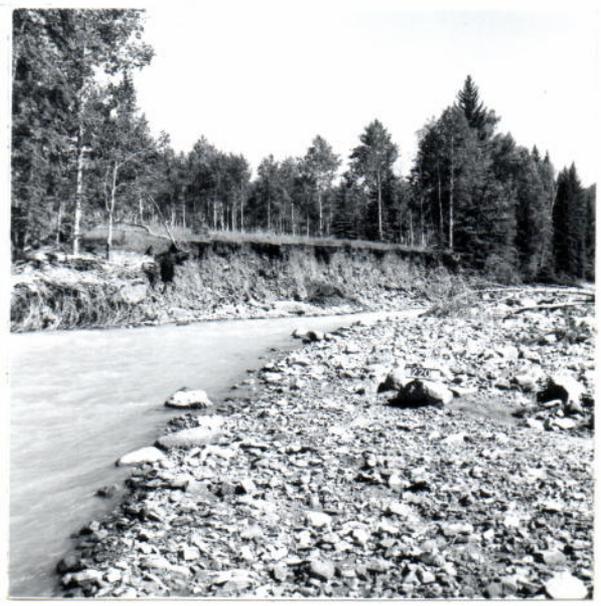
"L" Station 220 - Is located 2 miles downstream from the starting point. Left bank is high cut and needs protection. Right bank, not shown also needs protection. Channel is gouged and the gradient has been increased.

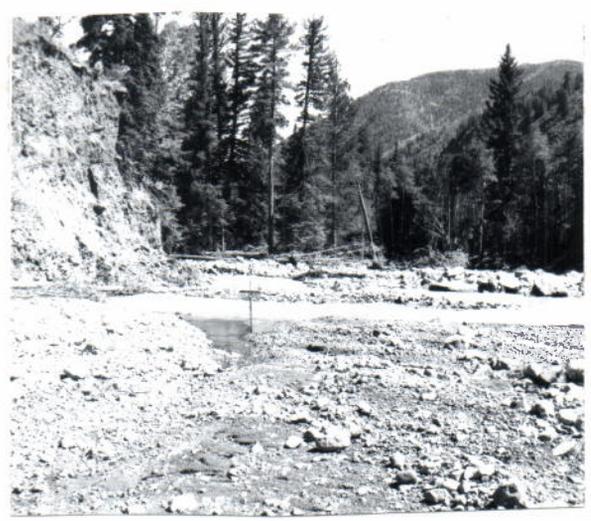
"L" Station 308 - Is located 100' downstream from station 220. This is the head end of a long channel change within the upper half of mile 3. The material, which blocked the original channel, must have come from the high cut banks at stations 219-220-308. Unable to locate the original channel definitely, downstream from this station. Believe it to be far to the right side of present channel. The left bank at this station is high cut and needs protection. The new channel has an excessive gradient, is made up of loose rock, lacks vegetation, and appears to be permanent. Did not investigate possibility of putting stream back into original channel.

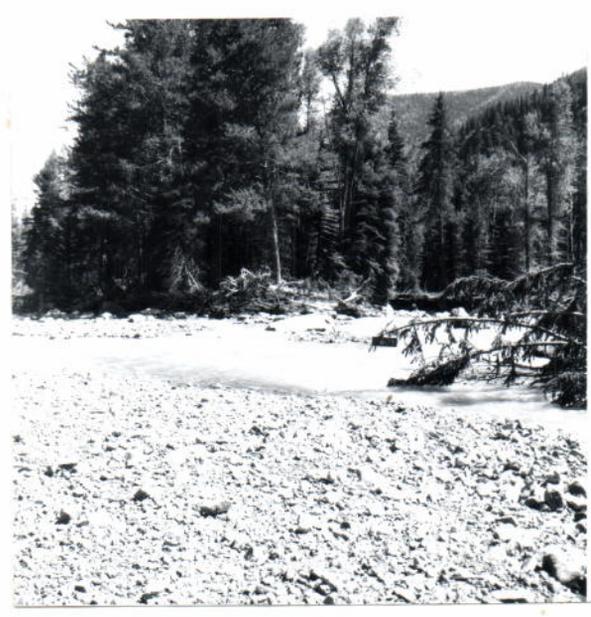
"L" Station 309 - The stream is separated into two channels. The right side is believed to be part of the original channel, or at least heading in its direction. There are sections with unstable banks, and the channel is made up of loose rock.

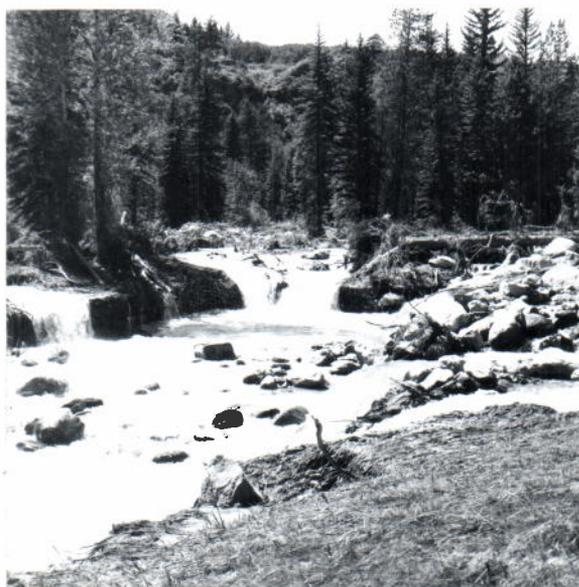
"L" Station 310 - Shows a deeply gouged new channel. Not positive as to location of original channel, however, believe a portion of it shows in background of left side of this photo. The impact is the increased gradient, lack of vegetation, effect on downstream banks, and loss of all bottom types except boulders. The possibility of returning the stream to its original channel should be investigated. Location of the original channel is probably 200' to 250' to the right.

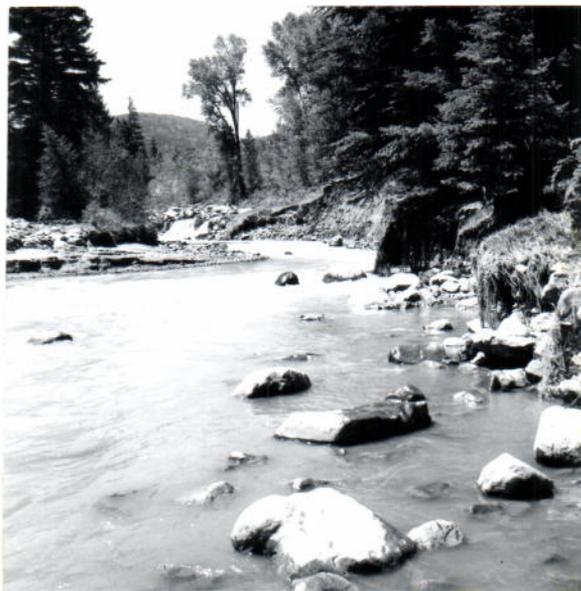
"L" Station 311 - Is a section of what is believed to be a new channel. The "new channel" is deeply gouged and the left bank is unstable. Again, investigations should be made to determine the possibility of putting stream back into original channel.

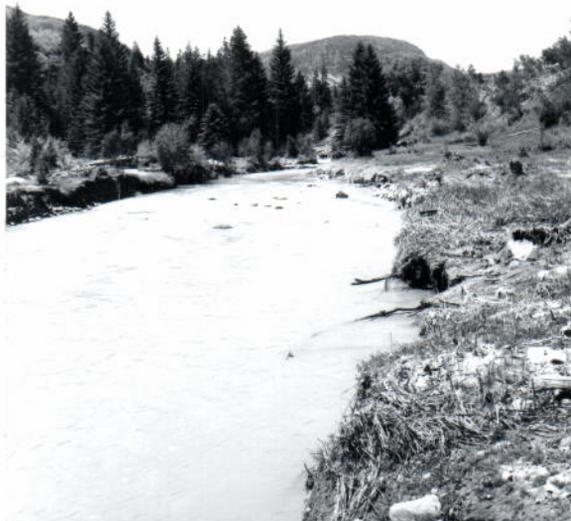
"L" Station 312 - Is more of same shown at station 311. Material gouged from this area is deposited at station 313, resulting in a channel change. The original channel at this station is believed to be 200' to 250' to the right.

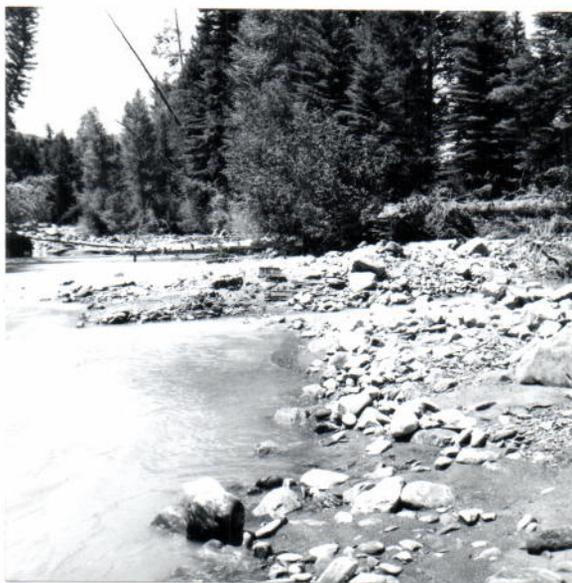
"L" Station 313 - Is a new channel gouged out 50' to the right of the original. There is a great pile of loose rock heaved up into the original channel. Change appears permanent, gradient is increased, banks may stabilize.

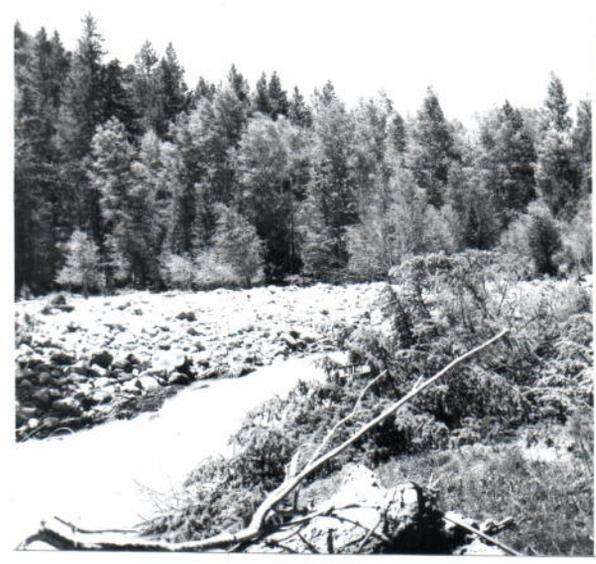
"L" Station 314 - Loose rocks have blocked the natural channel, diverting most of the stream into a new and permanent channel. The gradient has been increased considerably. This is just upstream from station 315.

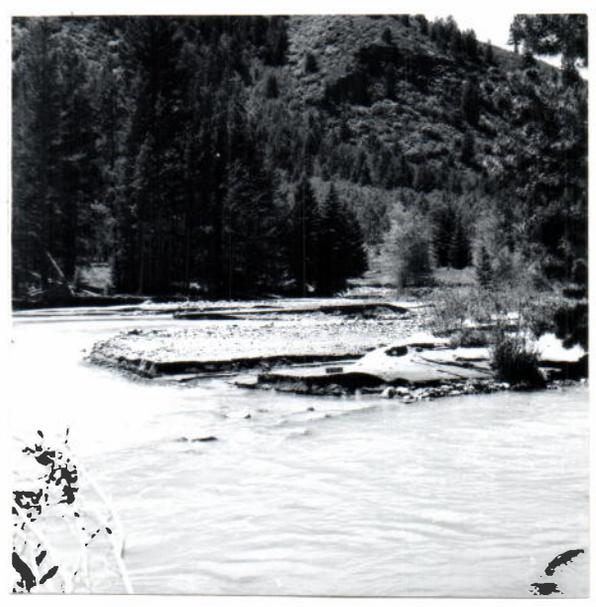
"T" Station 315 - The stream is separated into 3 channels. Impact is loss of shade and depth.

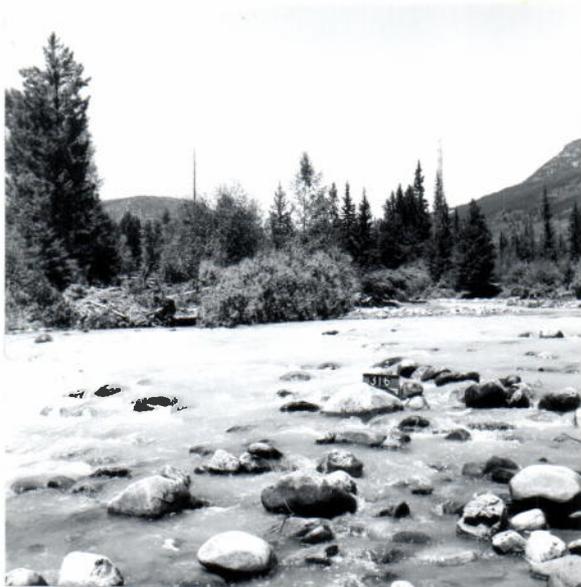
"T" Station 316 - The stream is widened out and lacks depth. The original channel probably was located in the area where the large conifer lays.

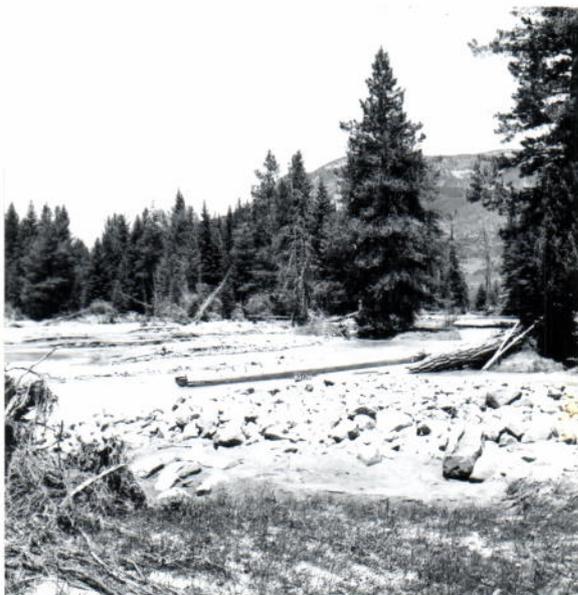
"T" Station 317 - Is typical of many channel changes, where banks are erosive, stream lack depth, and shade has been lost. Time will heal these areas somewhat. Main channel is on left side of stream.

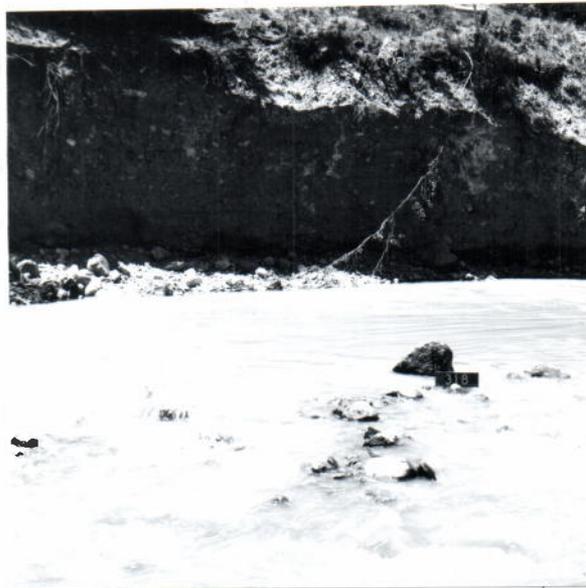
"L" Station 318 - Shear cut left bank needs protection. Anchored, cut tree revetment might do nicely.

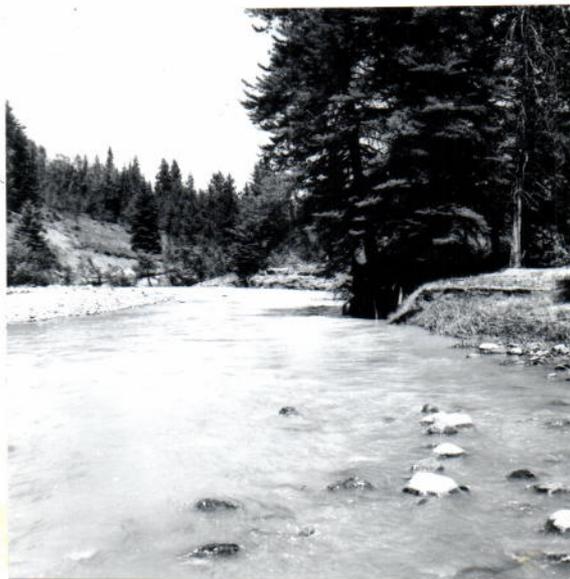
"L" Station 319 - Quite a typical shot of stream bank damage. Some vegetation remains, but left bank in background needs protection, or may heal itself in time.

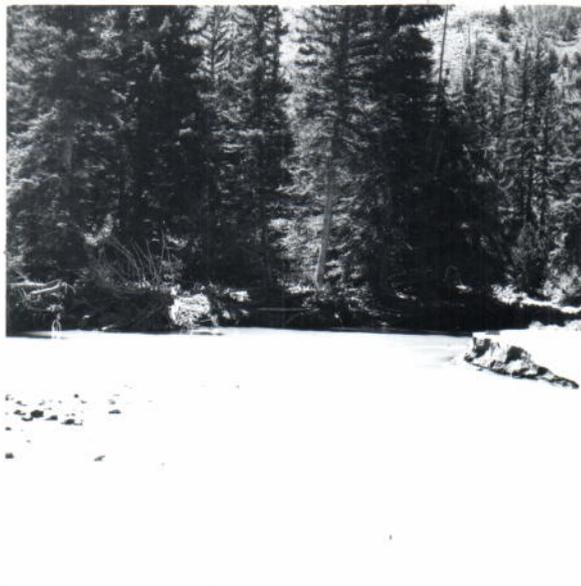
"L" Station 320 - Is three miles downstream from starting point. This station has unstable banks with a fair chance of regrowth of vegetation. Considerable loss of shade on right bank.

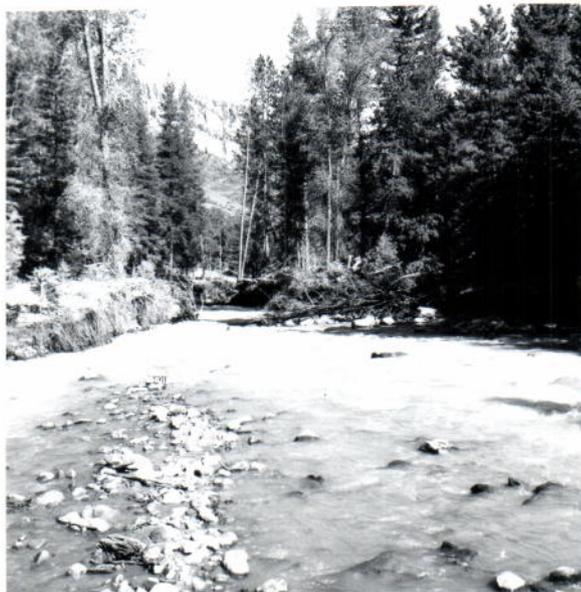
"L" Station 401 - Is a channel change, permanent type. Change probably occurred before flood. Both banks are undercut and channel is gouged. Banks should be protected to save large conifers and cottonwoods.

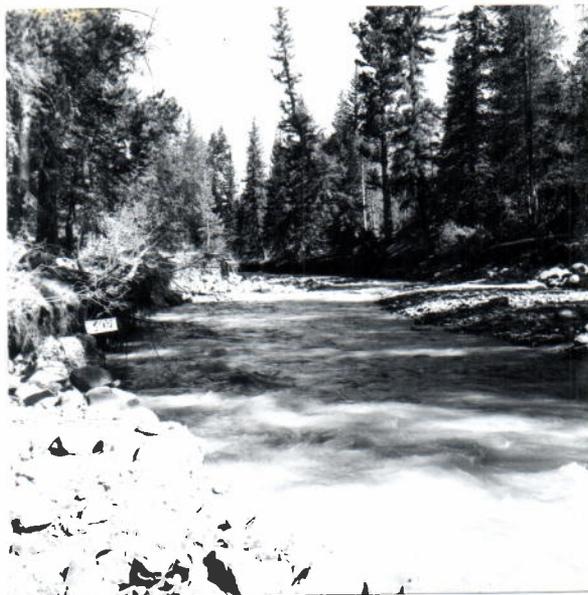
"L" Station 402 - Original channel, conifers both sides. Channel gouged 3-4' deep. Banks are mostly rock, and will probably stabilize, with some chance for regrowth of vegetation. Location is near River Side Camp Ground.

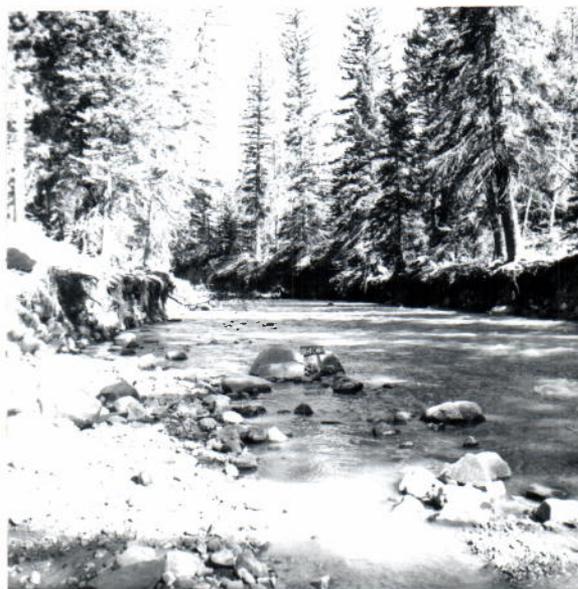
"L" Station 403 - Channel just down from station 402 is gouged 3-4' deep. Undercut banks need protection to preserve large conifers.

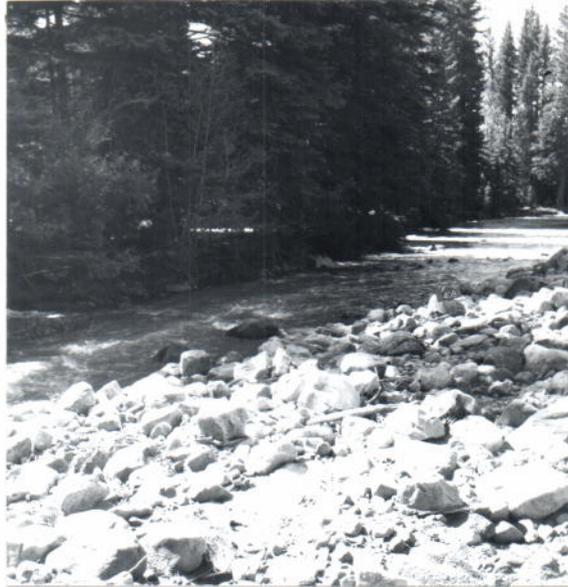
"L" Station 408 - Water that left the normal channel at station 407 re-enters through trees approximately 200' downstream. Boulder island in foreground blocks a large portion of the original channel. Right bank, not shown in photo needs protection.

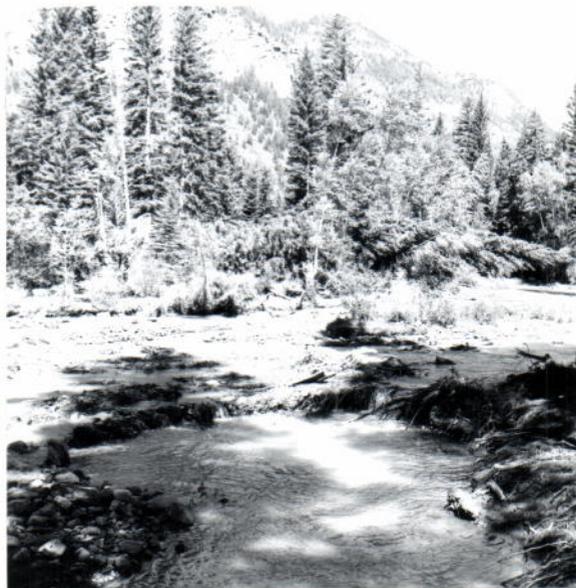
"L" Station 502 - Stream scattered and almost split into two channels. Appears that stream will stay in original channel. Placement of boulder deflector would avert channel change.

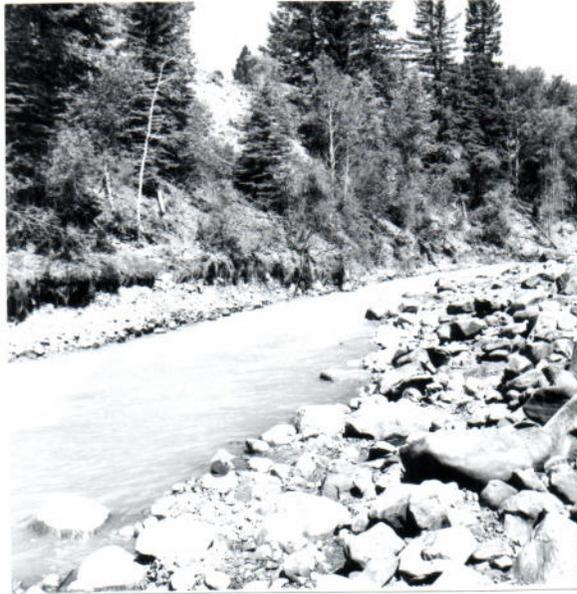
"L" Station 505 - Channel has been gouged 4' to 5' deep. Rocks deposited by flood cover nearly one-half of the original channel's width. Bank may stabilize itself.

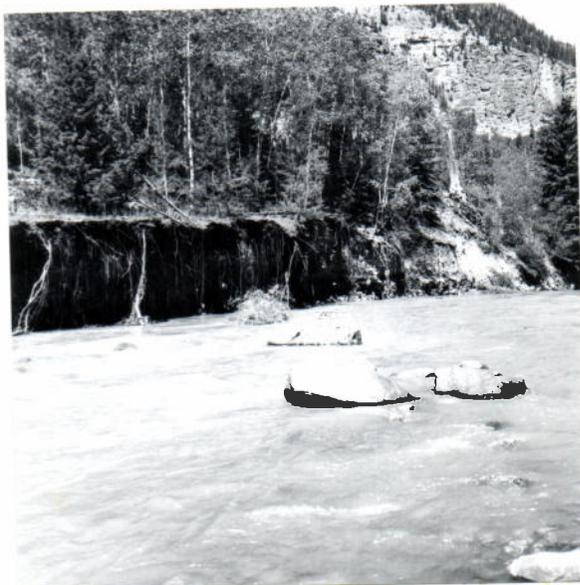
"L" Station 506 - Location approximately 200' downstream from station 505. Right bank very unstable, needs protection, approximate length 250'.

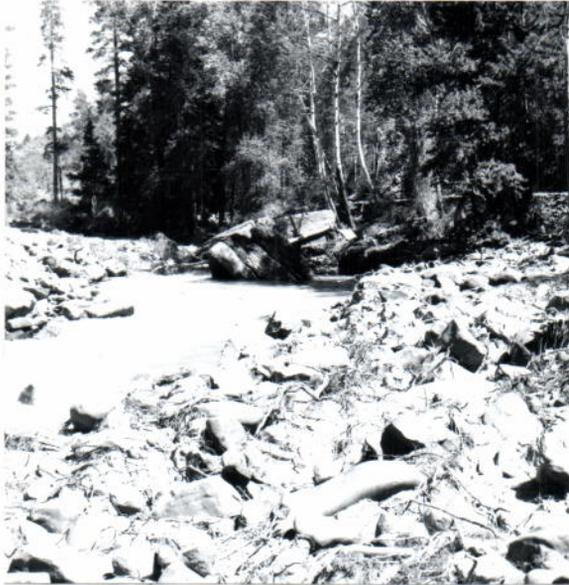
"L" Station 507 - Channel is gouged possibly 10' deep for a distance of 150'. No chance for regrowth of streamside vegetation. Location is alongside of road. Depth and cover are still adequate for trout habitat.

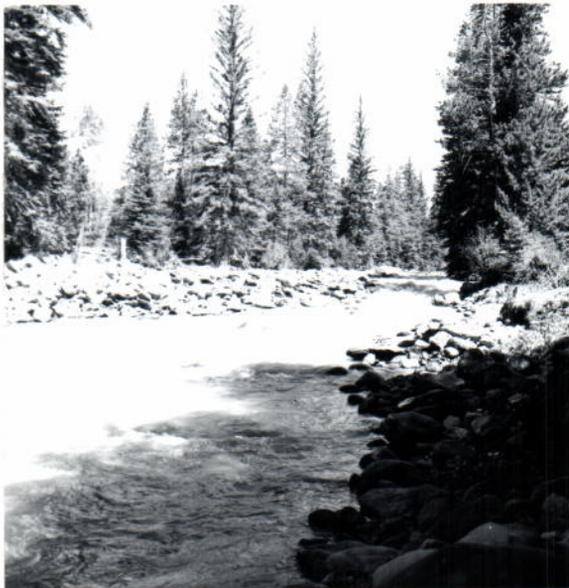
"L" Station 508 - Loose rock heaved up, and blocks some of the original channel. No streamside vegetation left, or chance for regrowth along right bank. Downstream section gouged 3' to 4'.

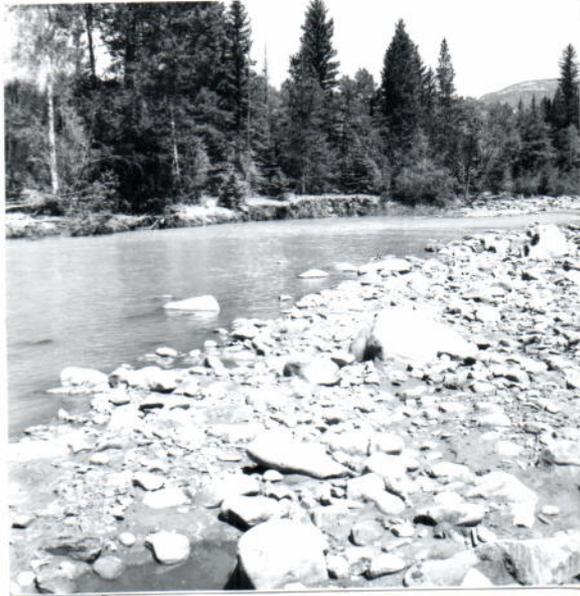
"L" Station 509 - Location is Aspen Camp Ground, where flood wiped out wide stretch of vegetation along left bank, and forced part of stream into new channel. Unstable bank on right side of stream needs protection. It is quite likely that the stream will be put back into its original channel at this station and station 510 because (1) it is running through Aspen Camp Ground, (2) The original channel downstream is in good condition.

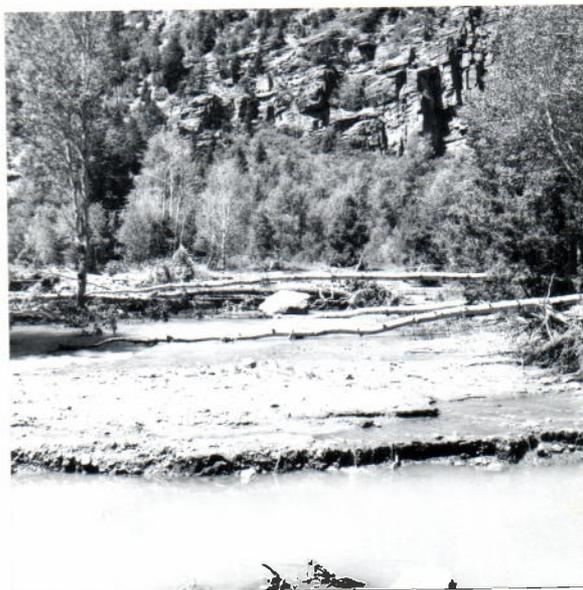
"L" Station 510A - This picture is taken across the section of Aspen Camp Ground, where the flood made a swath 200' to 250' wide. A good share of the stream now flows through the camp ground here. It is quite likely that the stream will be returned to the original channel at this station.

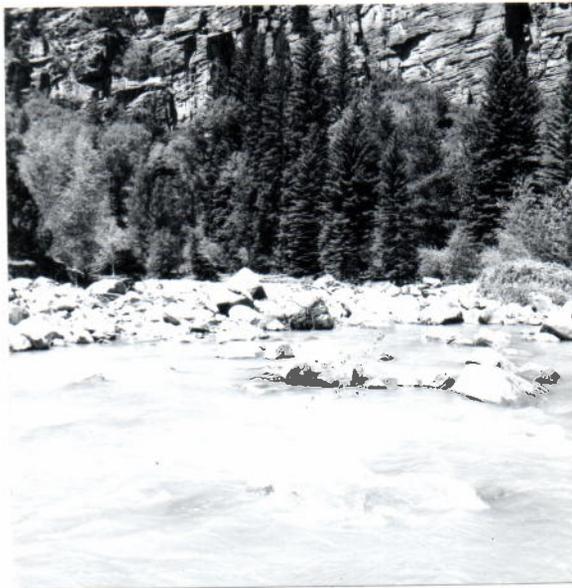
"L" Station 510B - The loose rock material shown here prevents the stream from flowing in the original channel. It is likely that the same material will be used to return the stream to its original channel, which is in good condition downstream from this station.

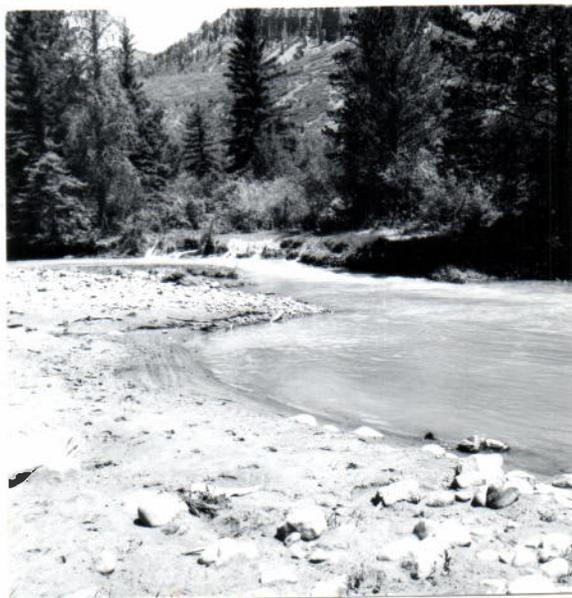
"T" Station 511 - Shows water lost from normal channel at station 510, returning to the normal channel 300' to 400' downstream.

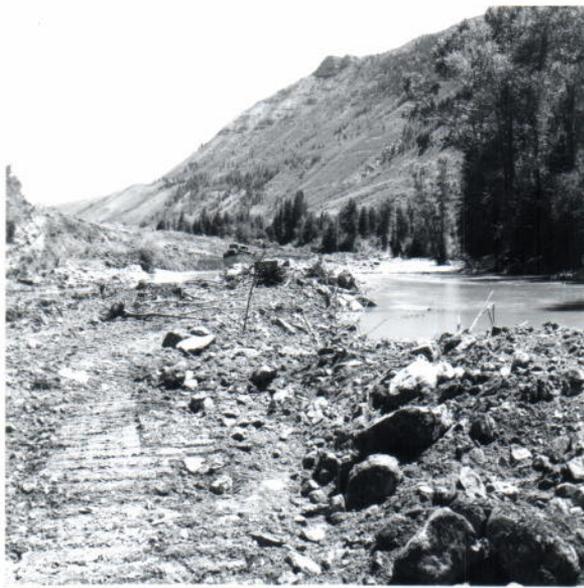
"L" Station 603 - Shows canal repair by (U.S. Army). This is just downstream from diversion dam. Disturbance is only temporary, providing that adequate protection is given the dike.

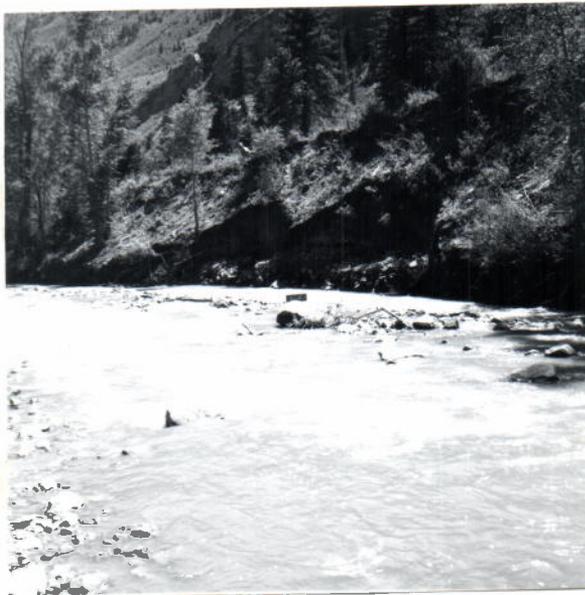
"L" Station 604 - Just downstream from where canal is taken out. Right bank is unstable for a distance of 300' + , and needs protection. Appears that the channel has been gouged 2' to 3' at this station.

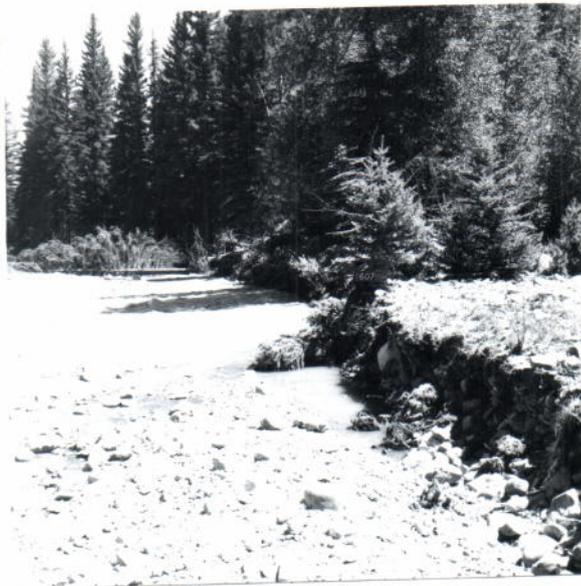
"L" Station 607 - The original channel is 40' to the left. It is plugged with boulders. The right bank is unstable and needs protection.

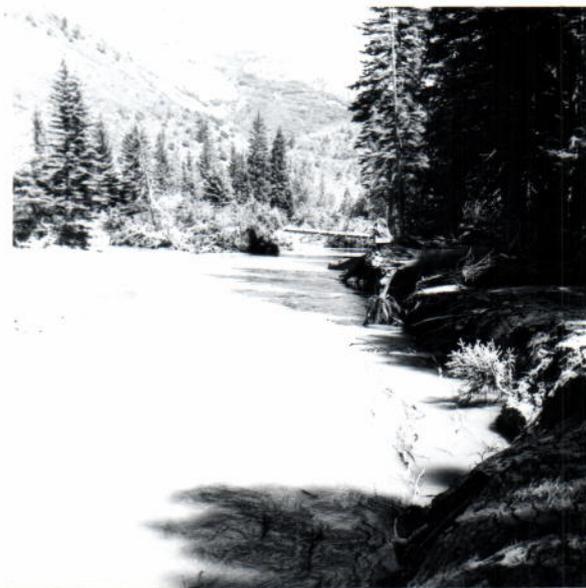
"L" Station 608 - Is approximately 100' downstream from station 607. The loose rock projecting into the stream, on the left side of picture is probably where channel should be. The stream has moved to the right and the right bank needs protection.

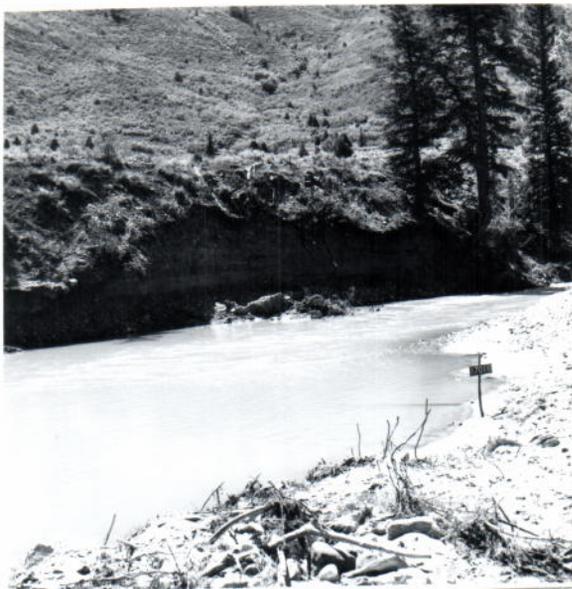
"L" Station 701 - Approximately one-tenth mile above start of seventh mile. Right bank is high cut and needs protection. Stream again has moved to the right, and the original channel is plugged with rock.

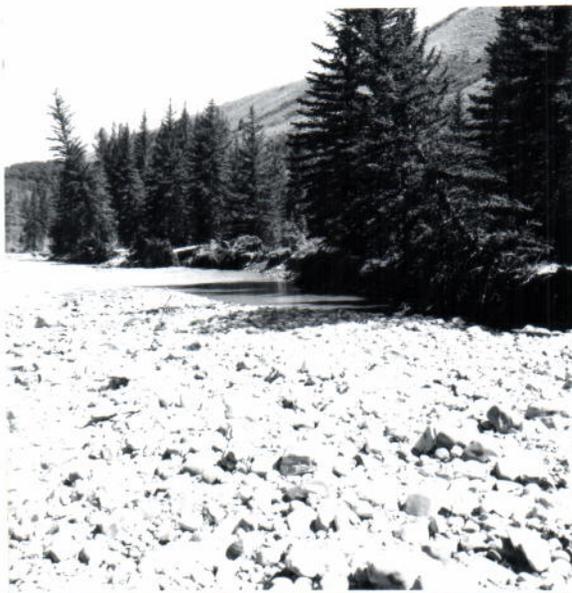
"L" Station 702 - Taken from center of original channel, which is now a pile of rock. The right bank is unstable and the water is undercutting the conifers.

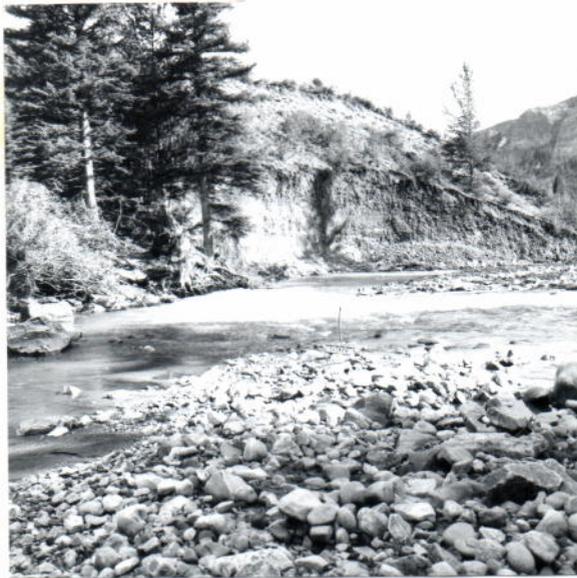
"I" Station 802 - High cut left bank on bend, needs protection.
Channel has narrowed, velocity of stream increased.

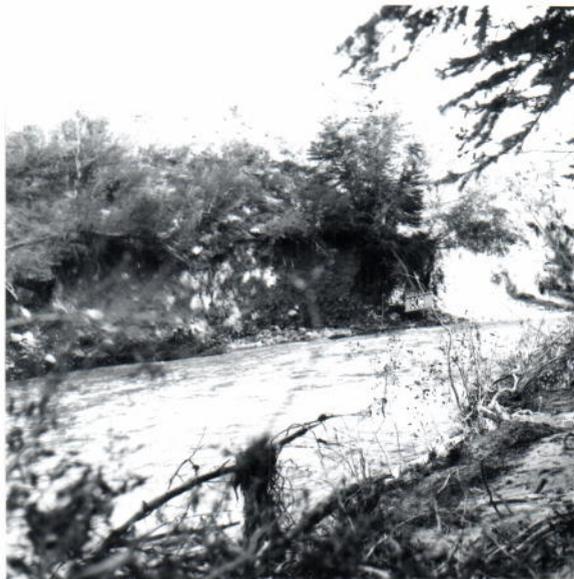
"I" Station 803 - High cut left bank, on bend. Should be protected.
