Hugh A. McKellar

ENGINEER

January 9, 1970

Reference is made to your letter of December 17, 1969, in connection with the washout of the Timpanogos Canal.

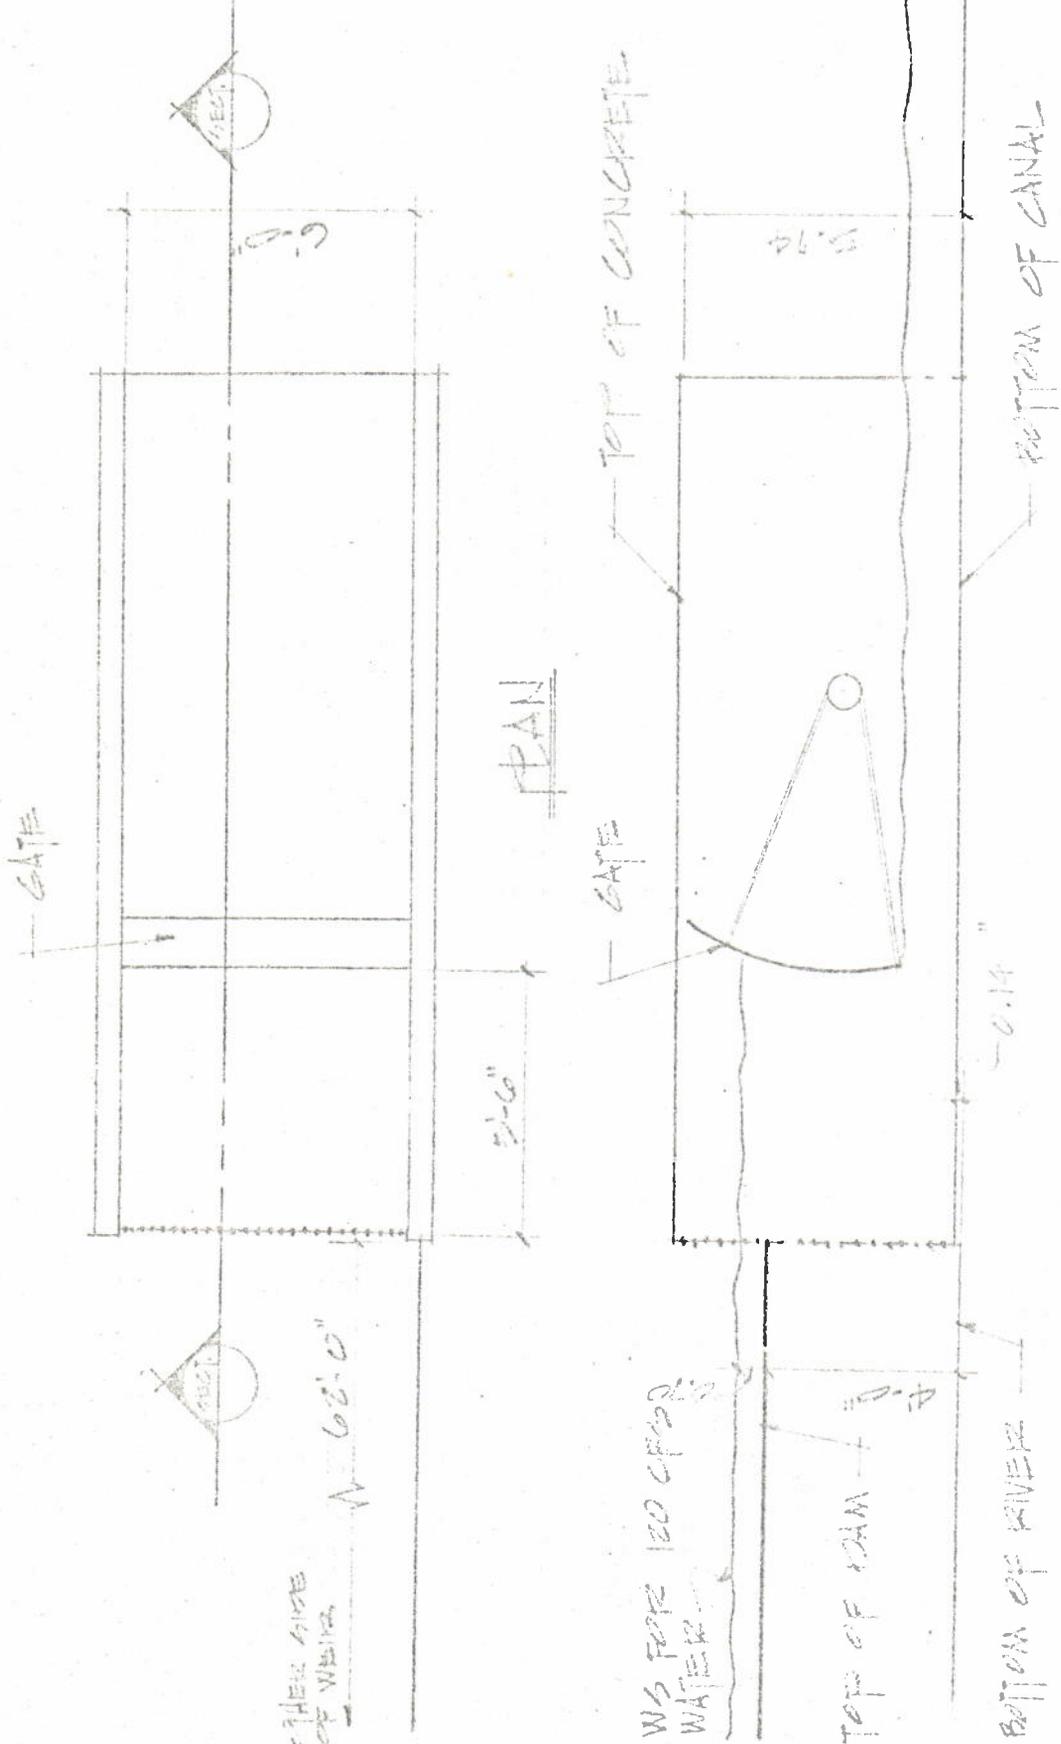
CANAL SECTION

During this period the Timpanogos Canal was carrying 13.5 CFS. The width of the diversion dam for the Timpanogos Canal is 62 feet; 120 CFS flowing would raise the water surface at the diversion dam 0.70 feet.

It is not known whether the canal gate was wide open or not. This is something I do not check. It is difficult to keep this canal regulated, because it is the only one between the power company flume inlet and outlet and picks up any extra water that might come down the river from any source. Quite often it gets more water than the decree specifies. If the canal gate were closed to an area of 2 square feet, a head difference of 2 feet (assuming submerged orifice) would permit 13.7 CFS to flow. Increasing head difference to 2.70 would permit 16.10 CFS to flow.

Enclosed is a sketch showing the relationship between the elevations of the canal bottom, the top of the diversion dam, and the water depth over the dam for a flow of 120 CFS.

The Timpanogos Canal has no bypass or other safety device to prevent a flush of water from going down the canal and causing damage. Most of the other canals in the area do not have any safety bypass and are susceptible to flood damage from unannounced flushes of water. It would appear that a little money spent for safety features could prevent a lot of damage claims.
