# FIELD INSPECTION REPORT FOR PRICE RIVER DISTRIBUTION SYSTEM

Prepared by Gertrudys Adkins  
Field Inspection date: July 6, 2004.

PRICE RIVER DISTRIBUTION SYSTEM TOUR OF DIVERSIONS ( 7/6/2004)

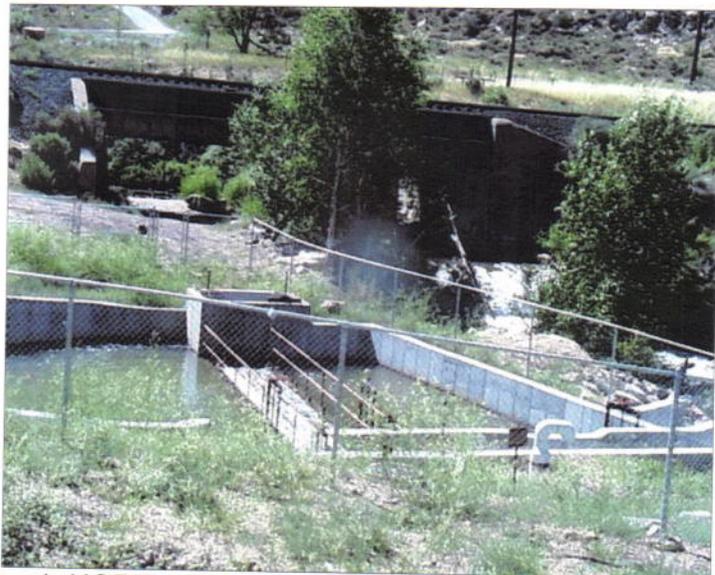
1: NORTH CARBON GROUP DIV. STRUCTURE

There is a pipeline at this diversion that was recently built and diverts water for the following water users: Spring Glen Canal Company, Bryner Hansen Canal Co., Stowell Ditch, and Oberto Ditch. Bryner Ploutz Canal Company has a separate pipeline that originates at this point. The North Carbon Group has direct flow rights as well as reservoir rights. The pipeline capacity is about half of the combined water rights flows. The pipeline has a 40-inch diameter, which later is reduced to 36 inches. There is a sedimentation pond at this diversion. Water is measured downstream with an Ultrasonic meter. The meter sometimes stops working and thus the totalizer does not indicate all of the usage. Picture #1: Diversion structure and pond. Picture #2: Diversion headgate. Picture #3: Meter.

→ North Carbon Ditch - Pict 2 Div. Headgate  
Pict. 1 Div. structure to pipeline

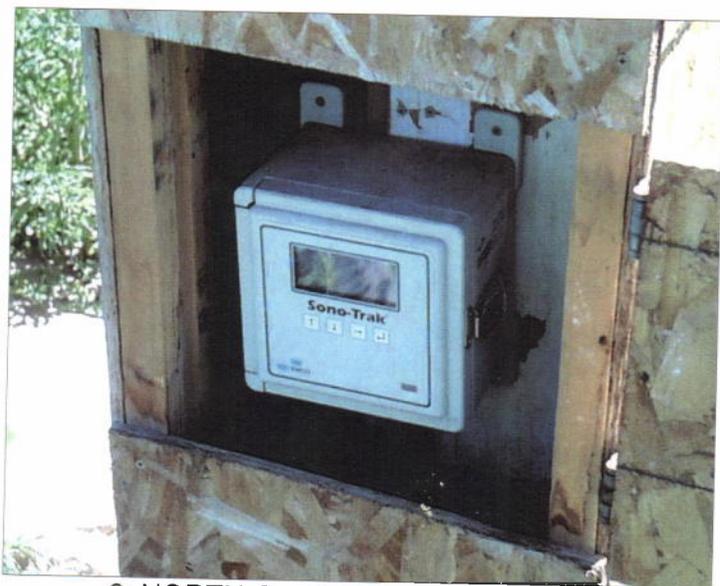
3: NORTH CARBON GROUP METER

In the past the main meter has stopped working so the totalizer does not indicate all usage.

North Carbon Group Meter by Gigliatti Pond  
Som-trax by EMCO ultrasonic meter Pict 3.

**Recommendation:** The meter should be maintained regularly to assure proper operation and accuracy.

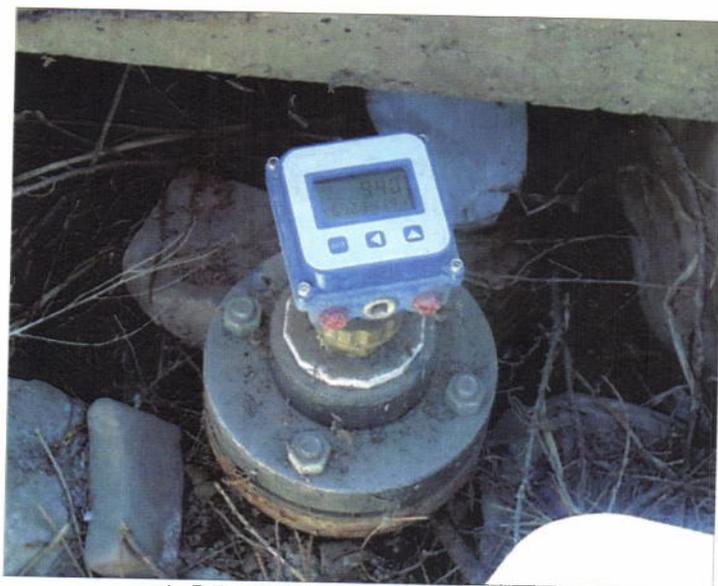
4: BRYNER-HANSON METER

This diversion splits out of the main pipeline. A few feet downstream there is a meter on the pipeline that records the flows at this diversion. The meter reading is constantly fluctuating, indicating that the flows maybe surging and not stable. At the time of the visit the meter reading was showing a flow varying from 750 to 900 gallons per minutes. The meter appears to be not working properly. Picture #4: Meter. Picture #5: Pipeline split structure.

Pict 4 meter shows in gpm (range 700-900+)  
it seems that the flows are surging - not stable  
Pict 5 split pipe structure

**Recommendation:** It is recommended that this meter be inspected regularly for accuracy.

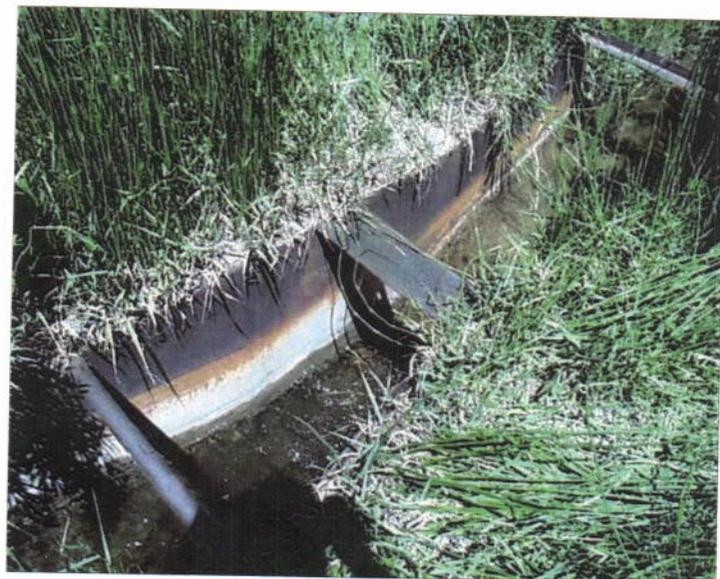
6: BRYNER-PLOUTZ DITCH 18" FLUME

There is an 18-inch Parshall Flume at this diversion that is tilted about 0.10 inch from side to side. The flume is also silted in. Some rust was observed on the side of the flume and on the staff gage. The channel has a lot of vegetation. Picture #6: Parshall flume.

The flume is tilted as 0.10" from side to side & silted in. The channel needs to be clean up & the flume re-set.

The flume is rusted in the side & the stop gage is also rusted.

**Recommendation:** The flume needs to be reset and the channel cleaned up to accurately measure the flows.

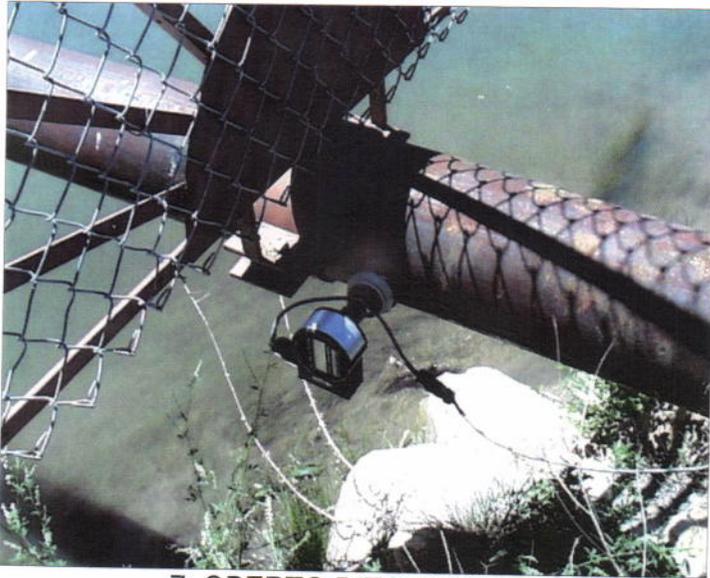
7: OBERTO DITCH METER

This diversion consists of a pipeline originating from the main North Carbon Group's pipeline and a meter. The meter is Hydro-flow Series by EMCO Flow System (Picture #7). There was no water diverted at the time of the visit.

Hydro-flow series by EMCO Flow systems  
It shows no flows at time of visit.

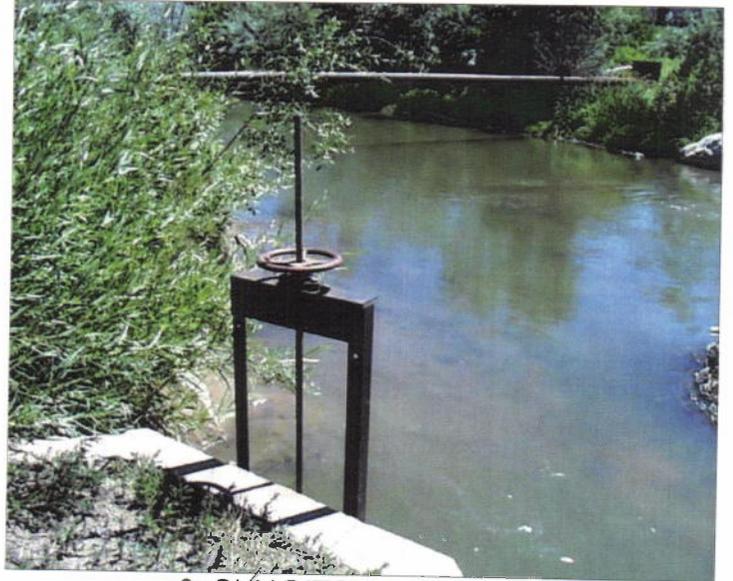
8: GUY DITCH DIVERSION

There is a small headgate at this diversion and it is in good condition. A 1-ft parshall flume located downstream on the ditch was inspected and found to be level in both directions and is operating well. Discharge measurements were taken upstream from the flume. The flow registered by the flume was 1.96 cfs while the amount measured was computed to be 2.2 cfs. The water entering the flume a little too fast may have caused lower flow reading at the flume. Also, immediately before the flume there is a headgate and cement box that causes the water transitioning into the flume to be a little turbulent. The flume staff gage reads directly in cfs. Picture #8: Diversion headgate. Picture #9: Parshall flume.

Guy Litch Diversion  
pic 8 good condition.

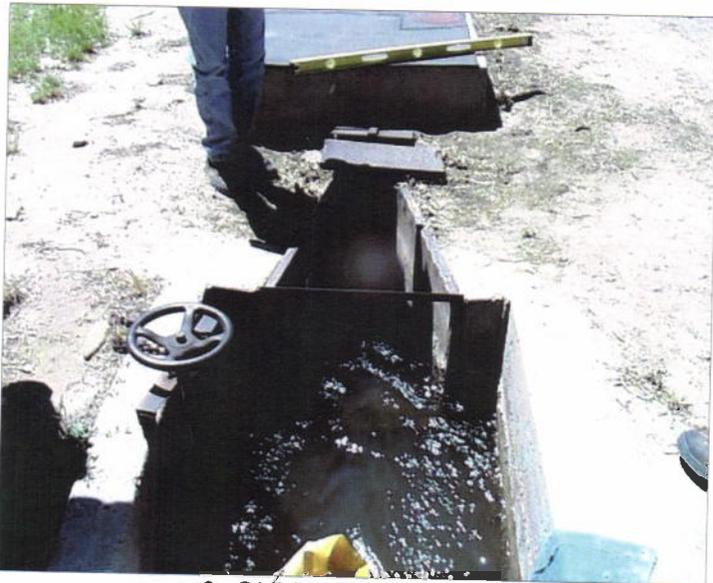
9: GUY DITCH FLUME

The flume is working good

The staff gage is showing a flow of 2.25 cfs  
The measurement taken upstream in the  
ditch computed as 1.96 cfs. The flume was  
reading a little high may be due to the  
setting at the entrance in which a drainage  
& headgate are located.

The flume was level in both direction.

**Recommendation:** It is recommended that the water commissioner use his staff gage with level readings and the standard tables to read the flows. Thus reducing the possibility of introducing errors when reading direct flows from the flume staff gage.

Rec: The Commis. should also use his staff gage  
to check level & cross reference the readings in  
the direct staff gage w/ tables.

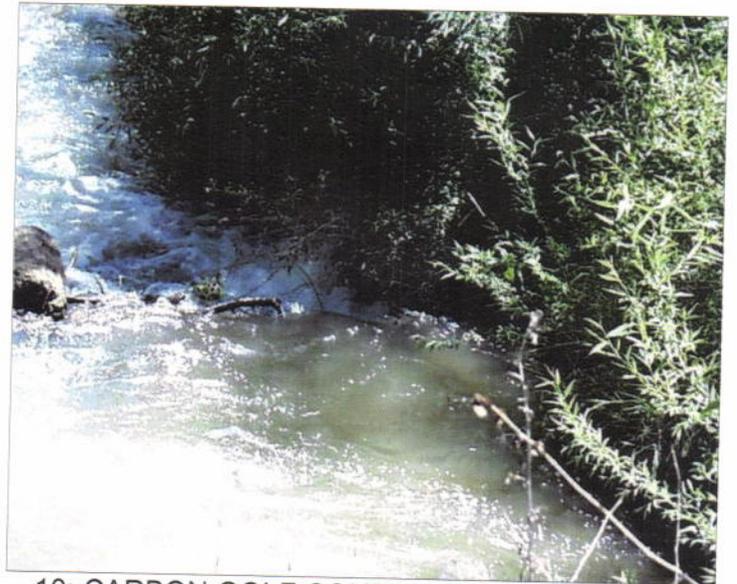
10: CARBON GOLF COURSE DIVERSION GATE

There is a small head gate a few yards below the Price Wellington Diversion structure that diverts water to one of the Golf Course ponds. Picture # 10: Diversion headgate.

Golf course slide gate pic 10 below the price-well  
the golf course pump water lead to a <sup>Div</sup> tank  
small pond & water return back to creek.

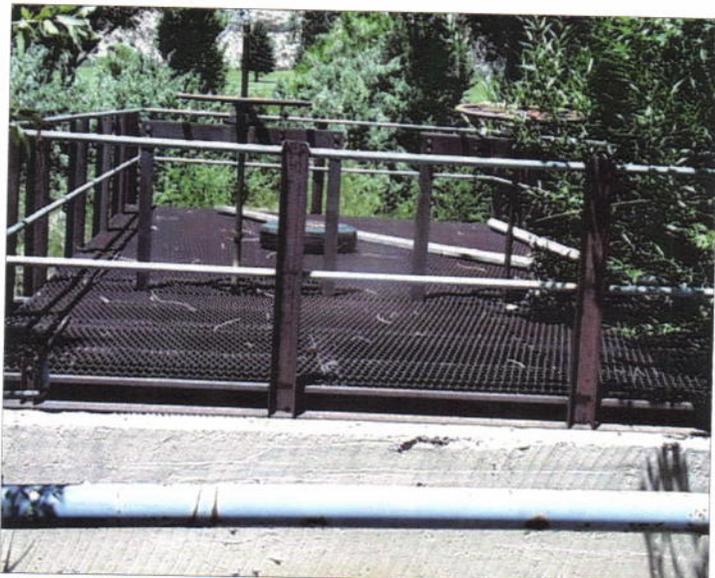
11: PRICE WELLINGTON DIVERSION STRUCTURE

No significant changes have occurred with this diversion since our last visit in the year 2000. Downstream from the main diversion structure there is 10 ft concrete Parshall flume that is in good condition. A good hydraulic jump is formed at the flume's exit. The canal is clean and well maintained. No current meter measurements were taken at this flume. The staff gage showed a reading of 0.95 ft at the time of the inspection. Picture #11: Diversion structure. Picture #15: Concrete flume.

Price Wellington <sup>Div Headgate</sup> pic 11

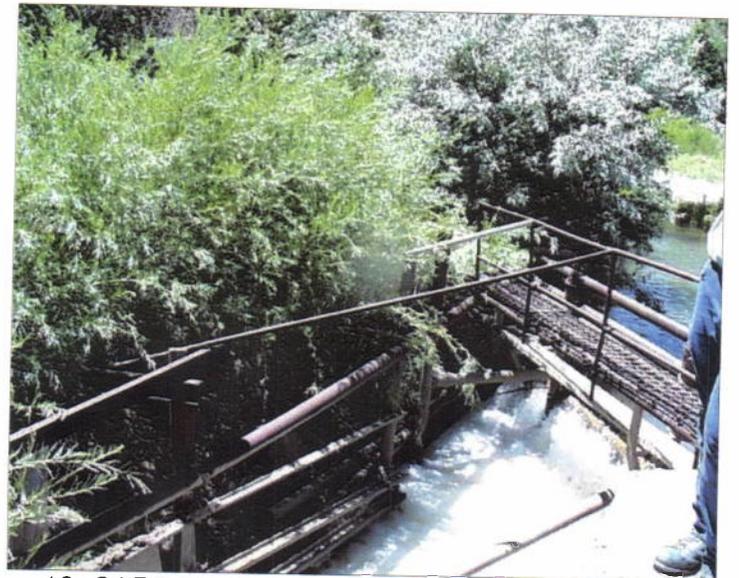
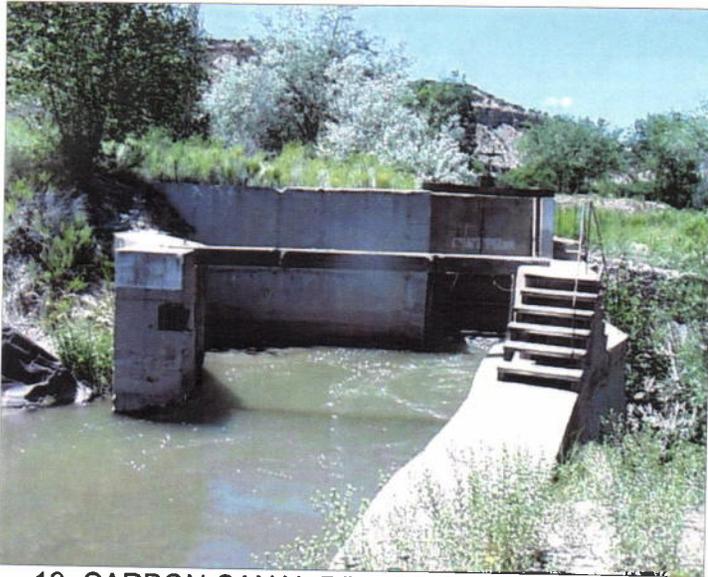
12: CARBON CANAL DIVERSION STRUCTURE

No significant changes have occurred with this diversion since our last visit in the year 2000. The 10 ft concrete Parshall flume was level and operating properly. The channel is clean and well maintained. The flows were measured at 47.45 cfs while the discharge table indicated a flow of 47.25 cfs. This diversion is the last diversion in the system. In regulating the flows in the river, the water commissioner checks all the diversions upstream from this diversion, then he checks the Carbon canal and decides if more water should be released from the reservoir to supplement flows in the river. Pictures #12 & 13: Diversion structure. Picture #14: Concrete flume.

Carbon Canal Div. Structure pic 12 & 13

This Div. has not changed any in the last  
A years since our last visit. The Comm. after  
he checks all his diversion & come check this one  
it tells him if he needs to open up gates

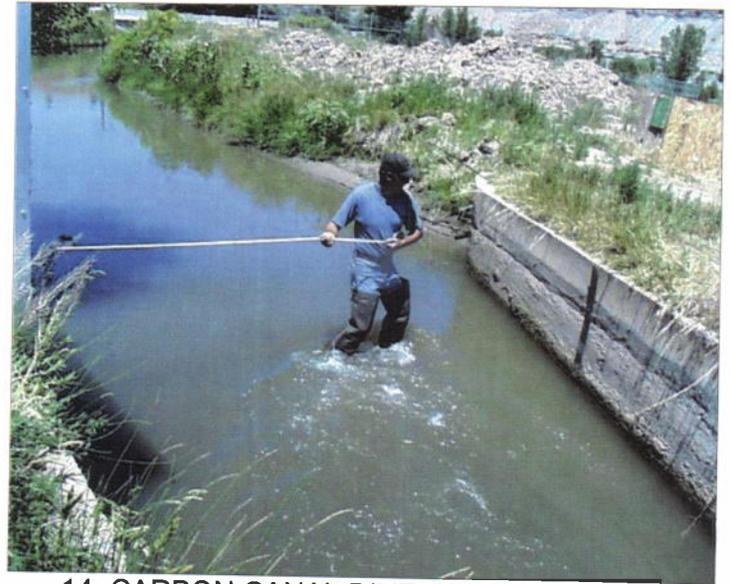
14: CARBON CANAL DIVERSION 10' FLUME

10' flume - concrete - good shape & <sup>worn</sup> <sub>good</sub>  
Current meter <sup>parshall</sup> measurements for this flume  
was 47.45 cfs. & staff gage 1.12 = 47.2 cfs

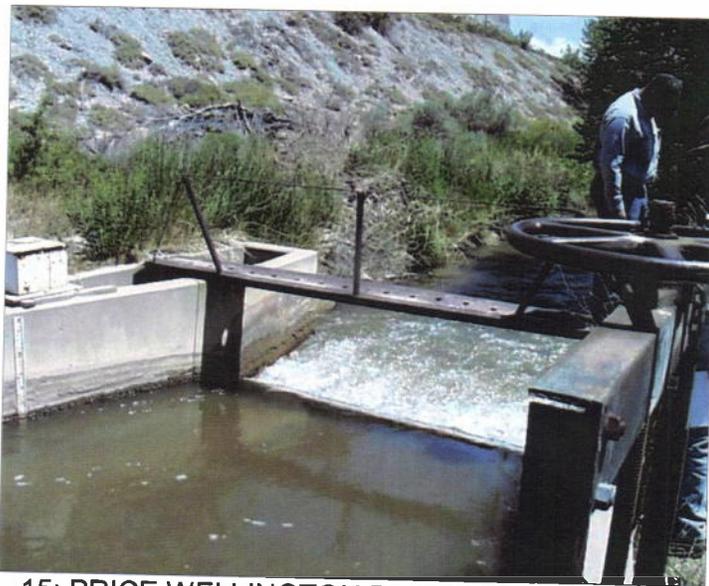
15: PRICE WELLINGTON DIVERSION 10' FLUME

Price - Wellington flume - <sup>10 ft</sup> parshall  
the flume is in good shape & good exit & entrance  
conditions & hydraulic jump.  
staff = 0.95'
