FRACTURING AND SUBSIDENCE OF THE LAND SURFACE CAUSED BY THE WITHDRAWAL OF GROUND WATER IN THE MILFORD AREA, UTAH

By R. M. CORDOVA and R. W. MOWER, Salt Lake City, Utah

Prepared in cooperation with the Utah Department of Natural Resources

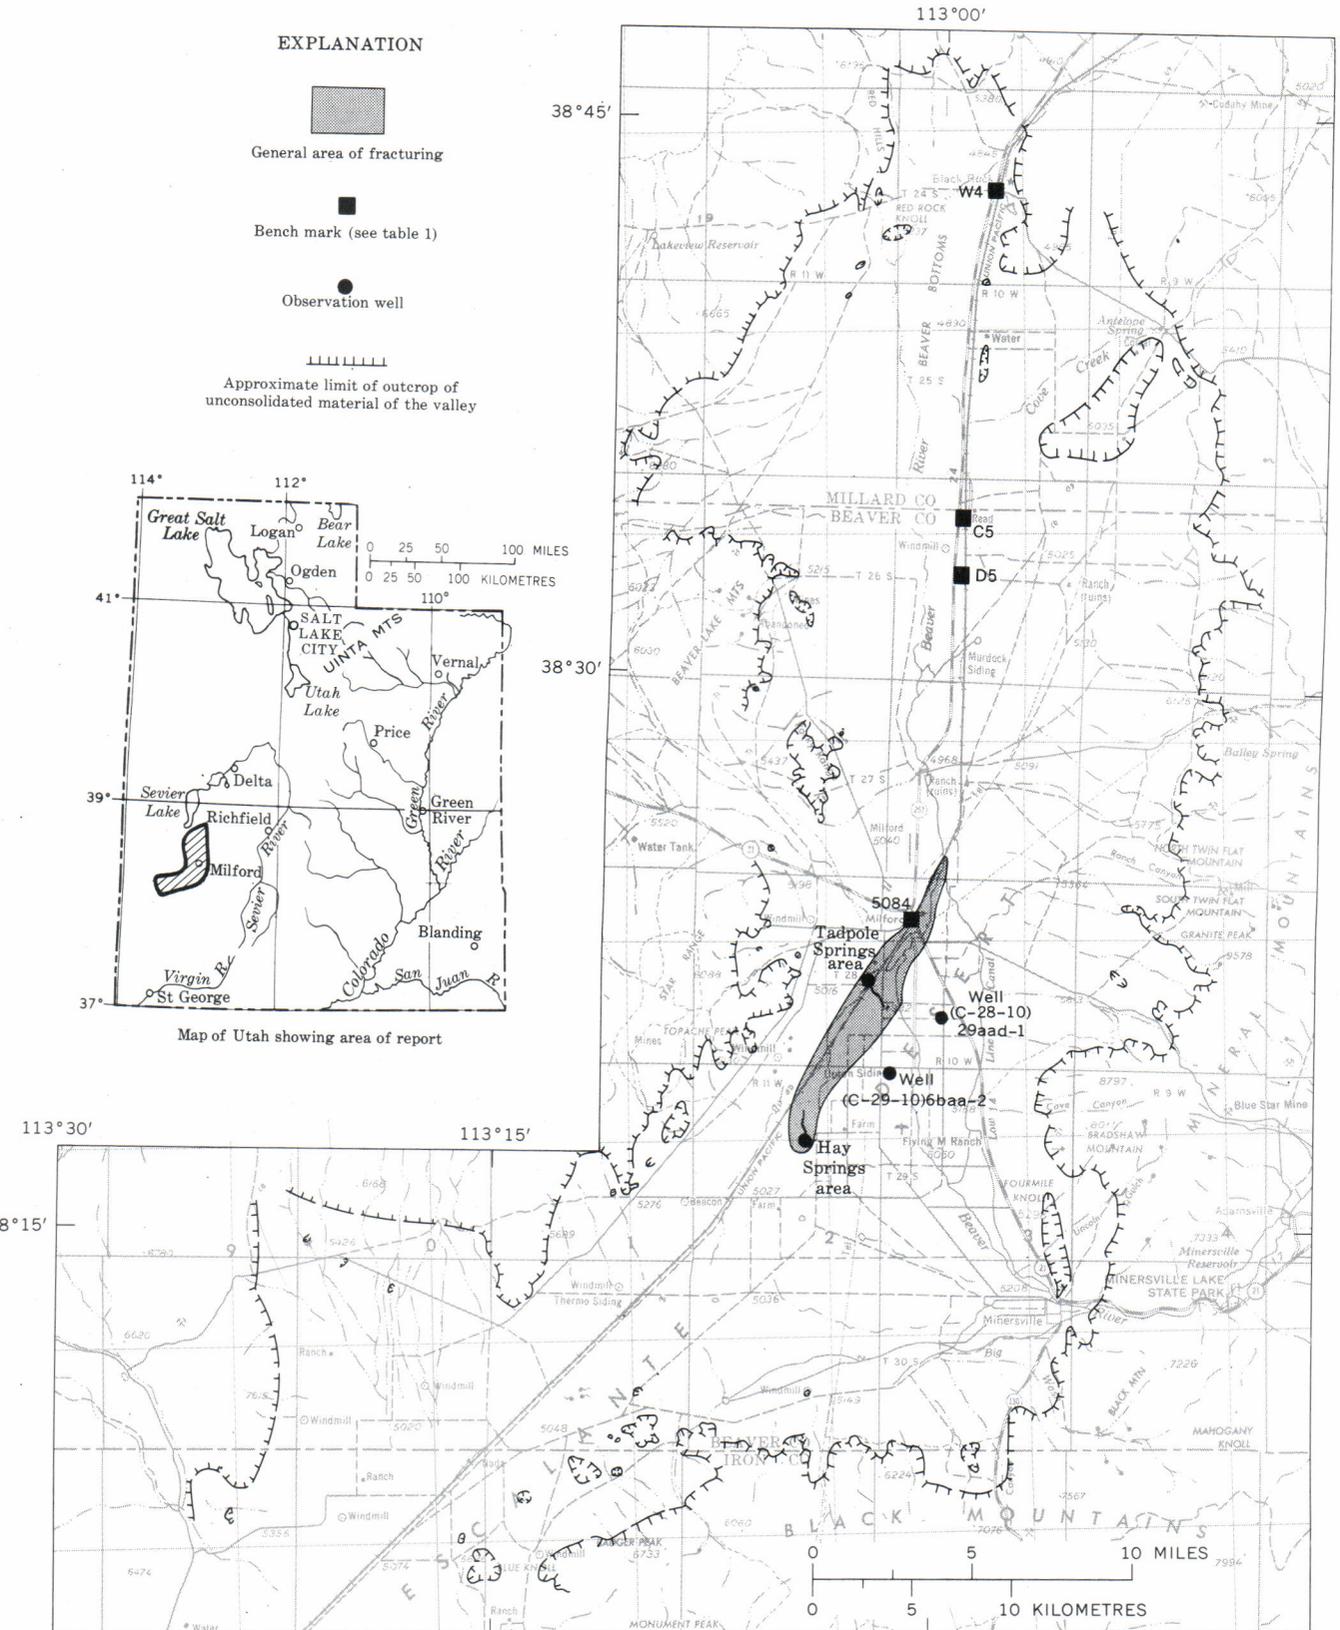
The fracturing is in an area about 1 mile (1.6 km) wide and 11 miles (18 km) long, extending mostly southwest of Milford (fig. 1). The fracturing has developed in the upper part of the principal ground-water reservoir in an unsaturated clay-silt zone which is peaty at top in the Hay Springs area. The clay-silt zone ranges in thickness from about 3 feet (1 m) to about 40 feet (12 m) but most commonly ranges from 15 to 25 feet (5 to 8 m). The largest fractures are in Tadpole Springs and Hay Springs areas (fig. 1), both of which are now dry. The photographs in figures 2 and 3 show examples of the fracturing.

FIGURE 1.—Location of the Milford area, approximate limit of outcrop of unconsolidated materials of the valley, and selected information pertaining to fracturing and subsidence of the land surface.

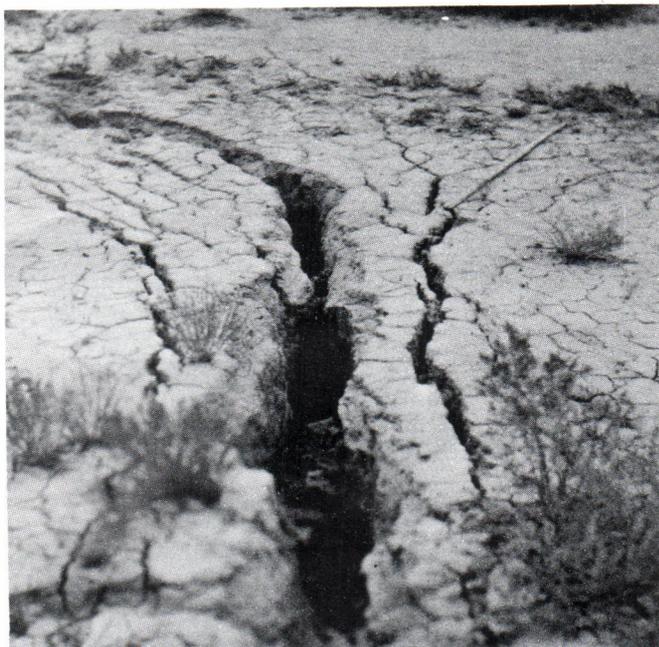
FIGURE 2.—Linear fracturing in the SW $\frac{1}{4}$ SW $\frac{1}{4}$ NE $\frac{1}{4}$ sec. 24, T. 28 S., R. 11 W., in the Tadpole Springs area. The stick at upper right is 4 feet (1.2 m) long. Photographed October 5, 1972.

The fractures are generally linear, but some are elliptical; they range in length from several feet to more than 100 feet (30 m). Linear fractures that intersect form polygons similar to those formed in drying mud. Most polygons range in longest diameter from about 3 feet (1 m) to about 40 feet (12 m).

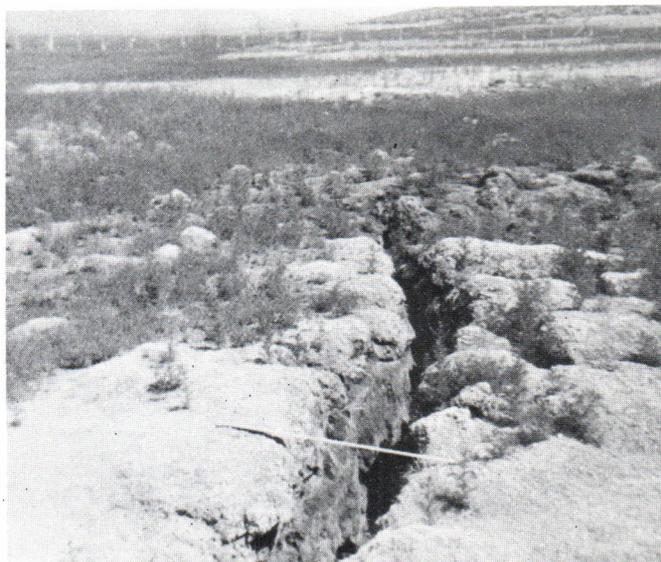
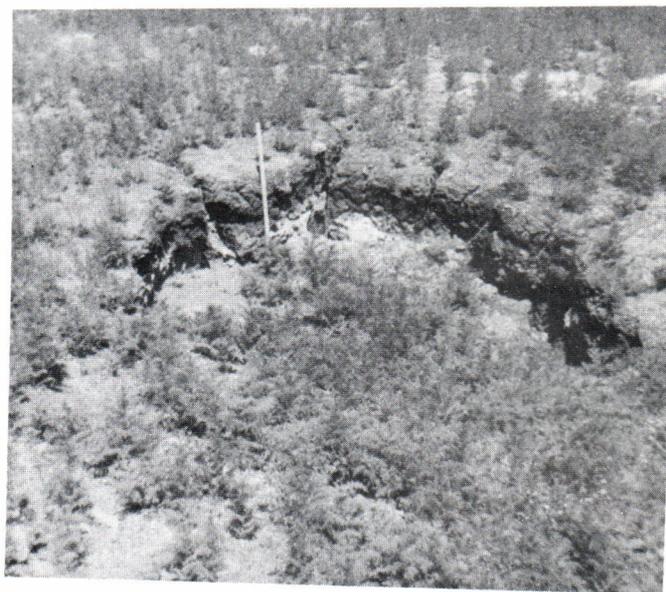
The collapse structures (see fig. 3, bottom photograph) include small grabens and elliptical sinks bounded by normal faults. These structures are in the areas of the Tadpole and Hay Springs and also in the SE $\frac{1}{4}$ sec. 7 and the west half of sec. 18, T. 28 S.,

FIGURE 3.—Linear (top) and elliptical (bottom) fracturing and land subsidence of near-surface origin (collapse structure) in the NE $\frac{1}{4}$ NE $\frac{1}{4}$ NE $\frac{1}{4}$ sec. 15, T. 29 S., R. 11 W., in the Hay Springs area. Metre stick is scale. Photographed May 16, 1973.

R. 10 W. The maximum amount of subsidence by collapse structures in the Hay Springs area is about 6 feet (1.8 m) and about 2 feet (0.6 m) in the other areas.

Fractures and near-surface subsidence were caused by the dewatering of part or all of the clay-silt zone after pumping of ground water from aquifers beneath the zone had lowered the potentiometric surface. Prior to about 1950, the potentiometric surface was near or above the land surface in the area of fracturing, and the clay-silt zone was saturated by ground water. After lowering of the potentiometric surface, at least the upper part of the clay-silt zone was no longer saturated. The clay-silt and peaty materials dried, and contraction, fracturing, and subsidence resulted during the processing of drying. Fracturing of the land surface due to ground-water withdrawal has been reported in States other than Utah; for example, see

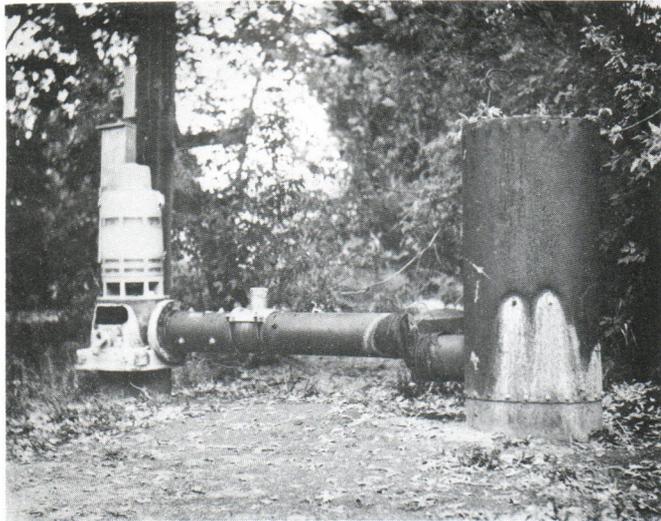
Casings of at least two wells in the most heavily pumped part of the valley protrude higher above the land surface than when they were installed. A result of land subsidence is shown in figure 4. Well (C-29-10)6baa-2 was drilled in 1953; therefore, the subsidence of at least 0.33 foot (0.10 m) at the well occurred during the period of heavy pumping that began in 1950 (fig. 5). Subsidence at a second well (C-28-10)29aad-1, for which the drilling date is un-

FIGURE 4.—A result of land subsidence at pumped well (C-29-10)6baa-2. Discharge pipe between standpipe and well is displaced vertically 0.33 foot (0.10 m) at flexible connection. Photographed October 5, 1972.

the discharge pipe of well (C-29-10)6baa-2 (fig. 4) indicates at least 0.33 foot (0.10 m) of subsidence.

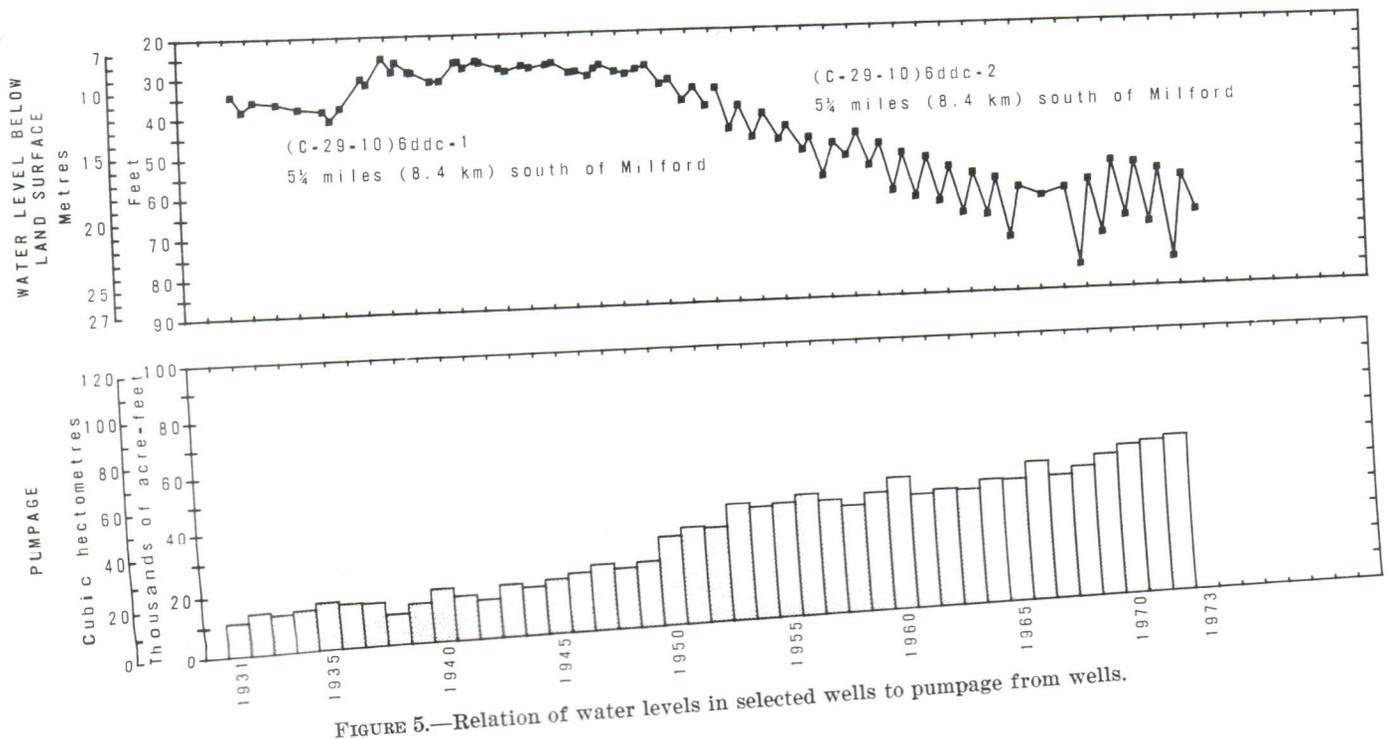
FIGURE 5.—Relation of water levels in selected wells to pumpage from wells.

Withdrawal from the ground-water reservoir began in the Milford area in the early 1900's (about 1914 for irrigation) and increased gradually until 1950. Since 1950 the annual rate of withdrawal for the entire area (mainly for irrigation) has increased markedly (fig. 5). Coinciding with the increased withdrawal rate was a fairly steady decline of water levels in most of the valley. The decline of the potentiometric surface from March 1960 to March 1972 is shown in figure 6.

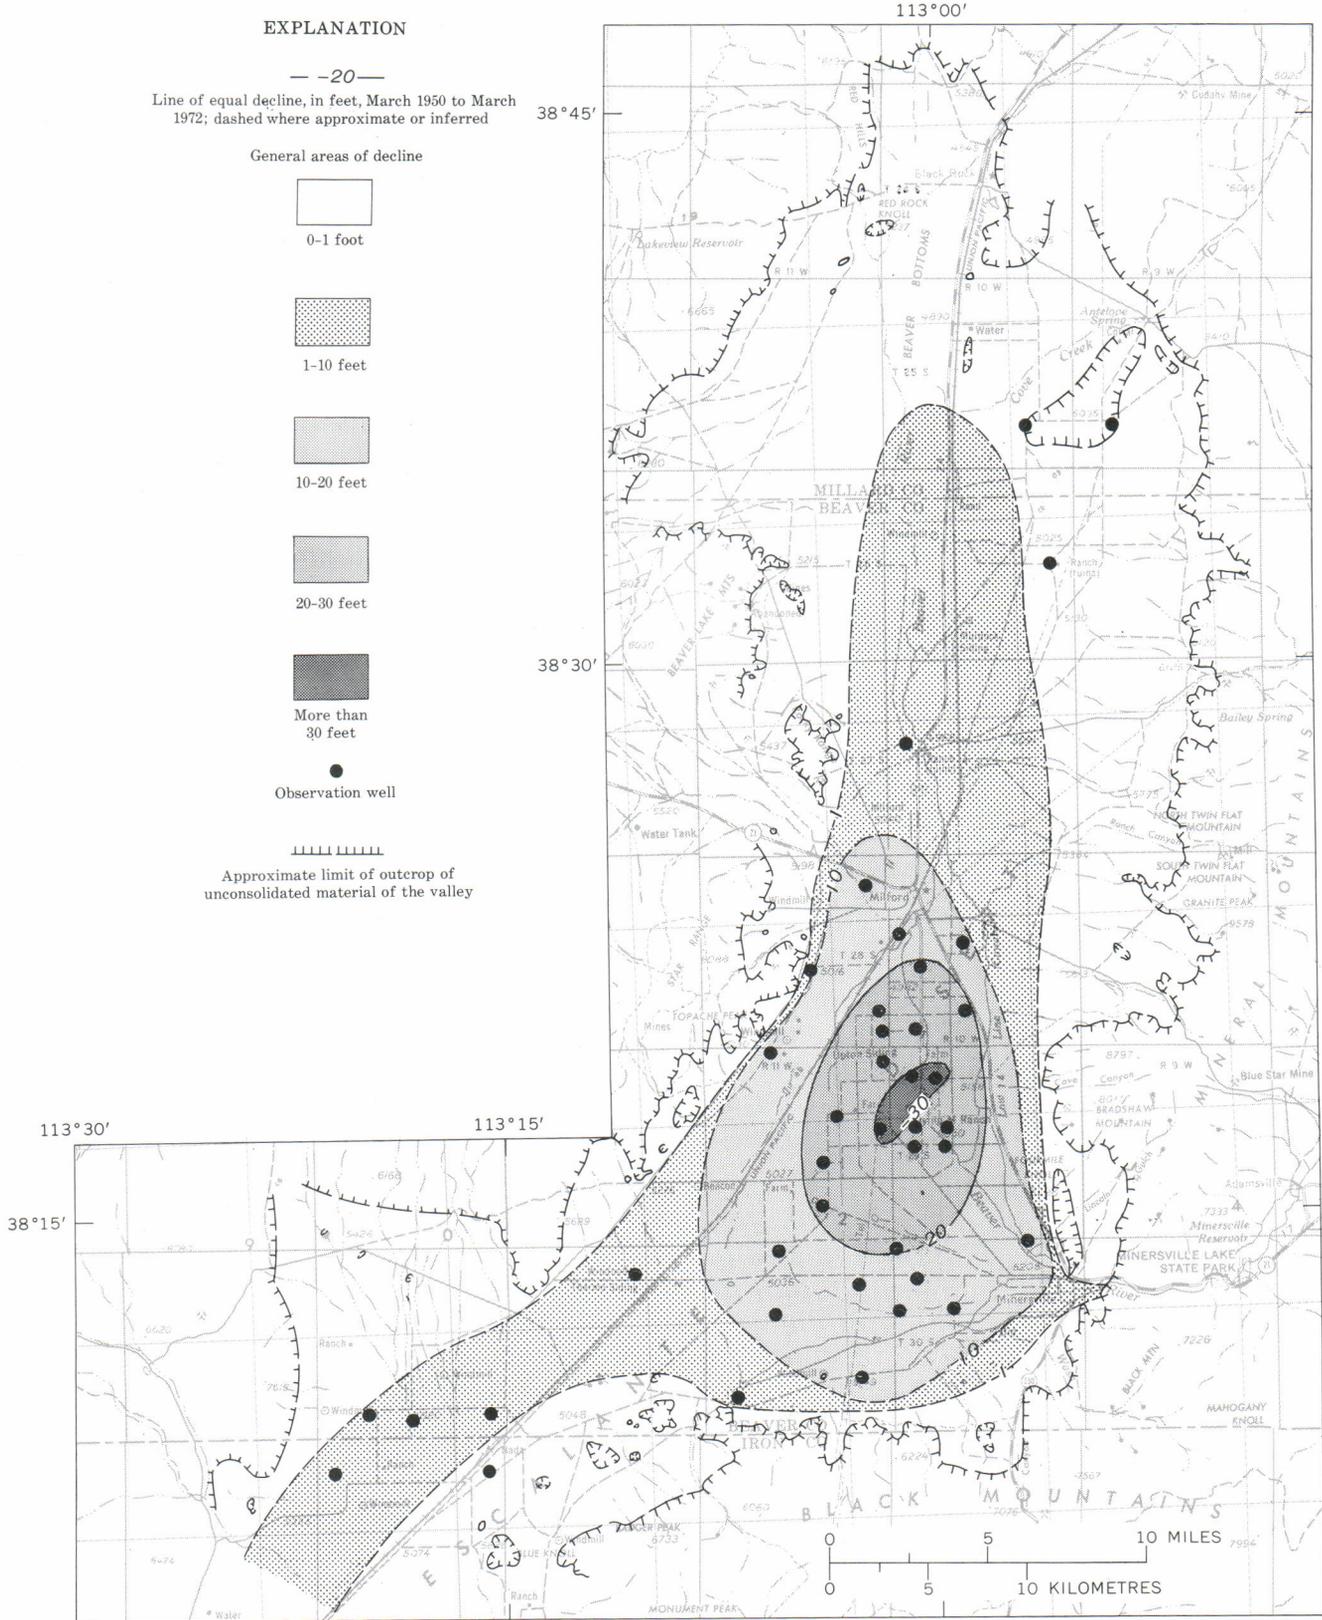
FIGURE 6.—Decline of the potentiometric surface of the principal ground-water reservoir from March 1950 to March 1972.
