## Panguitch Lake

## PROJECT REPORT

<b>Project No.</b>	202404-002		
<b>Project</b>	Panguitch Lake Dam		
<b>Day / Date</b>	Tuesday / April 9, 2024	<b>Weather</b>	Mild, Temp in 50's
<b>Report By</b>	Brad Price	<b>Position</b>	Geotechnical Engineer

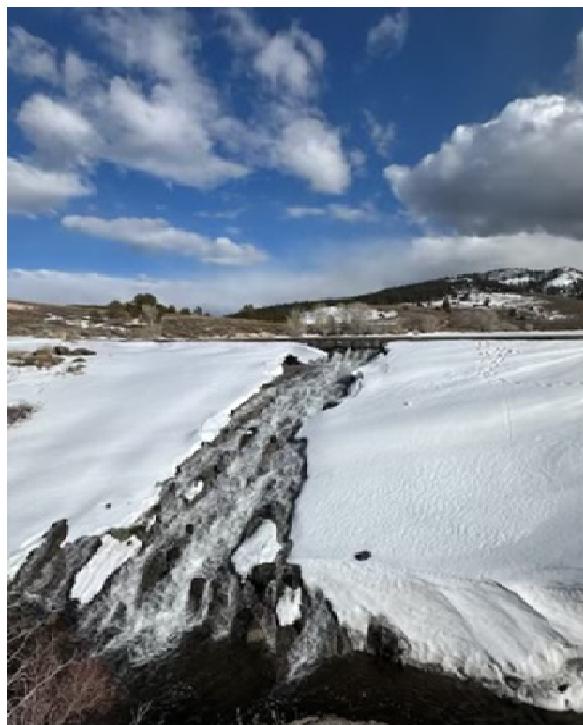
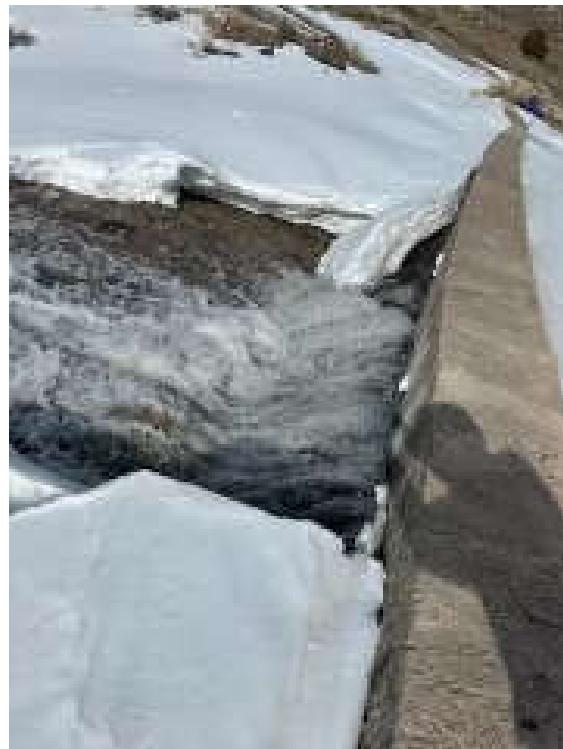
I observed conditions upon arrival with Mac Hatch and Matt Call (State Dam Safety Assist. Engineer). Water is flowing through cracks at the contact between the parapet wall and the masonry rock foundation east of the main dam. The parapet wall is about 2 foot wide and appears to be bowed in the center. The concrete wall appears to be about 2 high and sits on a masonry rock foundation. The major flow section appears to be about 25 foot wide where it has cut through

the ~2 foot of snow covering. It is likely that additional flow is occurring beneath the snow cap going to the east or right when looking at the dam from the reservoir side. I estimated the observed flow in the 20 to 25 cfs range. The total flow from the outlet works and seepage combined, as measured at the downstream weir is 160 cfs. They have a tilt meter sitting on the wall. It was reported that a 60 foot section of the wall had tilted 8 degrees downstream on Monday night and had rotated back to a 5 degree tilt during the day on Tuesday. The tilt was visually obvious. Mac said that the trencher on K-rails were scheduled to be on site at 7 am tomorrow morning. A light plant was being set up and the sheriff's department would monitor flow, measure tilt and observe conditions throughout the night. Garfield County had equipment and crews on standby to assist. They said they could begin snow removal from the downstream right abutment tonight if necessary and Mac said he could get the equipment and materials up to the site tonight if needed.

After assessing the existing conditions and history of what has transpired since the leakage was first discovered on Monday, my recommendation was to begin remedial action in the morning at daylight. My major concern was that the freezing night temperatures may cause additional wall tilting. I recommended that the sheriff's department call Mac if the tilt exceeded 8 degrees and that Mac call me so we could get up to the site. We went over our plan with Matt Call and he was in agreement with the planned course of action.

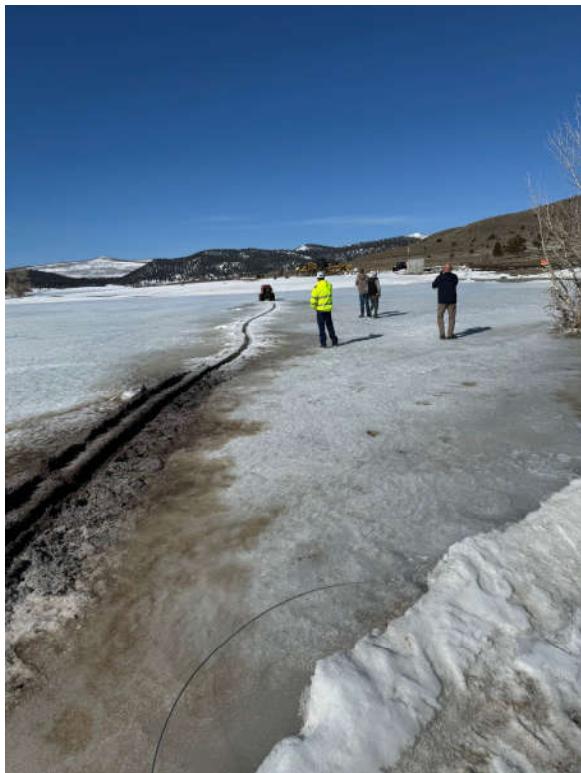
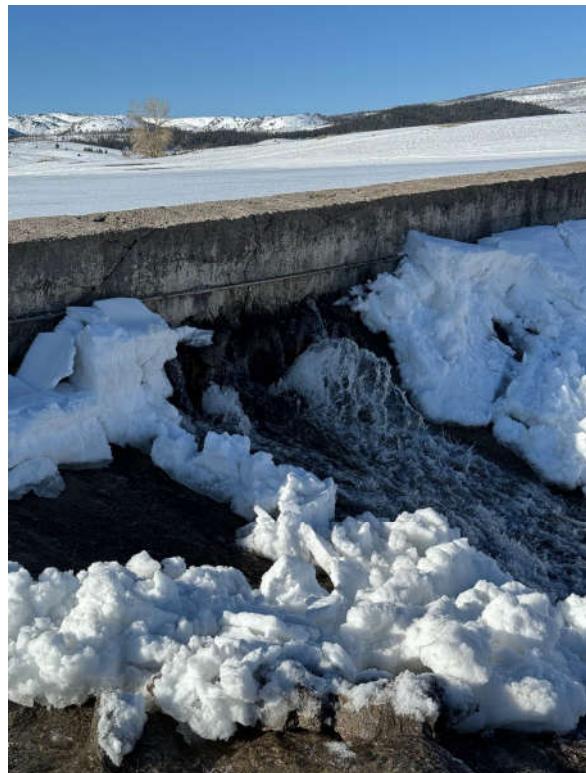
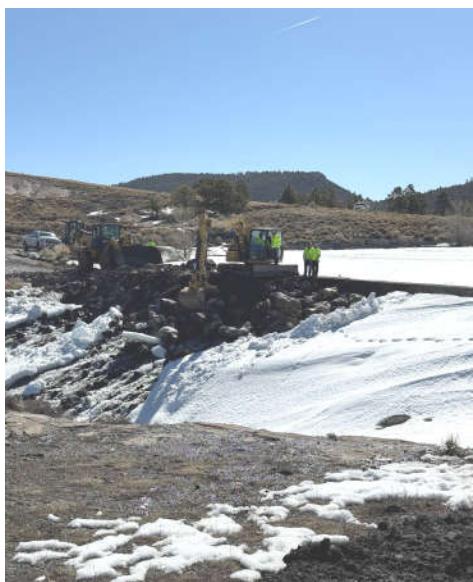
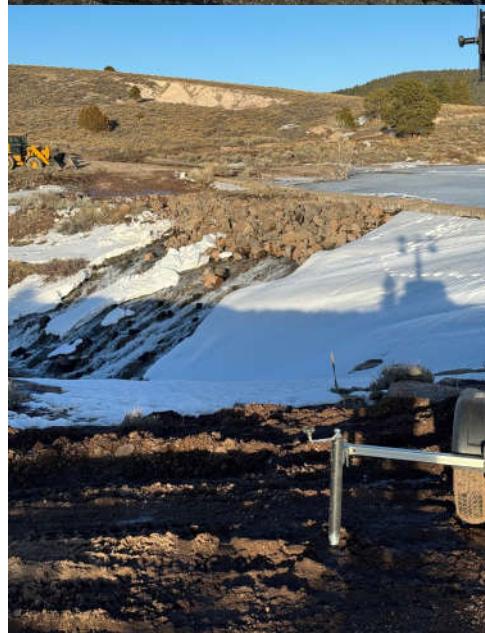
Photos on next page show cutting slot (9:51 am) and placement of rockfill. Lower left at 10:30 am, lower right at 7:15 pm

Rock placement continued throughout the day. From 4:30 to 5:30 pm the primary work was stabilizing the entrance road into the site. Five loads of crushed 8 in minus rock was used. By 6 pm the full build out of the rock buttress extended west to about Sta. 1+20, with the initial rock layer extending to Sta. 1+05, with the flow completely within the rock layer.
