EVALUATION REPORT

PANGUITCH LAKE DAM

Garfield County, Utah

July 2024

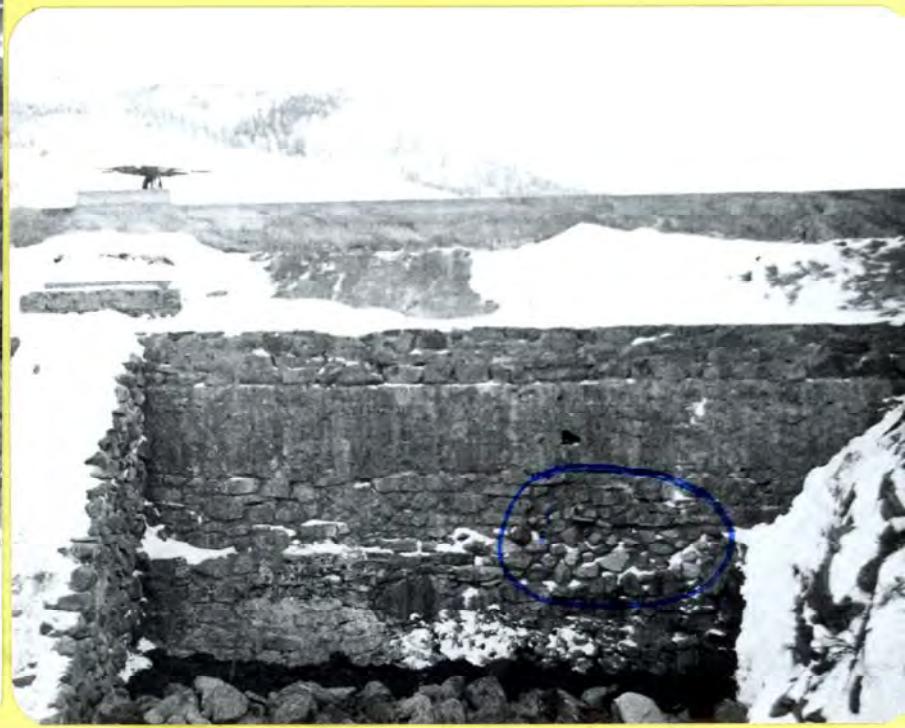
#4 *REPAIRED*
Required downstream face cavity was about 6 feet below outside edge and on the right side near the west side.

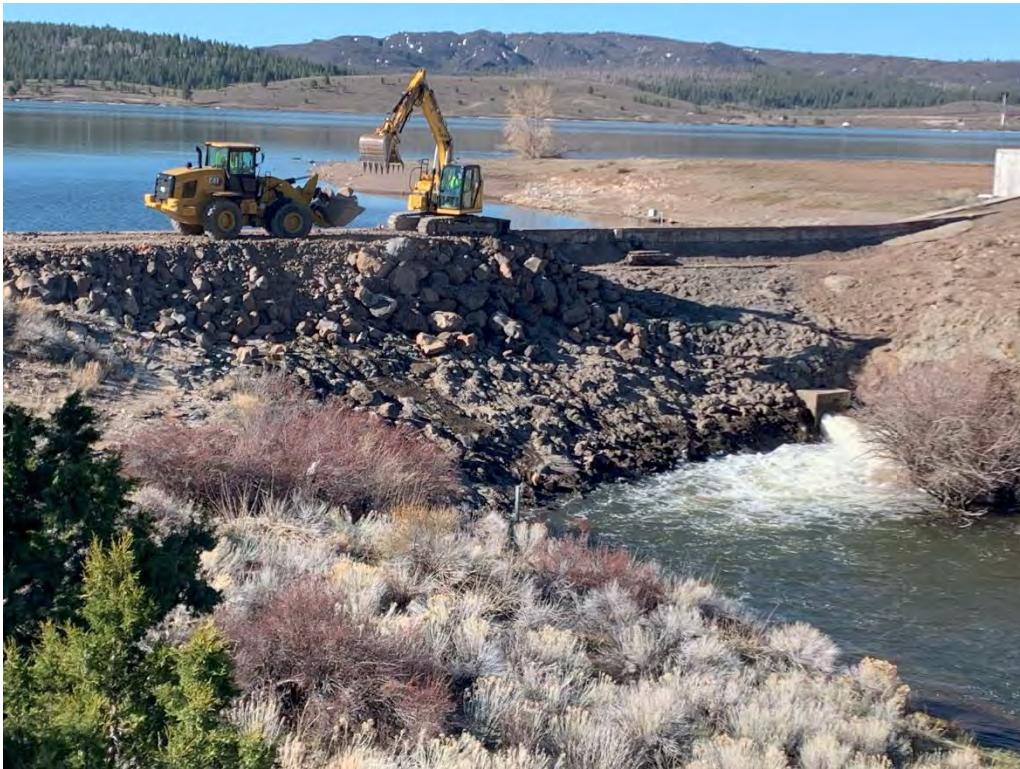
Rockfill berm being removed

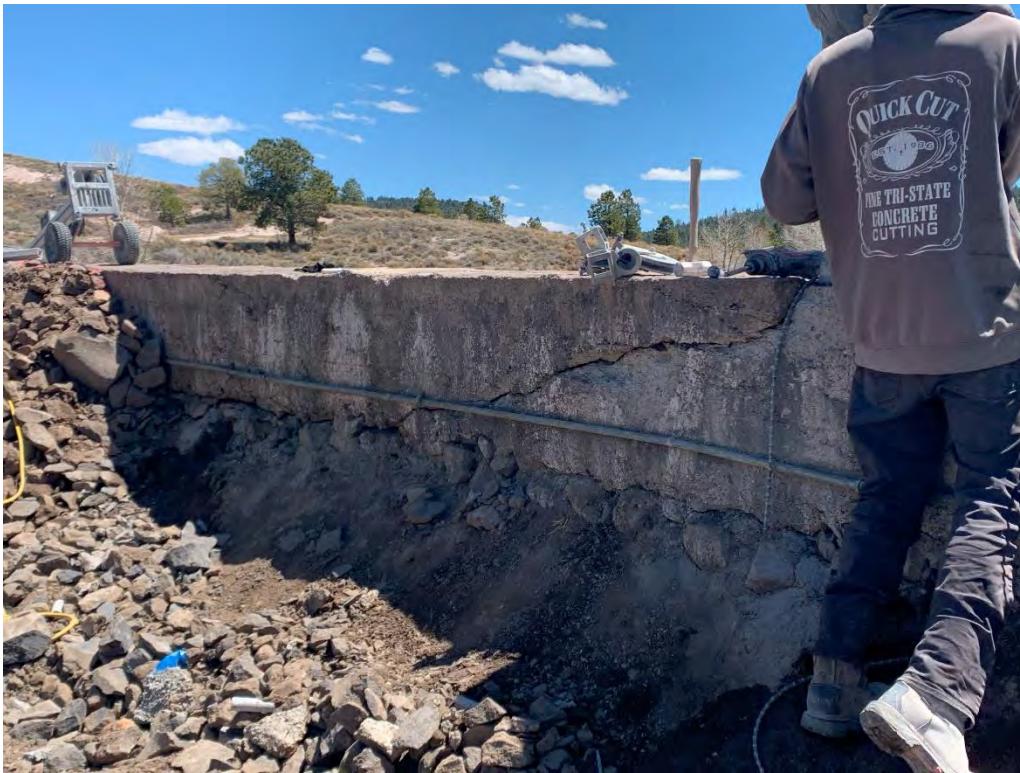
Downstream side of dam between ~Sta 1+04 and 1+20

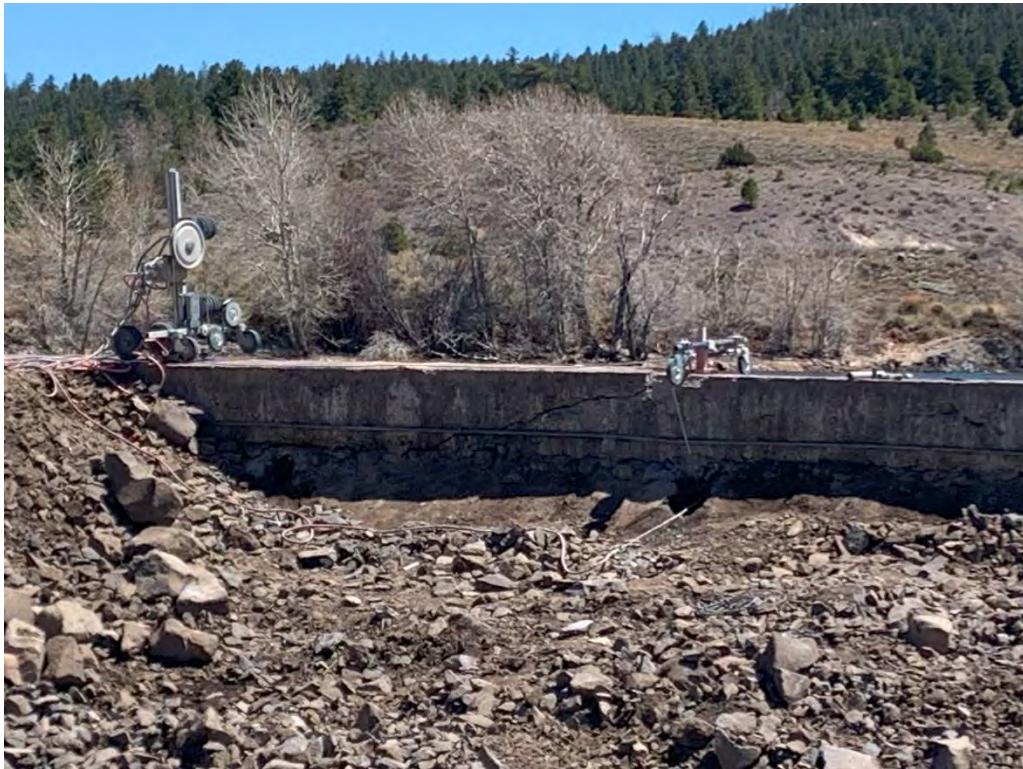
Wire saw set up for vertical cut at Sta 1+04

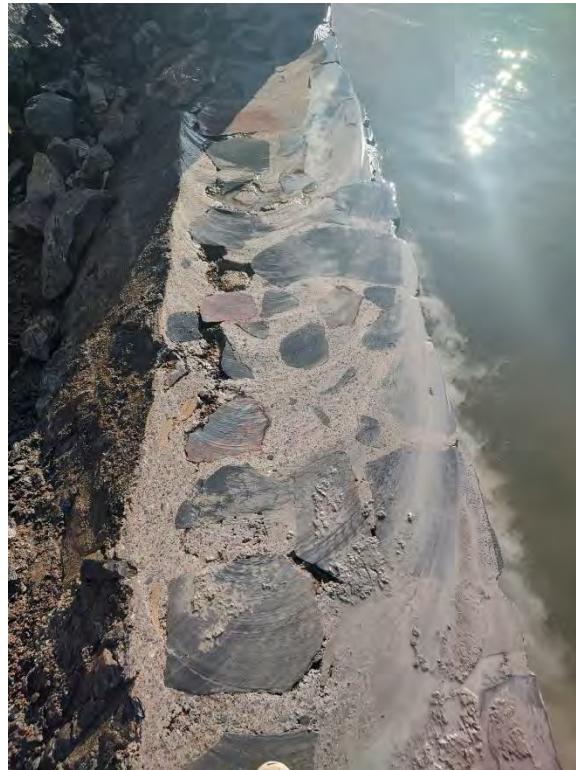
Left side of temporary spillway
(Photo taken by M. Hatch)

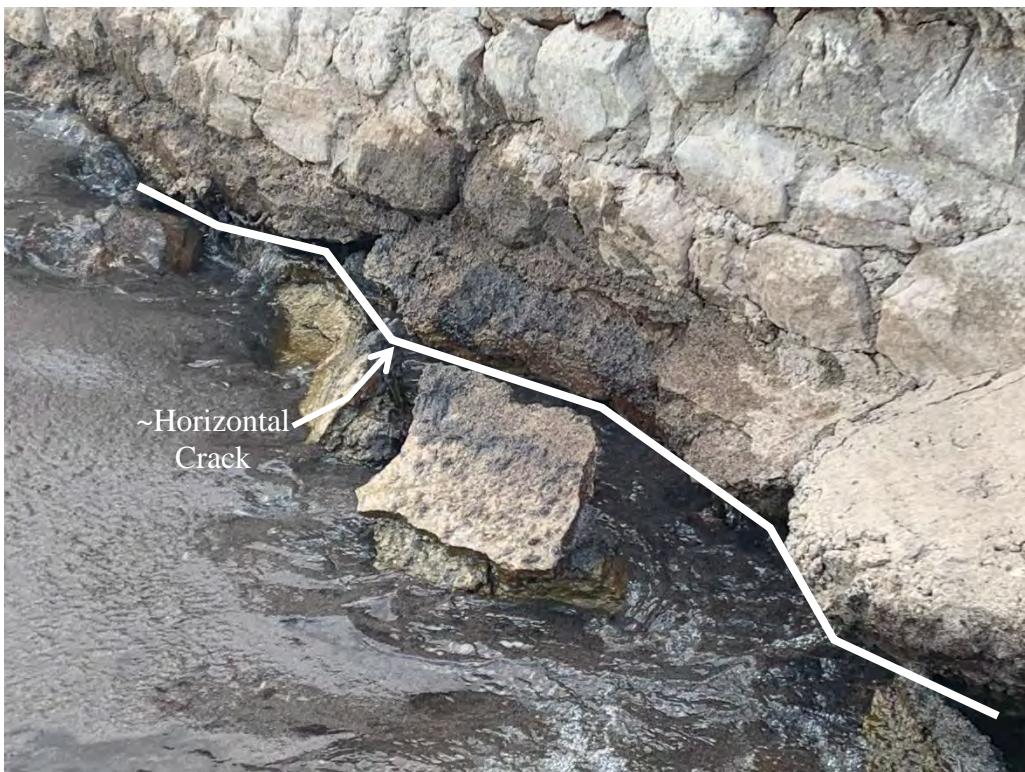
I visited the dam site with Mac Hatch during the afternoon after meeting with the Irrigation Company, Forest Service, and Dam Safety. The reservoir water surface was at elevation 8203.5 feet (55 inches below the dam crest) at the time of the visit. The horizontal crack caused by the ice action damage earlier in the year was visible near the water surface elevation, and there was no visible seepage on the downstream side of the dam. About 150 cfs was being released from the reservoir.

Upstream dam face, near right abutment

It is our opinion that it is unnecessary to continue to release water in excess of the amount required for downstream use. We recommend that the irrigation company be allowed to reduce reservoir release provided the water surface elevation remains at or below elevation 8203.5 feet. It will be necessary to draw the reservoir down to at least elevation 8201.5 feet for repair of the dam crest.

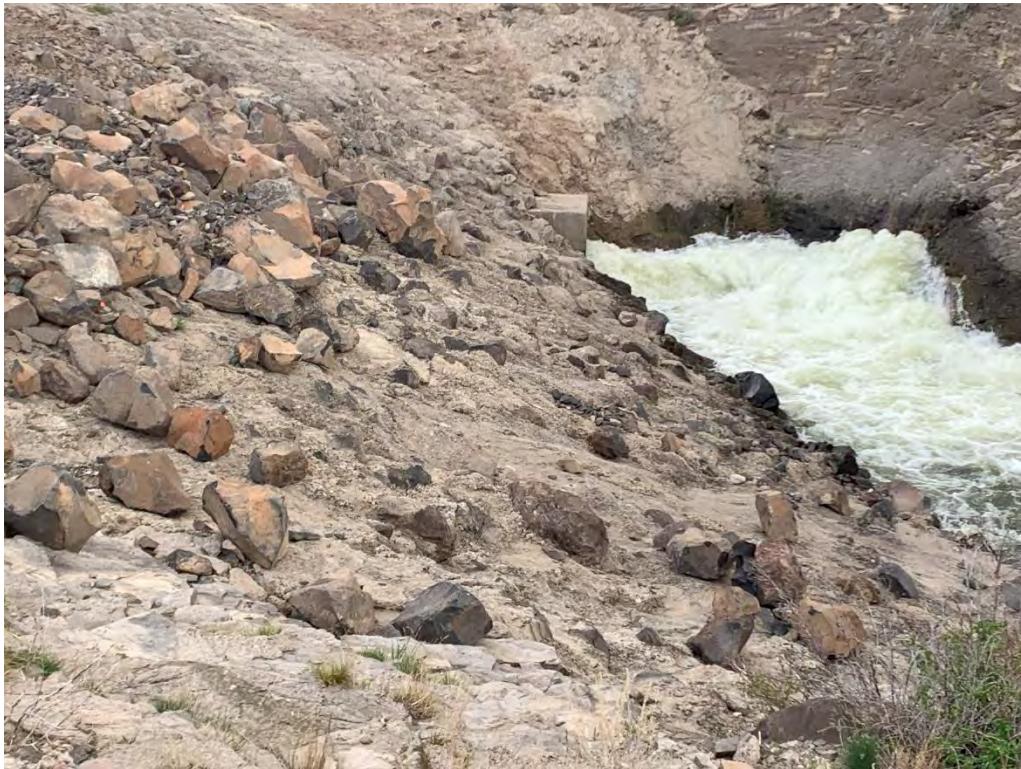
Downstream side of dam

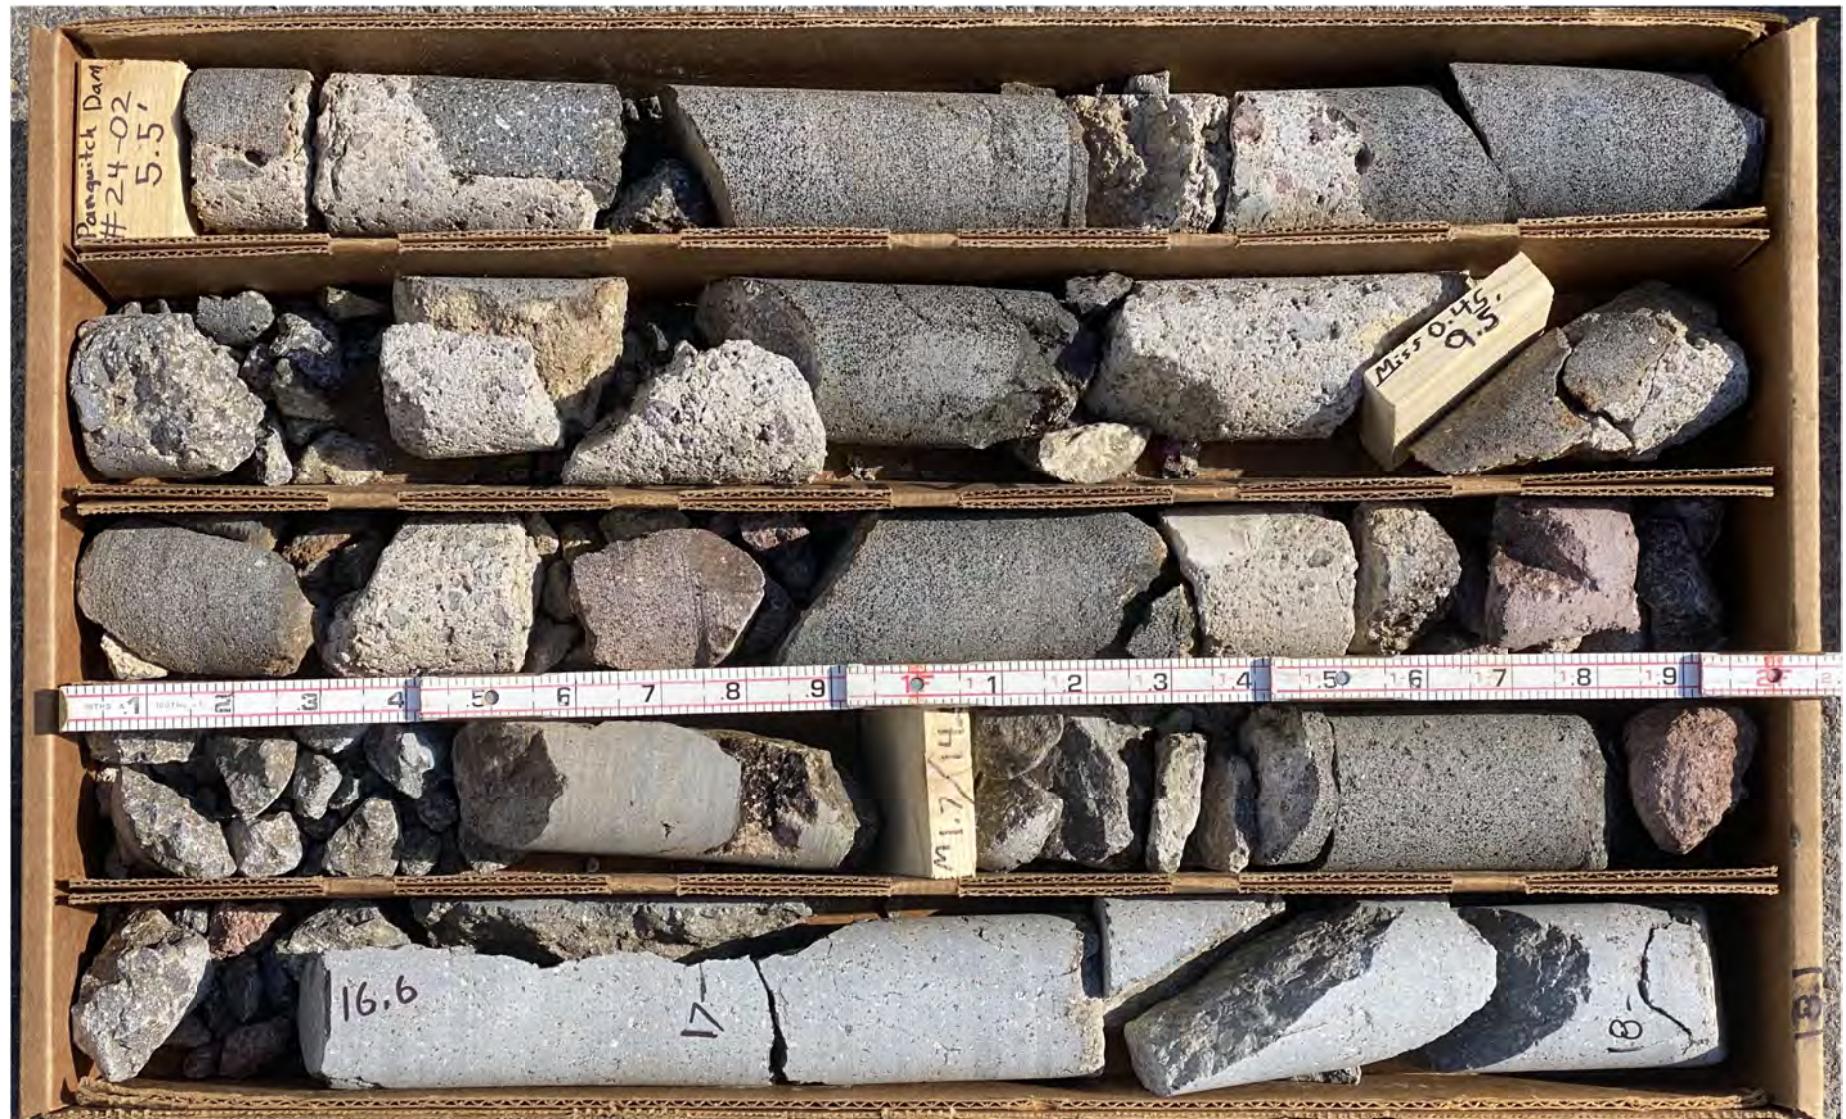
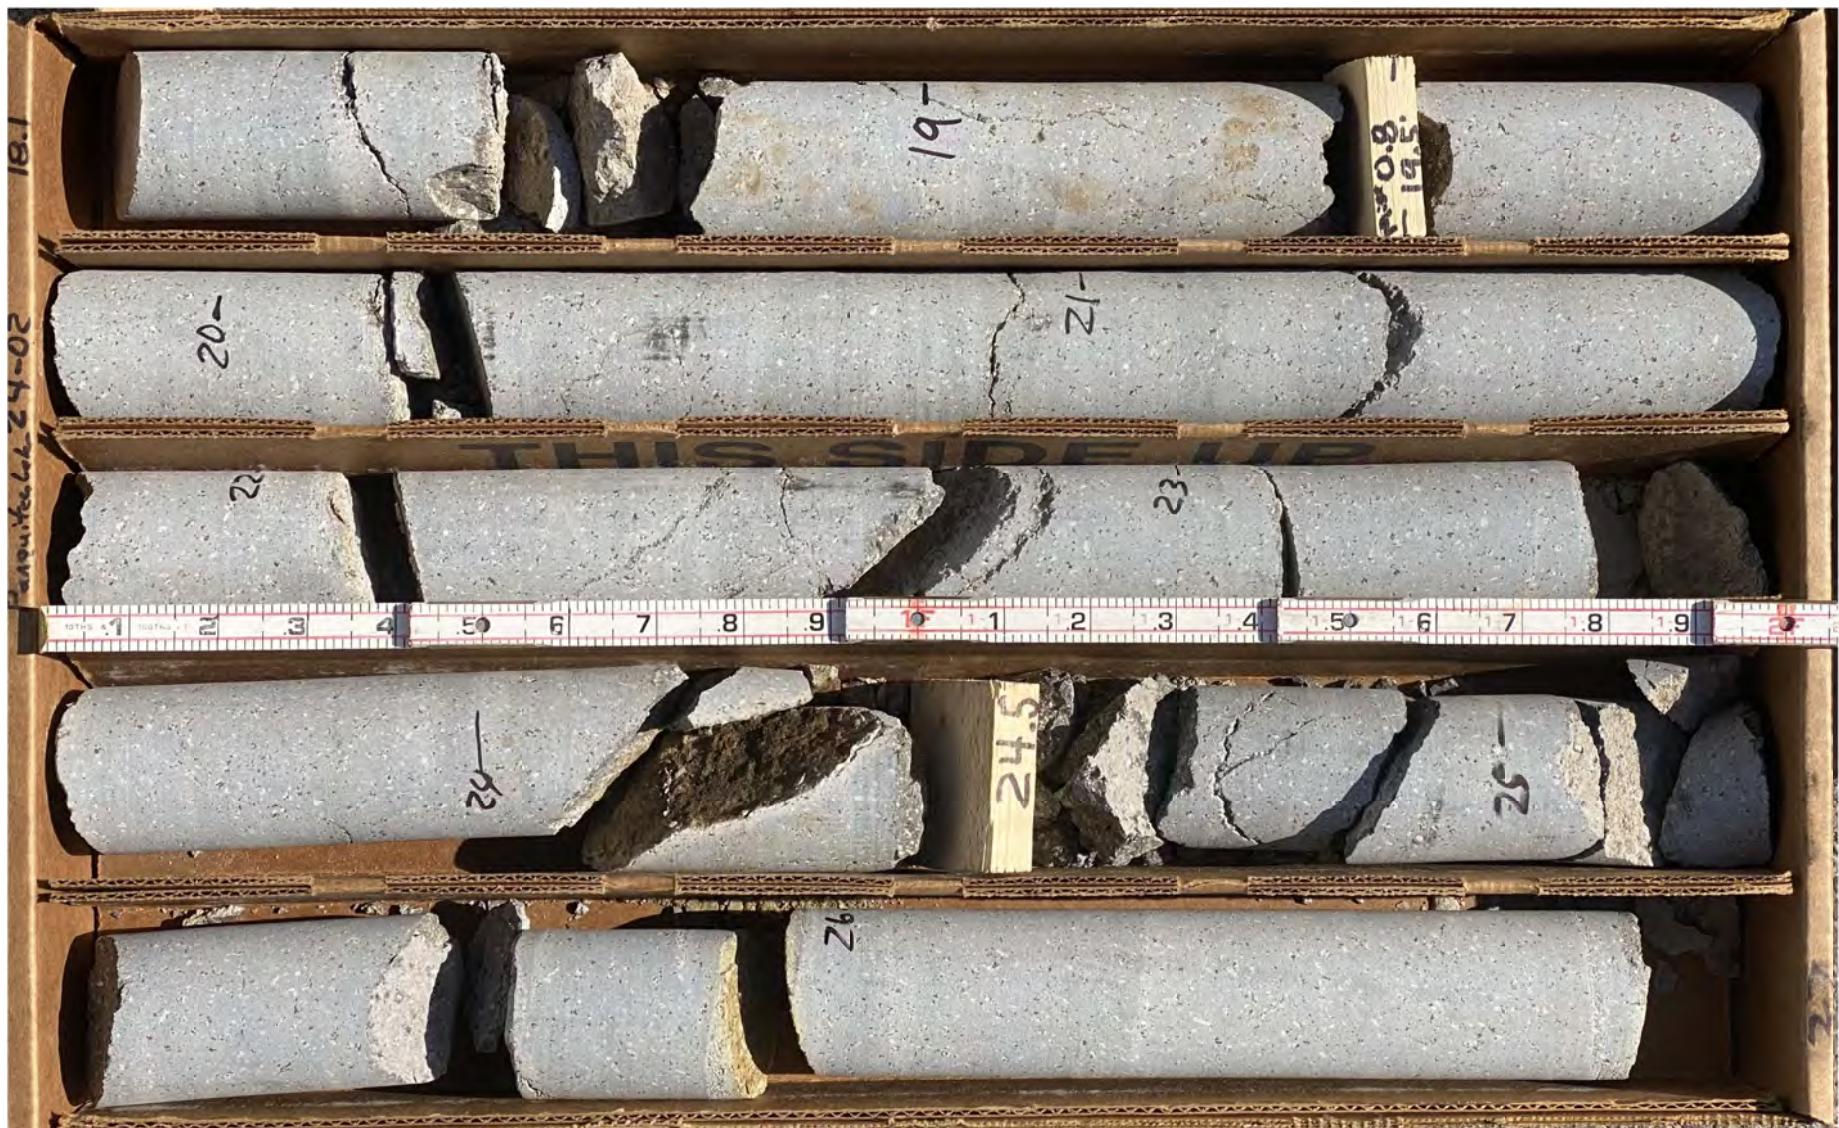
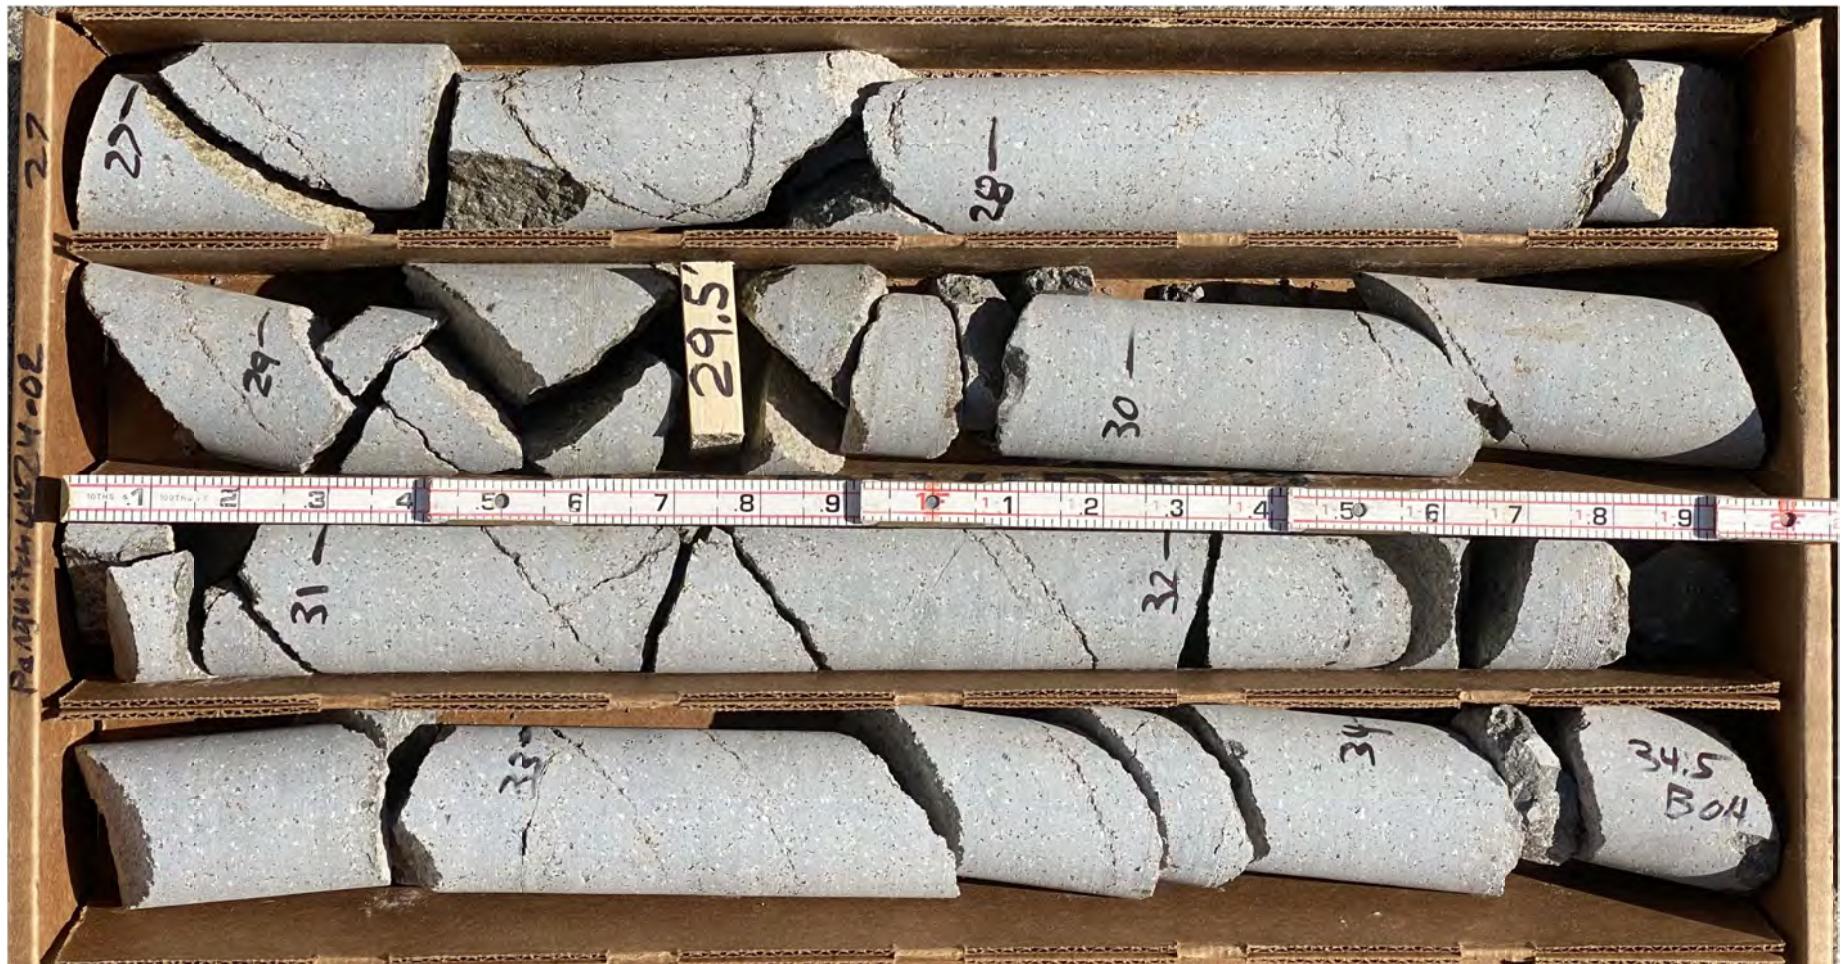
Figure CORE PHOTO SHEET - BORING 24-02, SHEET 1 OF 3
*Panguitch Lake Dam Crest Repair
Garfield County, Utah*

Observations made during drilling suggest that the existing masonry at the location of Boring 24-02 has voids within the matrix, and drill water loss occurred while drilling through the masonry at Boring 24-04. Based on the observations made, the existing masonry appears to be in poor condition.
