DIVISION OF WATER RIGHTS - DAM SAFETY SECTION

DAM INSPECTION REPORT – 2013

Dam Name & Number	Adobe Wash, UT53623		
Date	January 22, 2013	Reservoir Level	Empty
Dam Type/Hazard	Earthfill/High	Elev _{Spillway} -Elev _{Reservoir}	55'
Purpose of Inspection	Final Insp.	Spillway Flow	0 cfs
Weather	Sunny and clear 25°	Outlet Flow	0 cfs

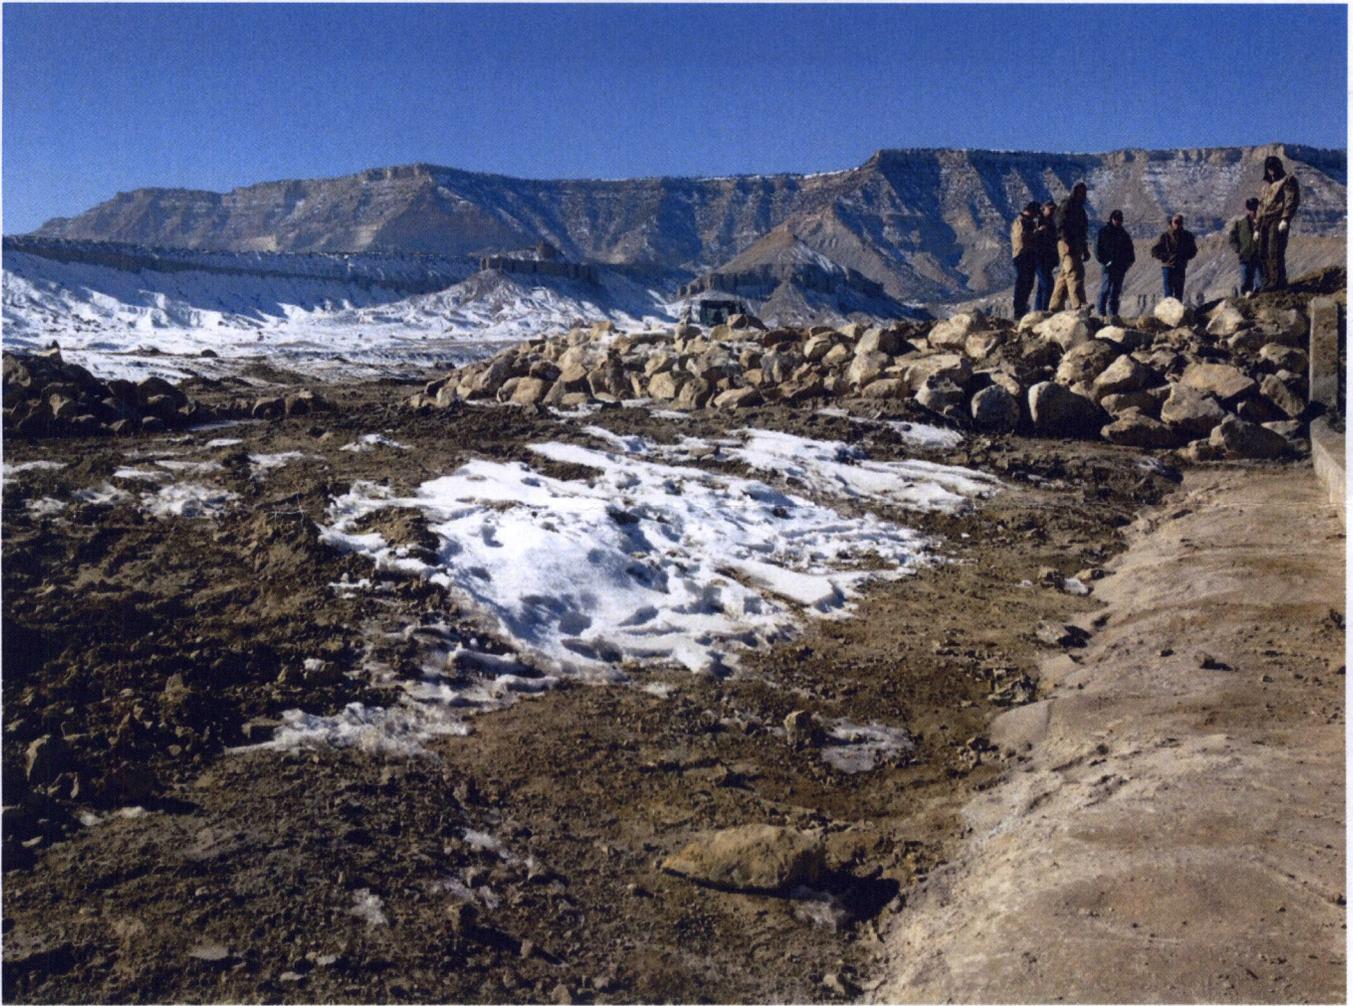
Grading of the spillway channel upstream of the control wall needs to be completed.

Checklist Item	Necessary Action, Maintenance and/or Repair:
1.	UTBC will be placed and graded this spring.
12.	Final grading of the spillway channel upstream of the control wall needs to be completed.
14. & 15.	Riprap needs to be placed in the spillway stilling basin and the downstream channel and berm need to be completed.
20.	Hydraulic ram will be rotated 180° so the stainless steel hydraulic lines do not extend into the flow path. Bolt control frame to floor.

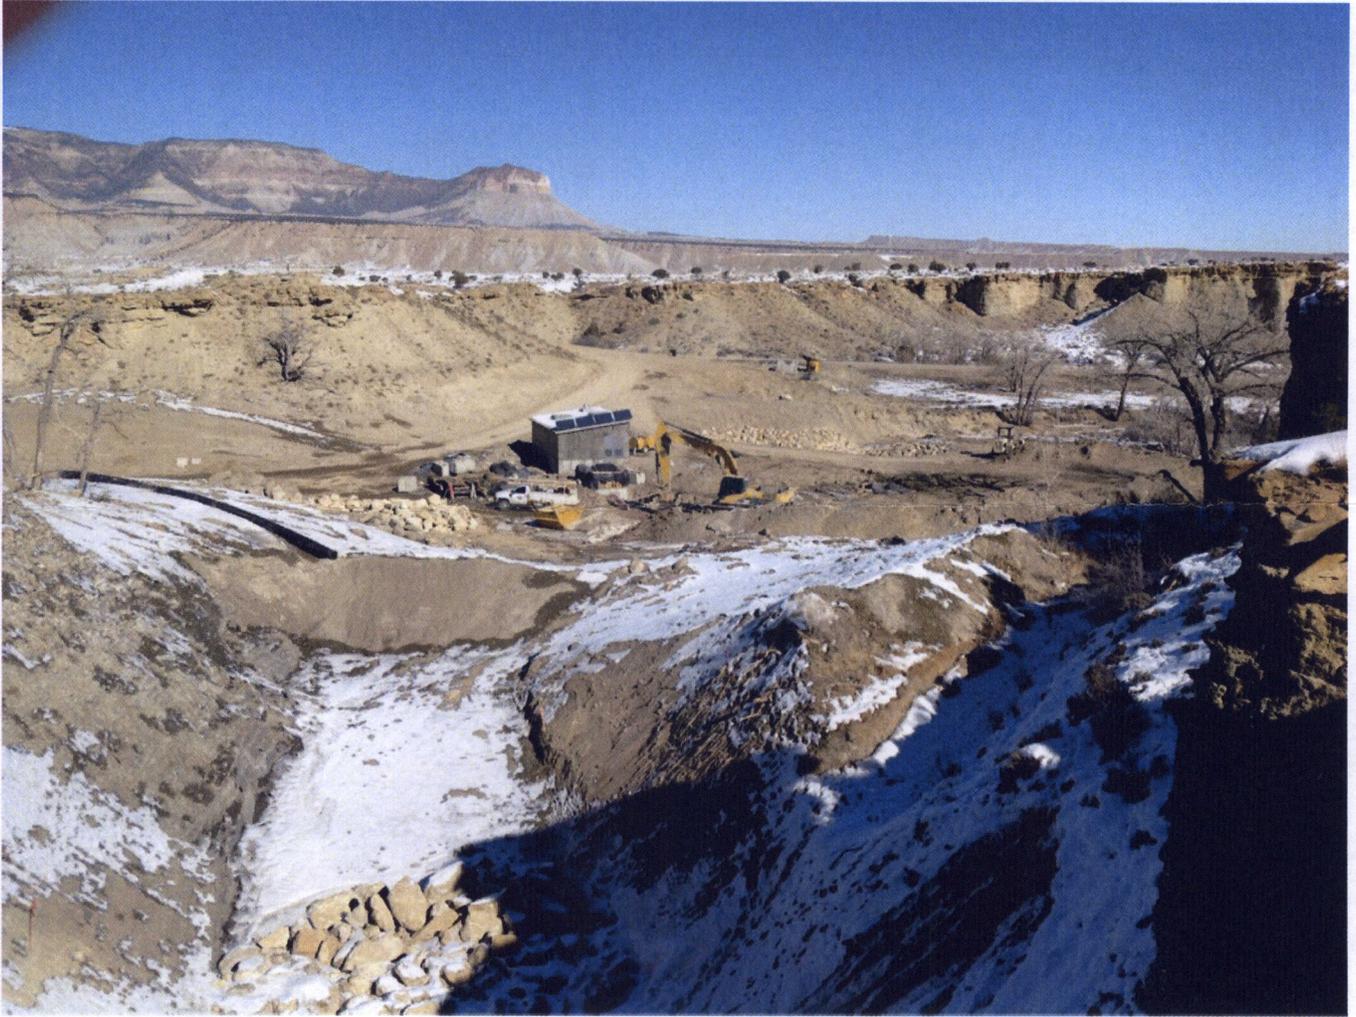
Spillway stilling basin and downstream channel still need to be completed.

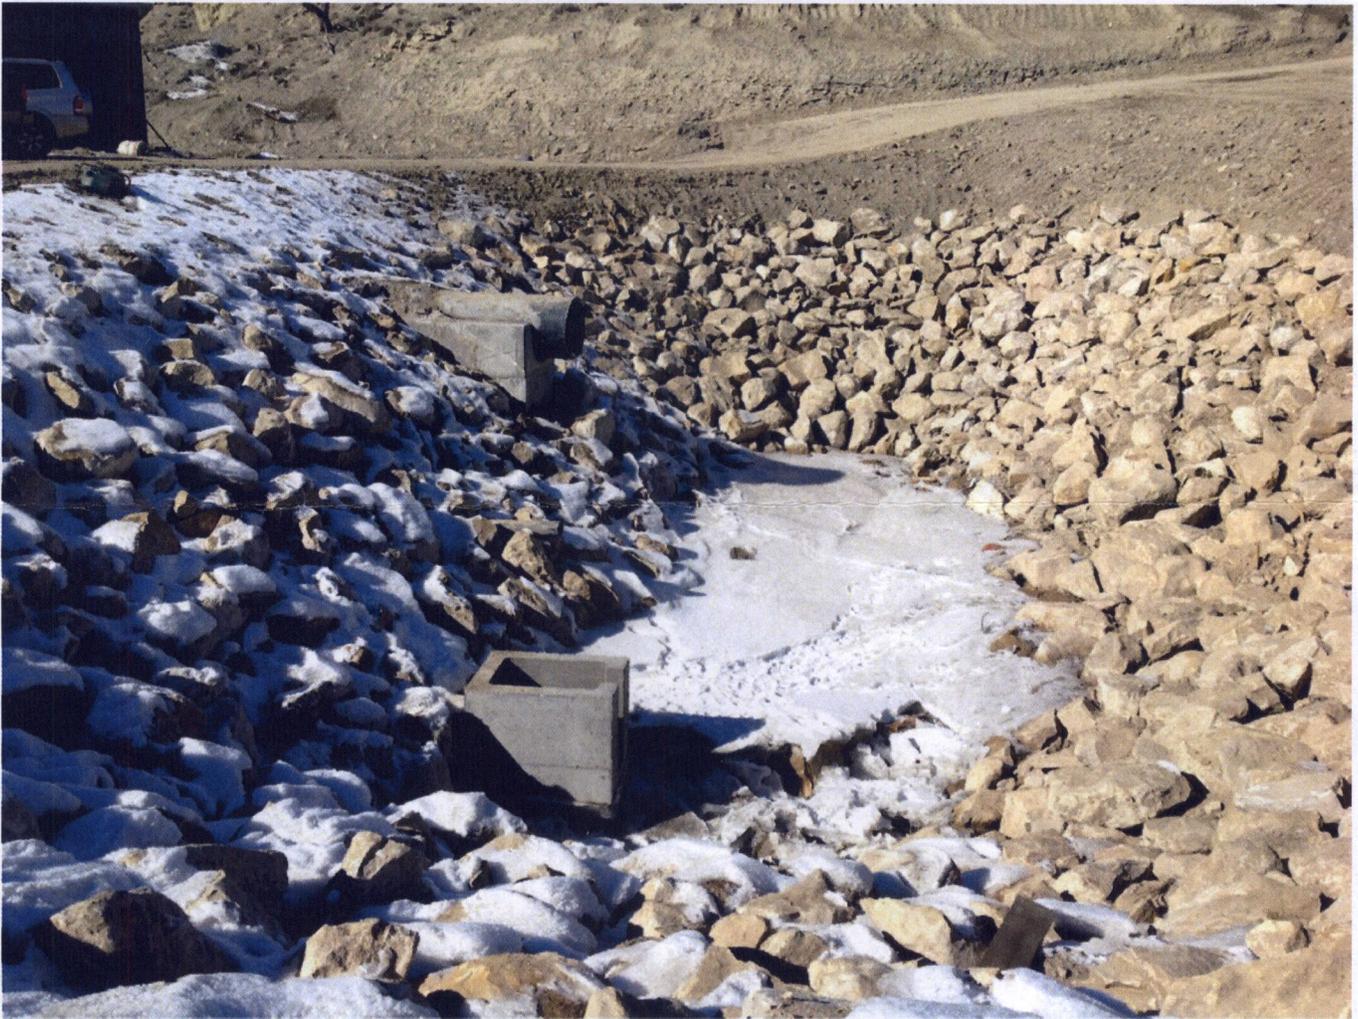
Stilling basin with concrete weir box. Weir plate and staff gages need to be installed in both letterboxes.

22. & 24.	Installation of piezometers and monuments needs to be completed.
25.	Drain lines need rodent screens. Finish the installation of the weirs and staff gages in both weir boxes. Grout the annulus between the concrete weir boxes and drain pipes. Install platforms in manholes.
-	Within 60 days record drawings for the project must be submitted to Dam Safety.

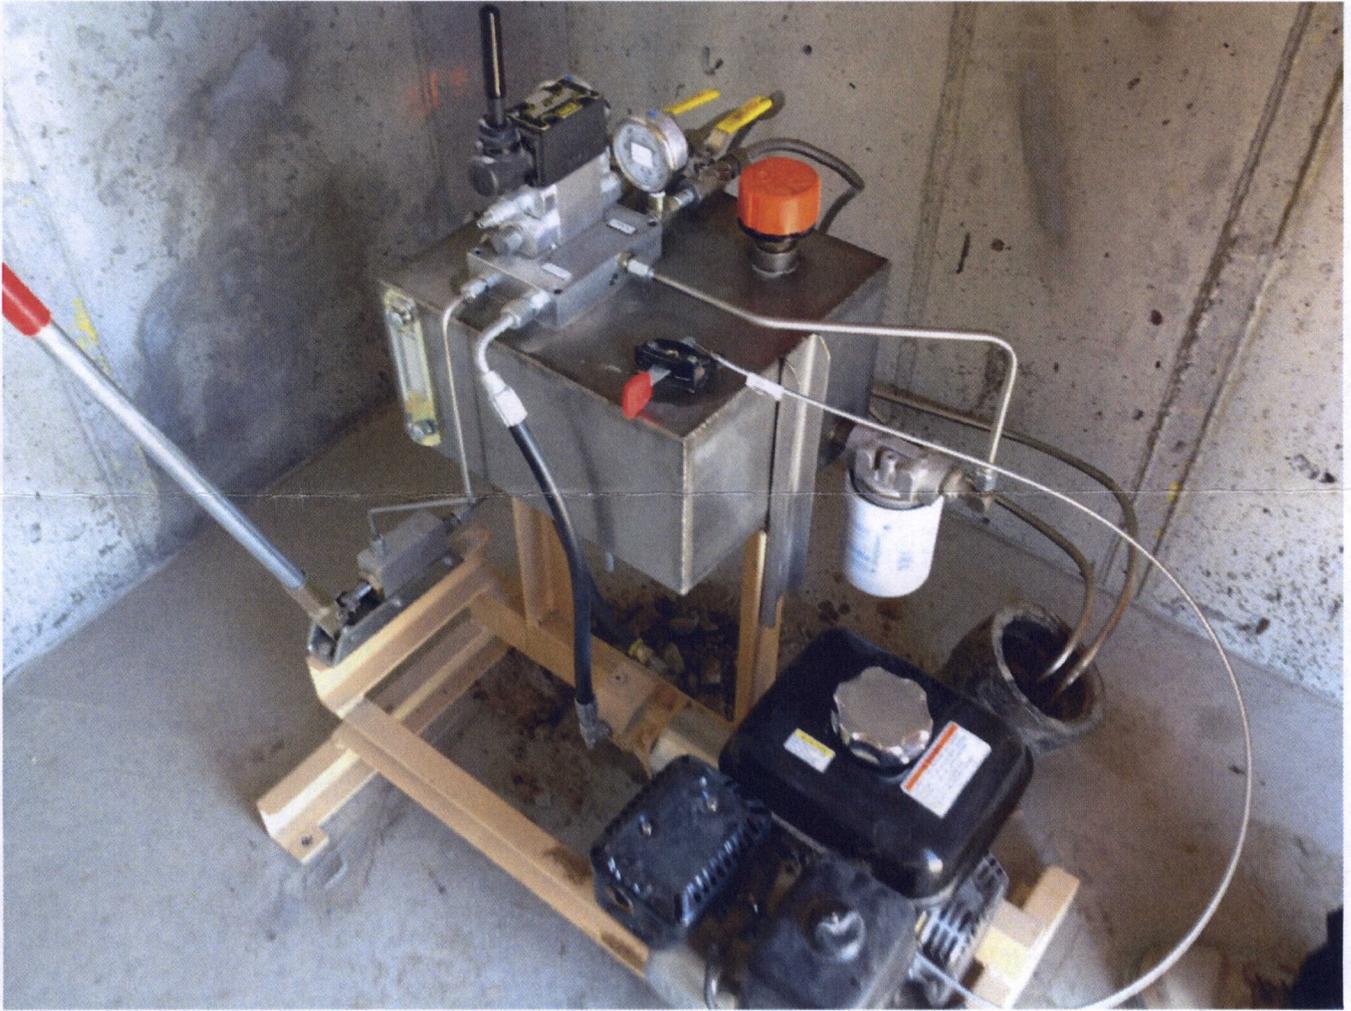
Hydraulic gate controls.

Checklist Item	Comments:
20.	Consider installing a gate position indicator.
