**FLOOD  
PLAIN  
INFORMATION**

**HOBBLE CREEK**

**SPRINGVILLE, UTAH**

FOR THE CITY OF SPRINGVILLE  
BY THE DEPARTMENT OF THE ARMY, SACRAMENTO DISTRICT CORPS OF ENGINEERS, SACRAMENTO, CALIFORNIA  
JUNE 1973

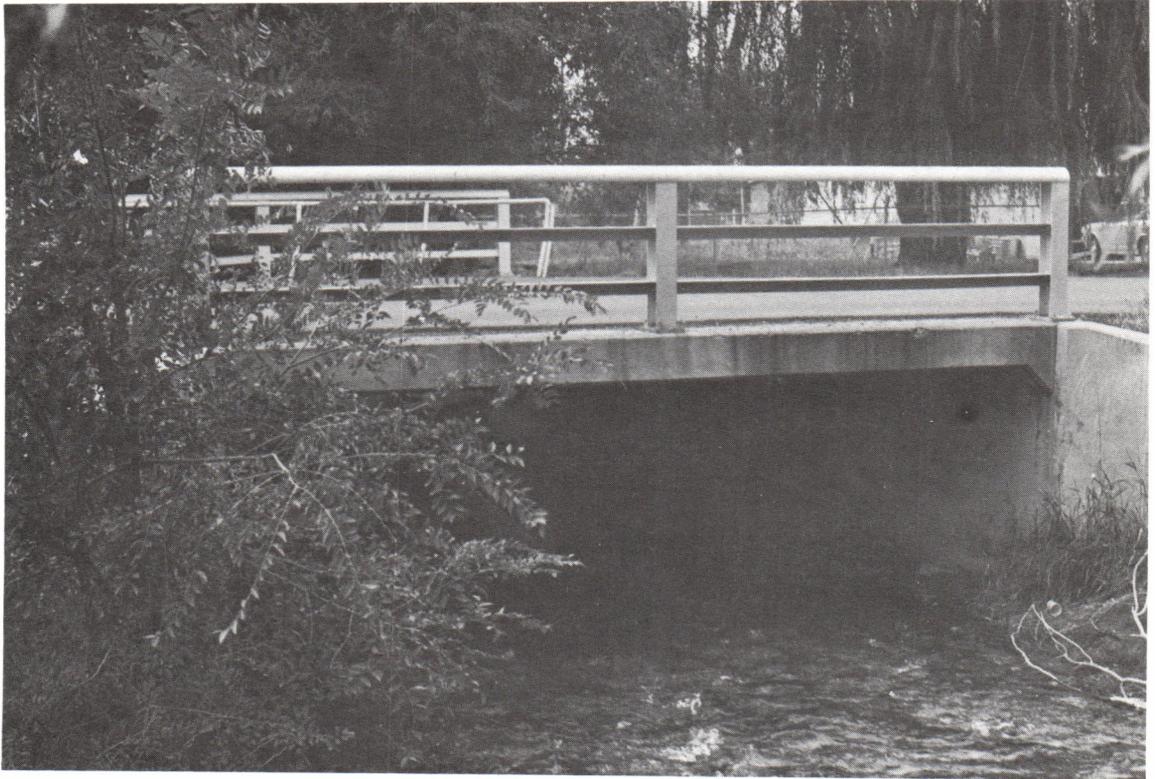
*Figure 1 - Bridge at 800 East Street.*

Man-made obstructions to floodflow in the study area consist of a number of bridges and culverts. Debris collecting against a bridge may increase to the point where its structural capacity is exceeded and the bridge is destroyed, or it may cause water levels to rise to the extent that abutments are eroded and the overlying and approach roadbeds are damaged.

In general, obstructions restrict floodflows and result in overbank flows and unpredictable areas to be flooded, destruction of or damage to bridges and culverts, and, increased velocities of flow immediately downstream. It is impossible to predict the degree or location of the accumulation of debris; therefore, for the purposes of this report, it was necessary to assume that there would be no accumulation of debris to clog any of the bridge or culvert openings. Representative obstructive bridges and culverts in the study area are shown in Figures 1-4. Pertinent data on obstructive bridges and culverts are contained in Table 2, page 20.

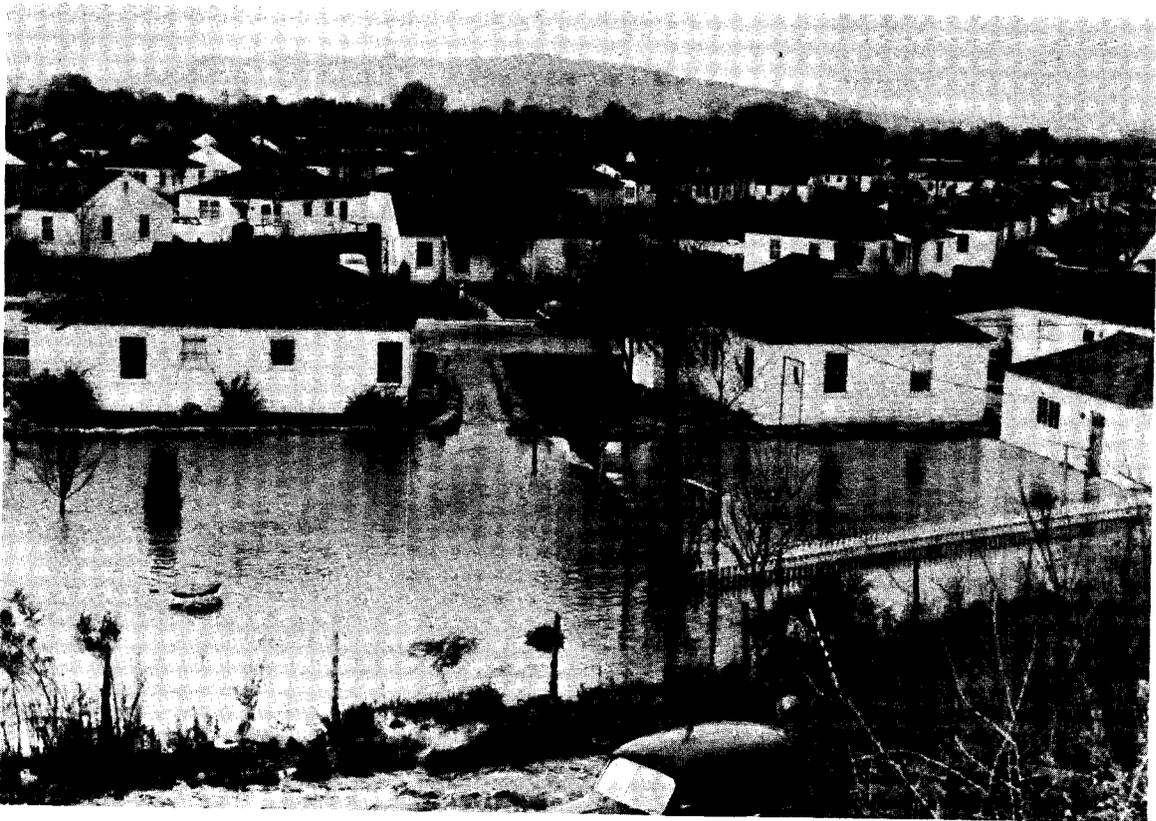
*Figure 5 - Brookside subdivision during the snowmelt flood of May 1952. (Provo Daily Herald photo.)*

Citizens in the east section of town, especially in Brookside, and along Fourth South, have filled and piled up sandbags about their homes to hold back the flood waters. In some homes nearest the creek banks, sandbags have had little effect.

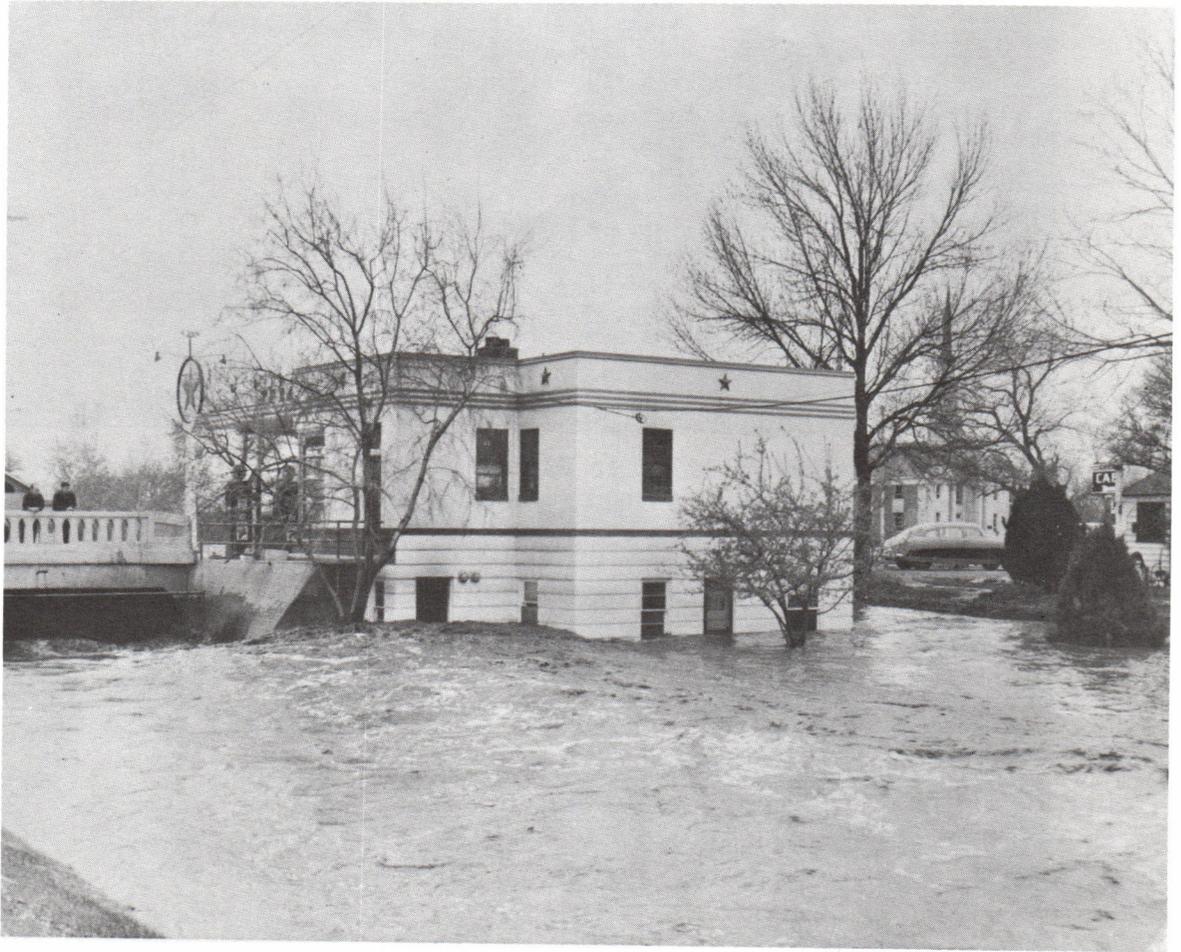
*Figure 6 - Service Station at Main Street during snowmelt flood of May 1952. (Provo Daily Herald photo.)*

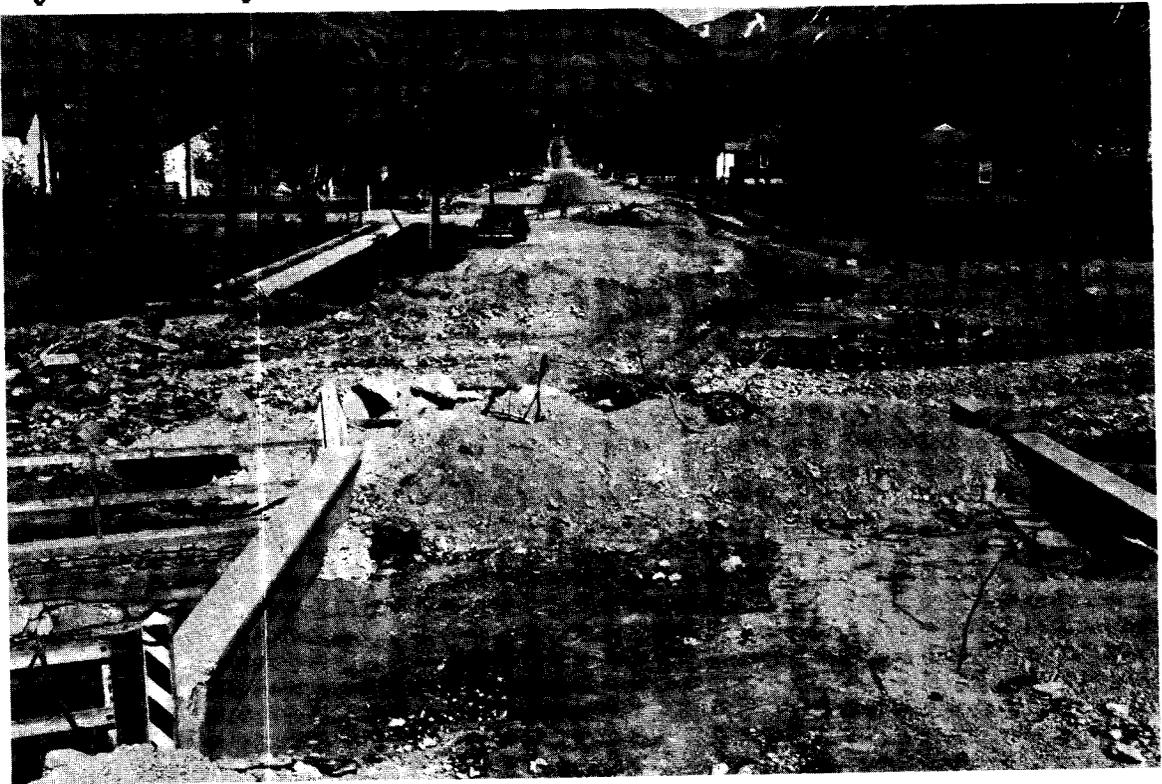
*Figure 8 - Bridge at Center Street during snowmelt flood of May 1952.*

As the swift-flowing stream, carrying trees, poles, lumber and debris of all kinds, gushed through the city, seemingly determined to cut a new channel, the rock walls in many places which heretofore have held the spring flow, have been washed away and the banks of the creek undermined and carried downstream. Foot bridges on practically every street have been removed and channels have been dug by workmen on the sides of the street bridges to divert part of the water which overflowed and endangered cement road bridges.
