STATE OF UTAH DEPARTMENT OF NATURAL RESOURCES

Technical Publication No. 50

SEEPAGE STUDY OF THE ROCKY POINT CANAL AND THE GREY MOUNTAIN-PLEASANT VALLEY CANAL SYSTEMS, DUCHESNE COUNTY, UTAH

R. W. Cruff and J. W. Hood Hydrologists, U.S. Geological Survey

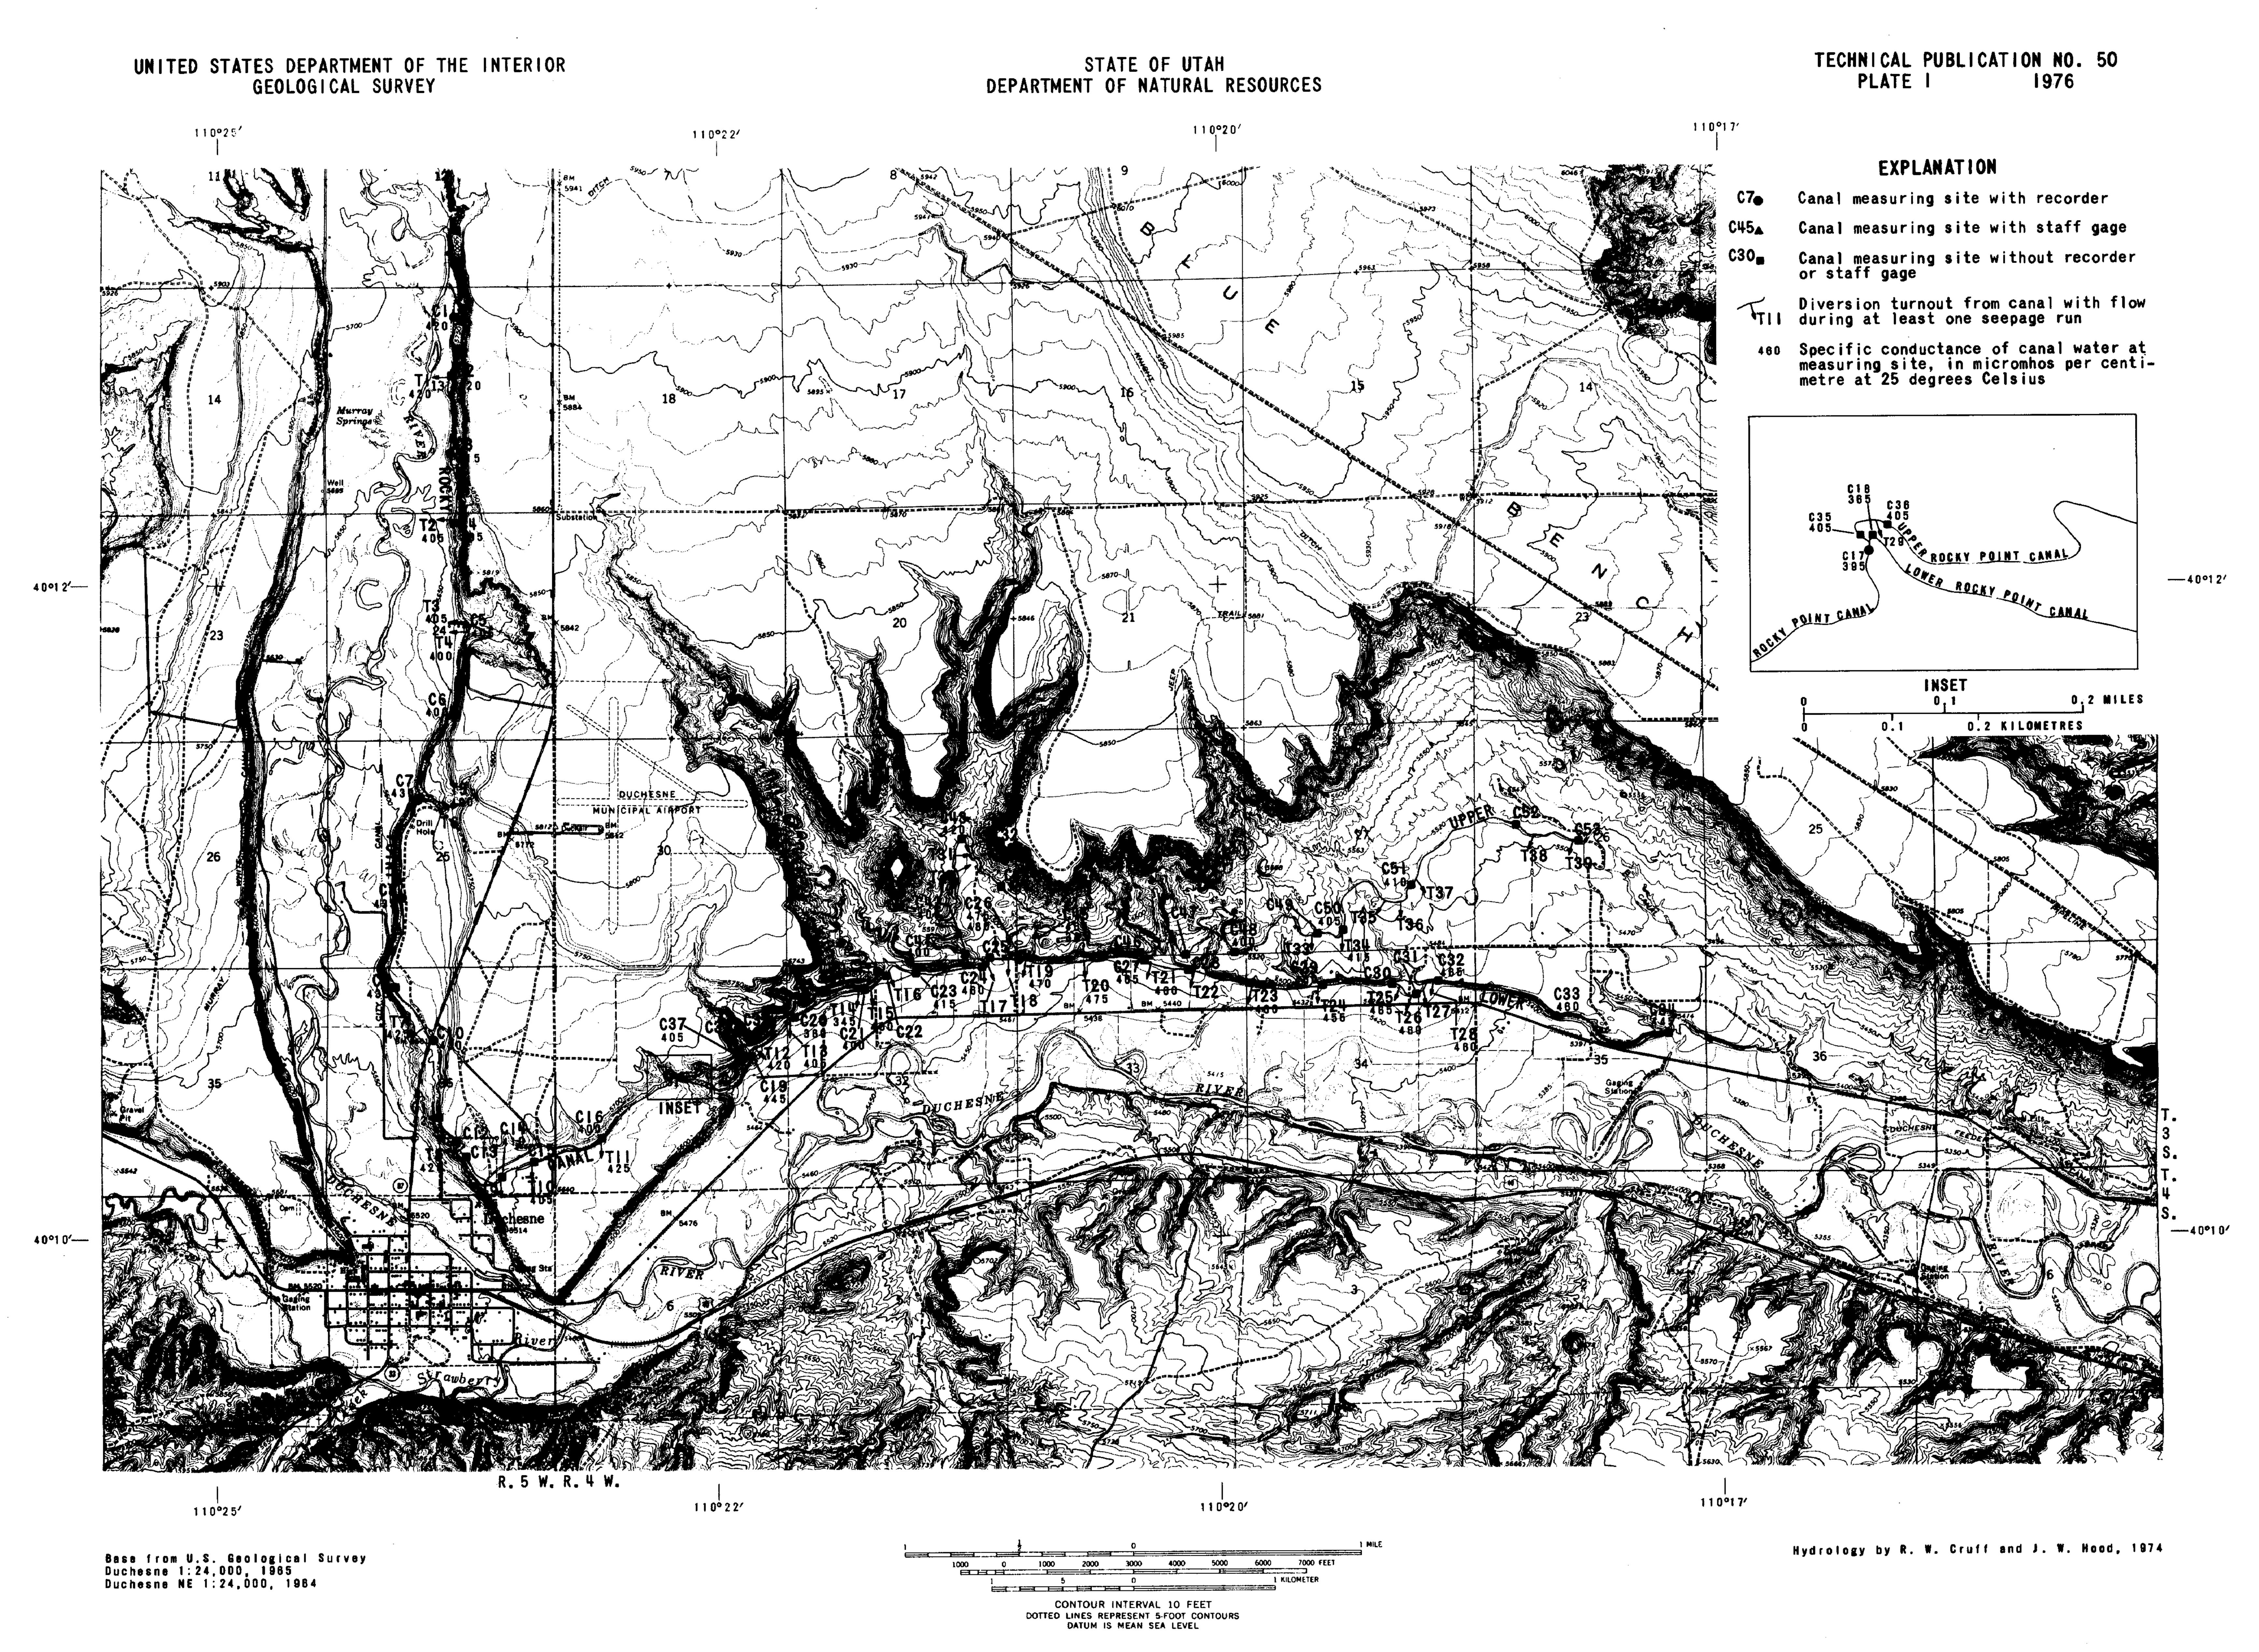
MAP SHOWING LOCATIONS OF CANAL AND OTHER MEASUREMENT SITES AND SPECIFIC CONDUCTANCE OF WATER DURING SEEPAGE MEASUREMENTS, AUGUST 30, 1972, ROCKY POINT CANAL SYSTEM, DUCHESNE COUNTY, UTAH

Plate	1.	Map showing locations of canal and other measurement sites and specific conductance of water during seepage measurements, August 30, 1972, Rocky Point Canal system.

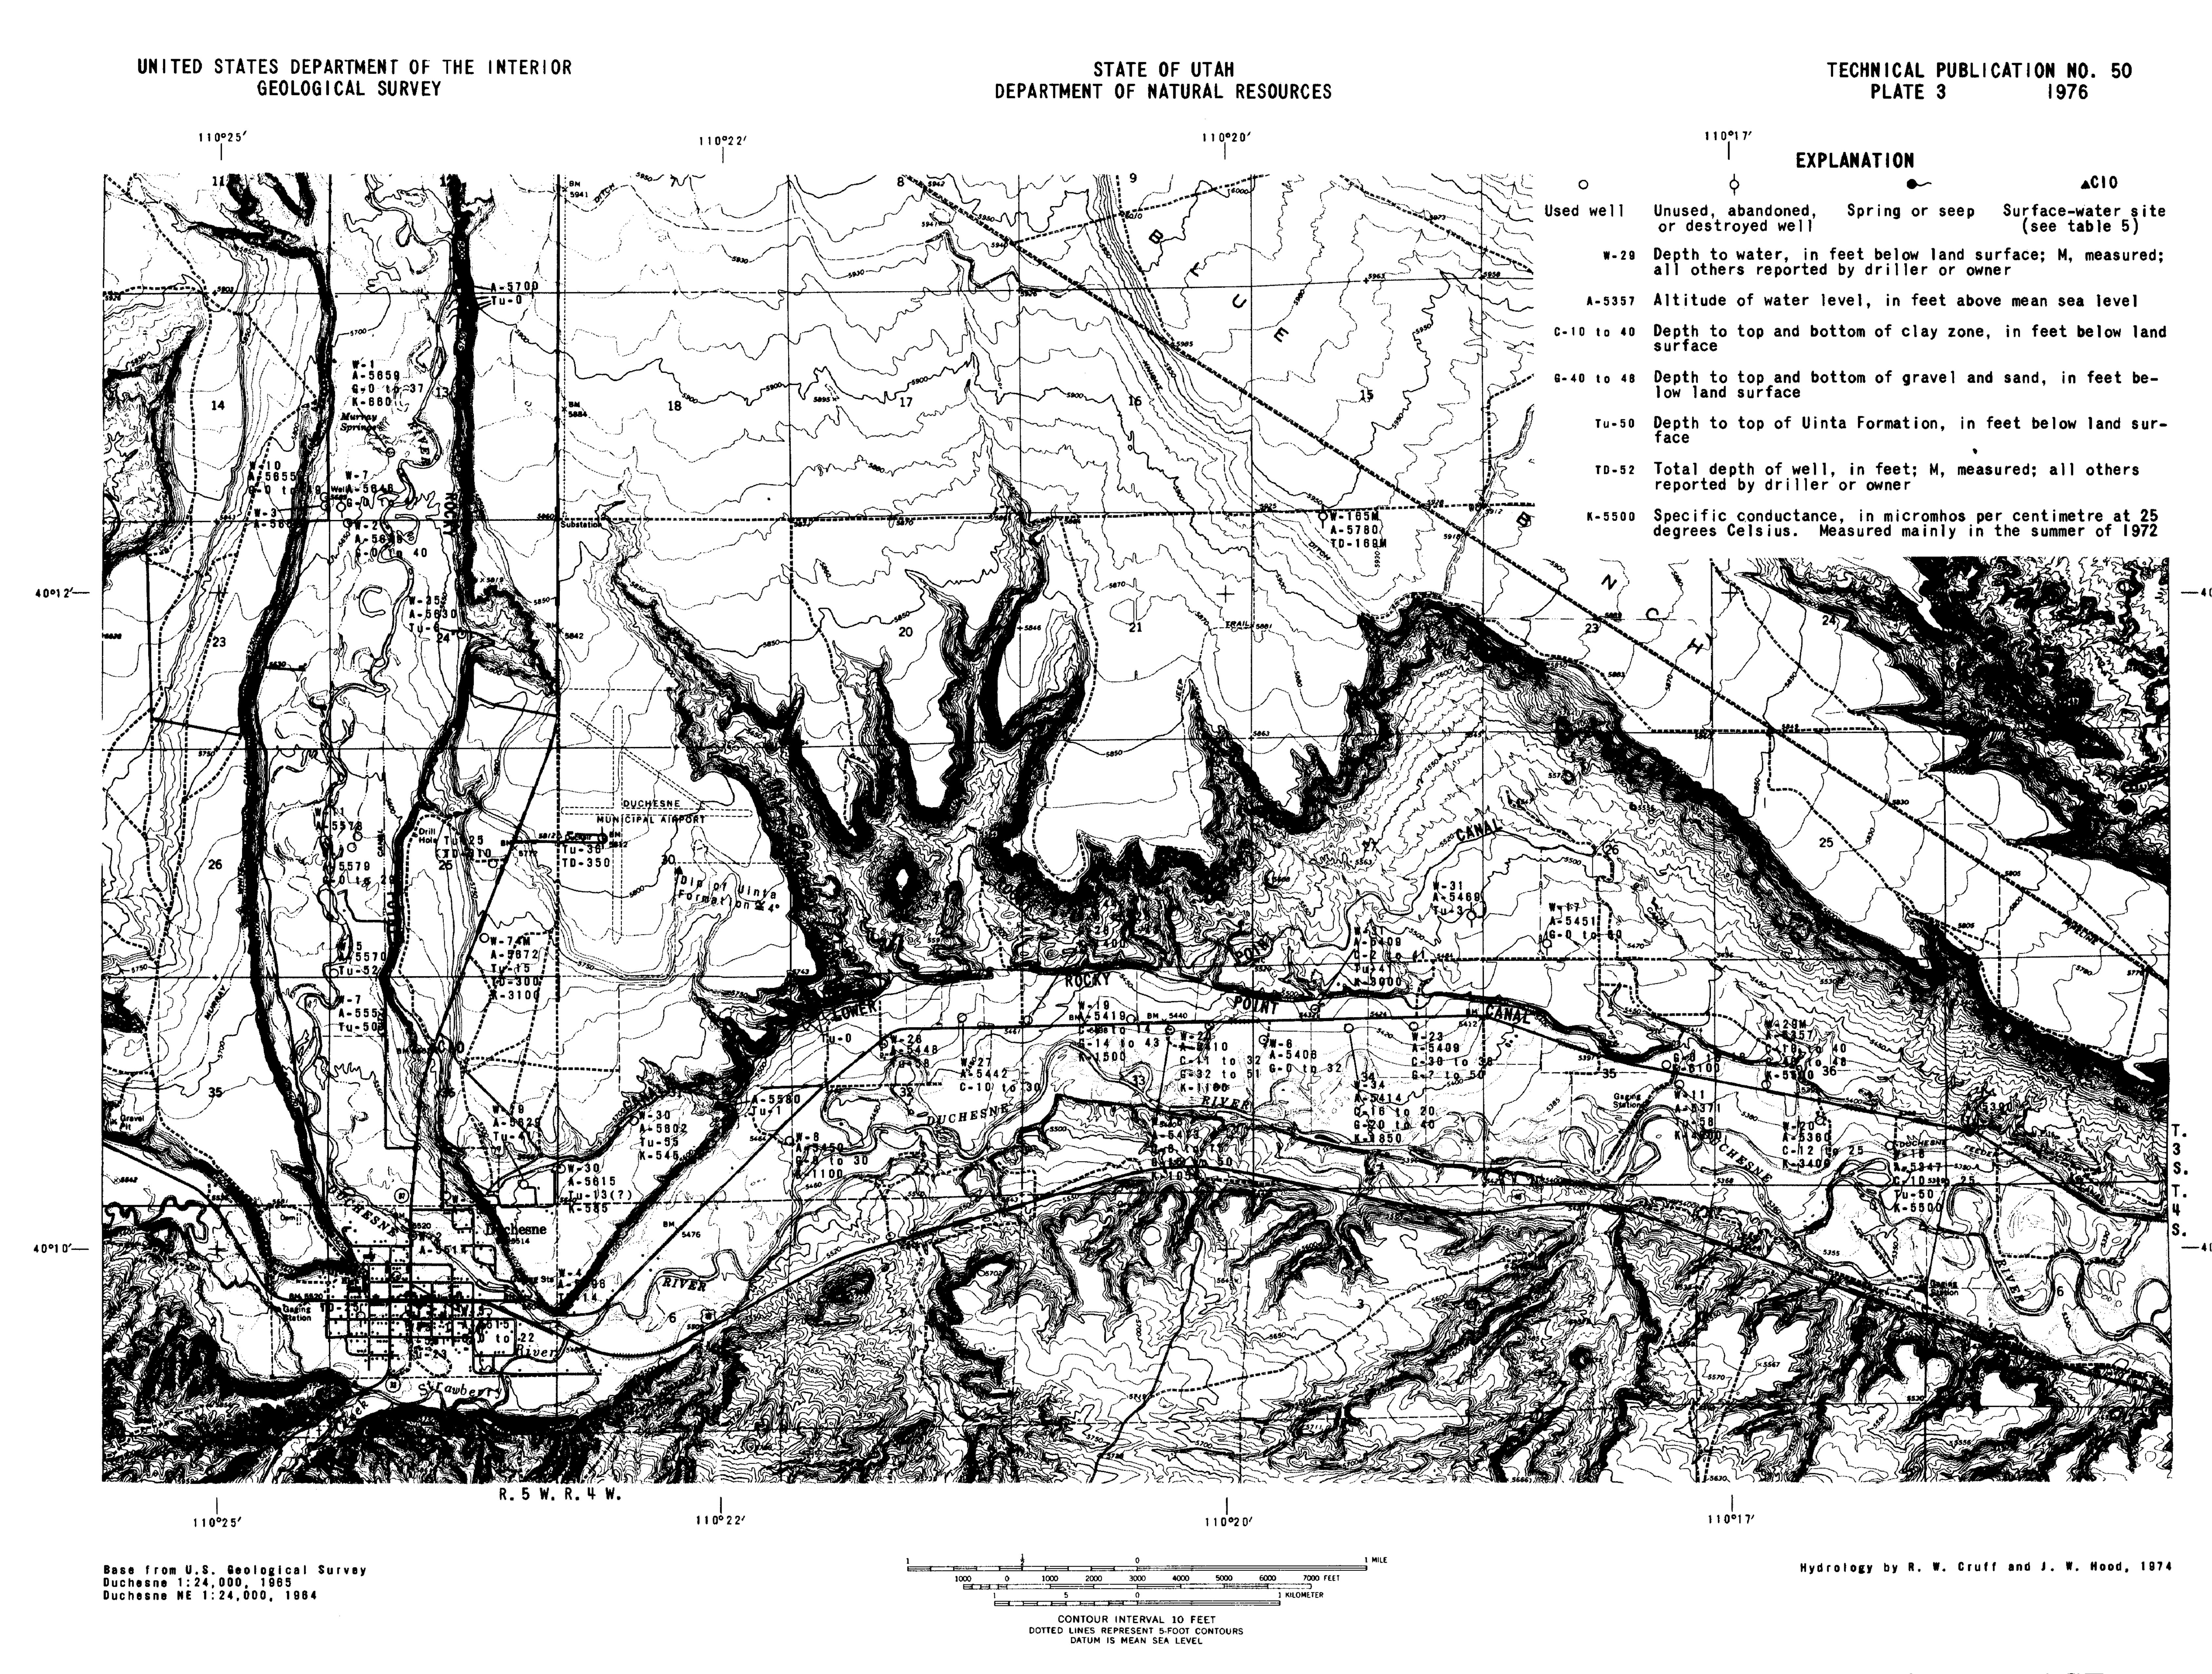
MAP SHOWING LOCATIONS OF WELLS, SPRINGS, AND MISCELLANEOUS DATA SITES USED IN EVALUATION OF SEEPAGE STUDY RESULTS NEAR ROCKY POINT CANAL SYSTEM, DUCHESNE COUNTY, UTAH

3.	Map showing locations of wells, springs, and miscel- laneous data sites used in evaluation of seepage study results near the Rocky Point Canal system.

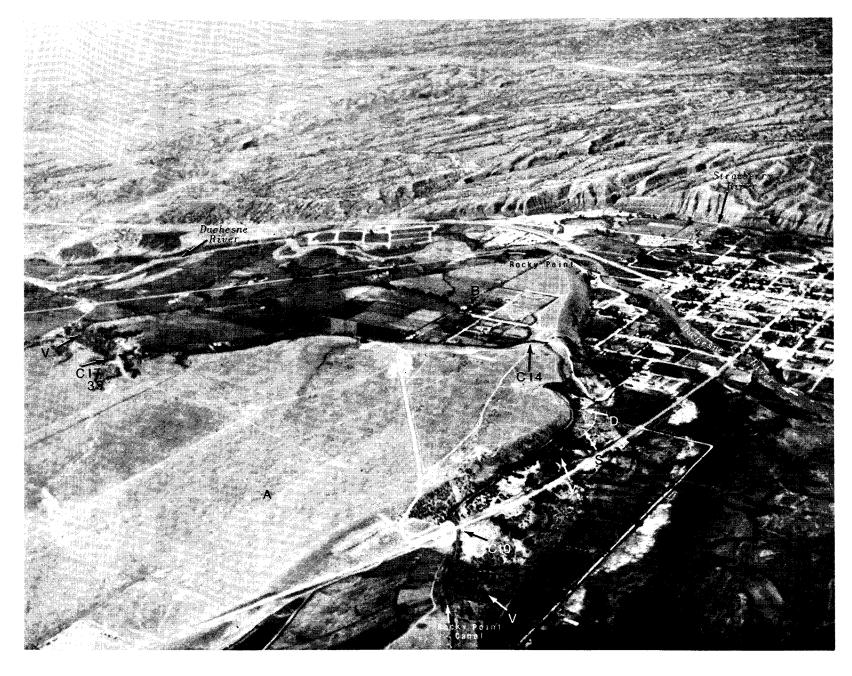
Figure 1.—Aerial view, looking southeastward, of Duchesne River at Duchesne, Utah, adjacent Rocky Point, dissection of Uinta Formation, terraces, canals, and streams. A - Blue Bench, B - terrace on Rocky Point, C - canal measuring sites and numbers, D - point of leakage behind house below canal, S - seepage from Uinta Formation when water first entered canal, V - example of vegetation that probably results from canal leakage.

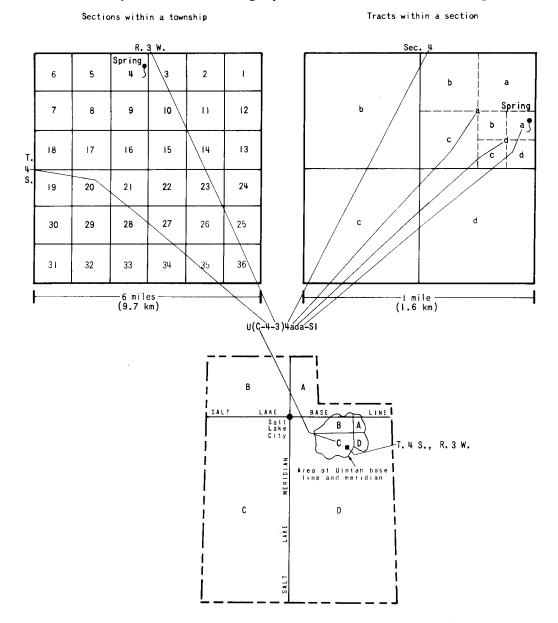
Figure 2. - Numbering system used in Utah for hydrologic-data sites.

Thus U(C-4-3)4ada-S1 designates a spring visited in the NE $\frac{1}{4}SE\frac{1}{4}NE\frac{1}{4}Sec.$ 4, T. 4 S., R. 3 W. If a well or spring cannot be located within a 10-acre (4-hm²) tract, one or two location letters are used and the serial number is omitted.

Other sites where hydrologic data were collected are numbered in the same manner, but three letters are used after the section number and no serial number is used. Thus U(C-3-4)32aba designates a point of field observations in the NE4NW4NE4 sec. 32, T. 3 S., R. 4 W., both in the Uintah survey. The numbering system is illustrated in figure 2.

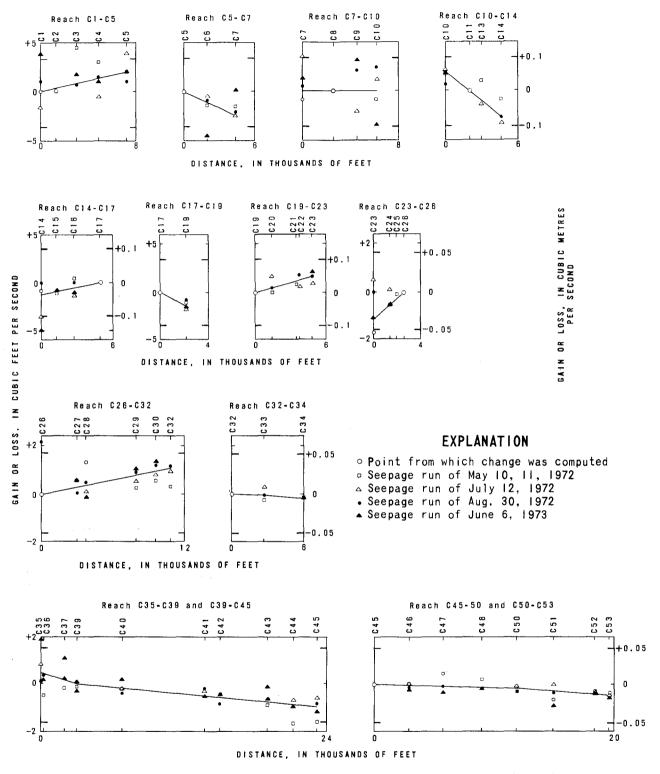
Figure 3. — Gain or loss for reaches of Rocky Point Canal system.

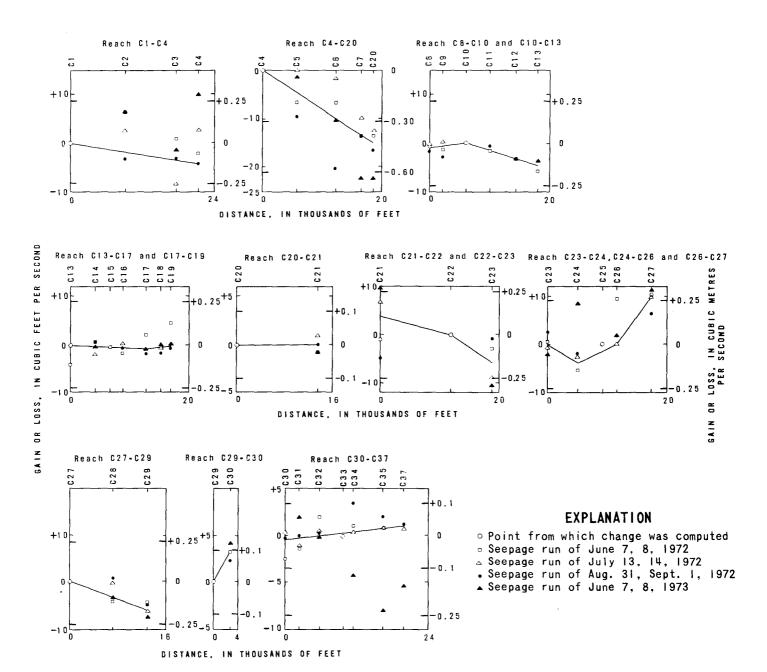
Figure 4. — Gain or loss for reaches of Grey Mountain-Pleasant Valley Canal system.

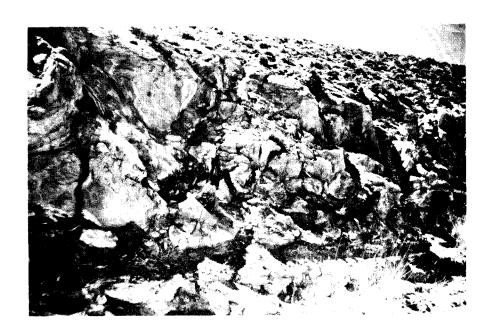
Figure 5.— Slumped area of siltstone in bluff above right (south) bank of Pleasant Valley Canal, about 0.25 mile (0.4 kilometre) below site C21. Site is below crevices (see arrow) in figure 6. Beds show much fracturing and contortion. Mineral efflorescence well above canal level indicates that water is in beds above canal.

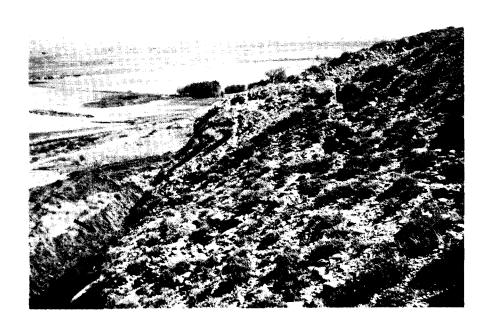
Figure 6.— Crevices opening (four arrows to right) in Uinta Formation, parallel to face of bluff above Pleasant Valley Canal at location U(C-4-2)5cab. Bedrock is only I-2 feet (0.3-0.6 metre) below land surface and is exposed in canal cut below (arrow to left). Grey Mountain Canal and Duchesne River bottom lands shown at upper left.

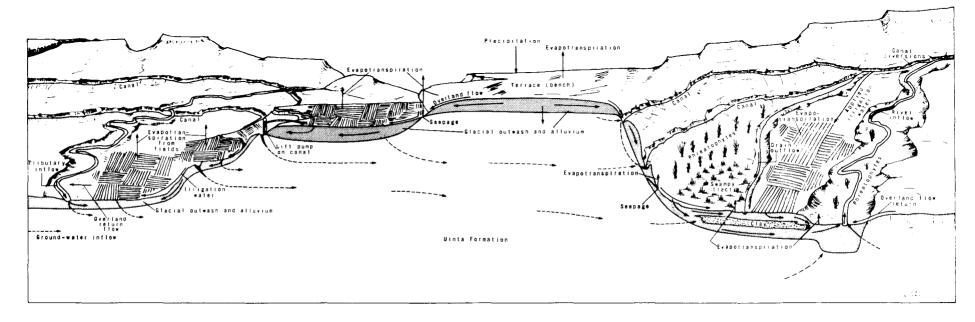
Figure 7.— Diagrammatic sketch showing movement of surface and ground waters in vicinity of canal systems near Duchesne and Myton.

Movement of water into, within, and out of the canal areas is complicated. Surface and ground water may go through several consecutive transfers from one channel or formation to another. Figure 7 shows the many possible paths and sources of water moving in the system. Owing to the intricacies of water movement in the system, the time allowed for this study was not adequate to develop a quantitative assessment that would apply only to that segment of the water in the system that has leaked from a canal. However, in the following discussion, each canal reach (shown in tables 1 and 2) is evaluated in the light of both the actual seepage measurements and the setting in which loss or gain occurs.

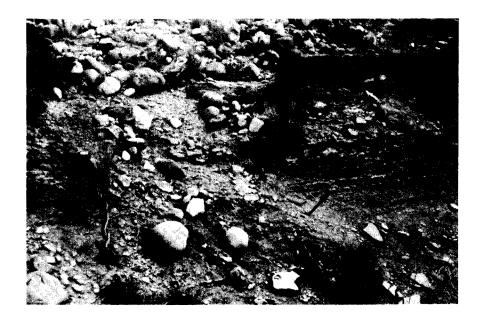
Figure 8.— Glacial outwash(?) overlying shale (see arrow) of Uinta Formation in left (east) bank of Rocky Point Canal at location U(C-3-5)25cdc.

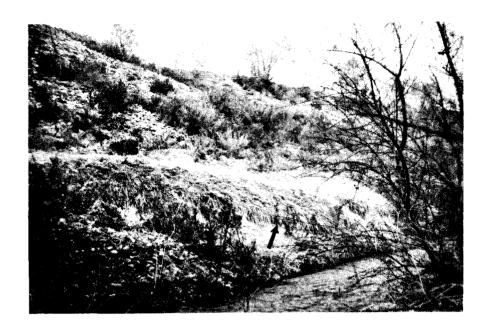
Figure 9.—Landslip between upper and lower Rocky Point Canals at location U(C-3-4)32aba. The tongue (arrow) of the slip is covered with saltgrass (Distichlis stricta) and has moved from left to right (in photograph), with edge of tongue on lower canal.

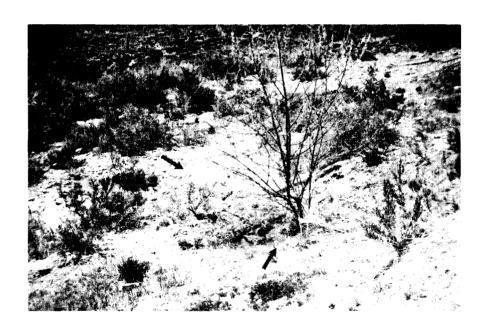
Figure 10.—Small spring (bottom arrow) at base of Russianolive (*Elaeagnus Augustifolia*) below bank of lower Rocky Point Canal at location U(C-3-4)32aba. Persistance of spring is indicated by saline accumulations (top arrow) on soils adjacent to flow.

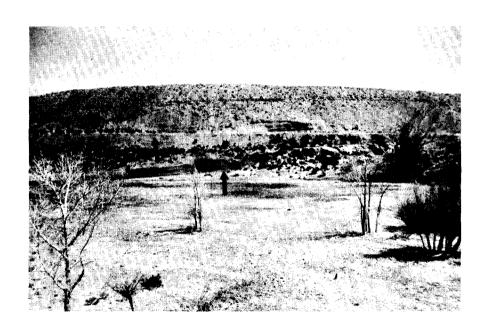
Figure II.— View eastward from location U(C-4-2)7aac of the Pleasant Valley Canal (upper arrow) along east side of a canyon tributary to Duchesne River valley. Leakage is indicated by darker vegetation (lower arrow). Valley is heavily grassed and when canal has contained water for a while, the entire valley bottom is awash.

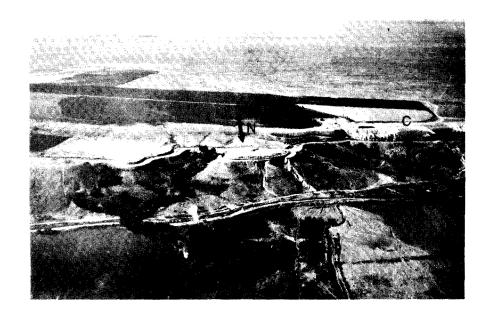
Figure 12.—Pleasant Valley (upper) and Grey Mountain (lower) Canals showing areas of breaks in spring 1972. Center of picture is about the center of sec. 5, T. 4 S., R. 2 W. Arrow at C points to area of crevices shown in figure 6. Arrow at N points to route of new section of canal. Lower arrow points to chute cut by break. Note heavily vegetated canyons at left. Duchesne River bottom in foreground, irrigated land on top of bluff, Pleasant Valley in distance, to south.

The upper part of this reach—from site C21 to the area between turnouts T44 and T45—is cut into the Uinta Formation along a precipitous part of the bluff overlooking the Duchesne River flood plain (fig. 12). Numerous bands of brush mark areas of probable discharge from the Uinta Formation, and the disasterous canal break of April 23, 1972, appears to bear out that movement of water in Uinta Formation contributes to the leakage into and out of the canal and the adjacent fields.

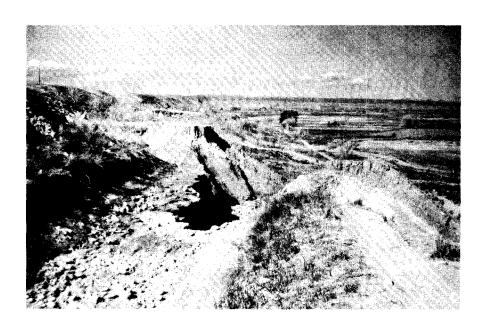
Figure 13.— View looking west of break of April 23, 1972, in Pleasant Valley Canal, showing chute cut in slumped beds of Uinta Formation. Note abundance of vegetation along bluff below canal in distance.

In the 1972 break, the water apparently did not overtop the canal bank (Mr. Sorenson, ditch rider, oral commun., April 27, 1972), but rather cut out a part of the bank where it had slumped. The slumping apparently was due to the wetting of the face of the bluff below the bank by water issuing from fractured rock beneath the scree on the nearly vertical bluff. Subsequently, the canal water cut a chute in the bluff (figs. 12 and 13), stripped the scree away, filled the Grey Mountain Canal, and inundated the field beyond. Nine days after the break, the chute had dried and the Uinta rocks could be examined. A bed of fractured siltstone in the bottom of the chute was wet (fig. 14) and actively discharging a small amount of water.

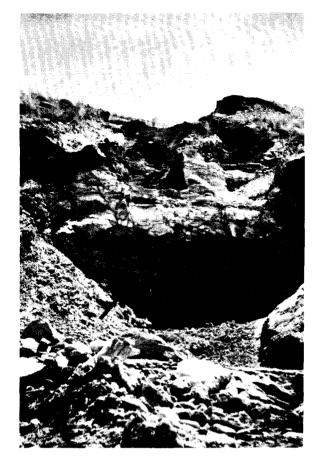
Figure 14. — View up bluff in the chute shown in figure 13. Water was actively flowing from saturated beds (arrow) in Uinta Formation at base of chute 9 days after chute was cut.

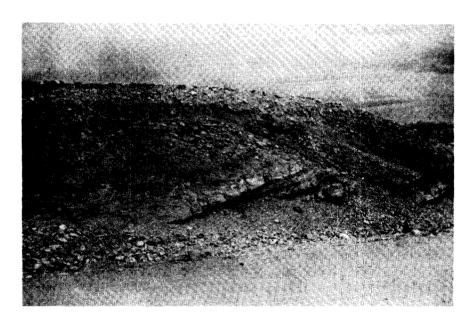
Figure 15.—Gravel and cobbles (glacial outwash?) dipping southward on eroded surface of Uinta Formation dipping northward, near south edge of South Myton Bench. Location U(C-4-2)10dcb, in east side of road cut on State Road 216.

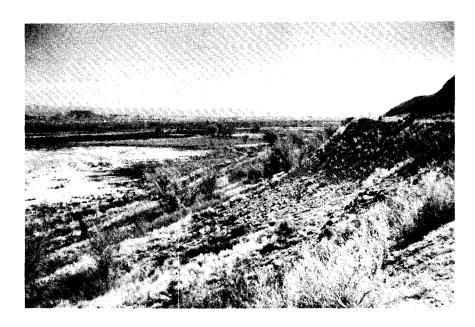
Figure 16.— View looking eastward from location U(C-4-2)7bba. Pleasant Valley Canal (arrow at upper right); Grey Mountain Canal (arrow at left) and canal-side drain at lower left. Pleasant Valley Canal is cut into Uinta Formation, which here has an apparent dip of $7\frac{1}{2}^{\circ}$ N. 20° W. Slope has thin veneer of gravel and clay, which is selectively covered with brush where leakage provides water. Much willow and other phreatophytes grow along lower canal and drain. Bottoms are marshy and have an alkaline band around old river meander scar.

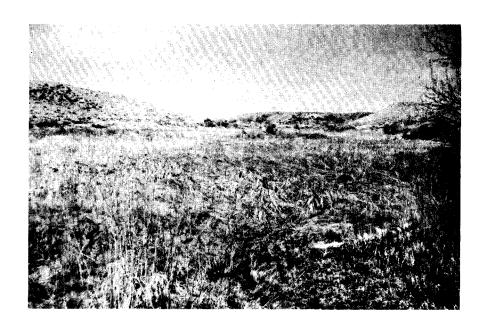
Figure 17.— View looking west-southwestward from bank of Grey Mountain Canal at location U(C-3-2)35daa. Large canyon containing return flow from irrigation on South Myton Bench. Floor of canyon is marshy and is choked with cattails (Typha Latifolia) to near head of canyon. Several channels (arrow) empty into Grey Mountain Canal, and these contain some flow between irrigation seasons.

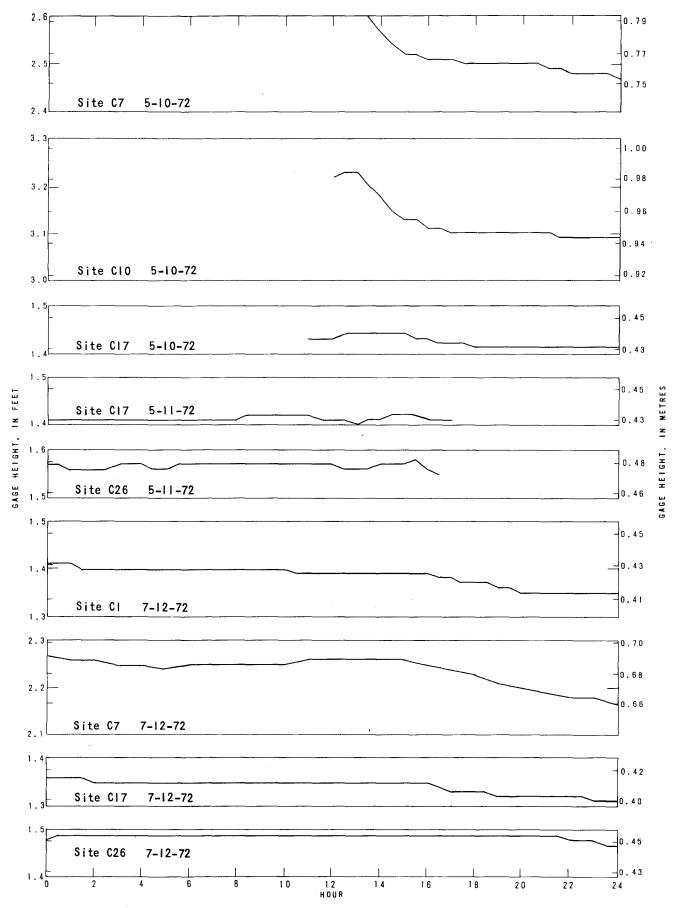
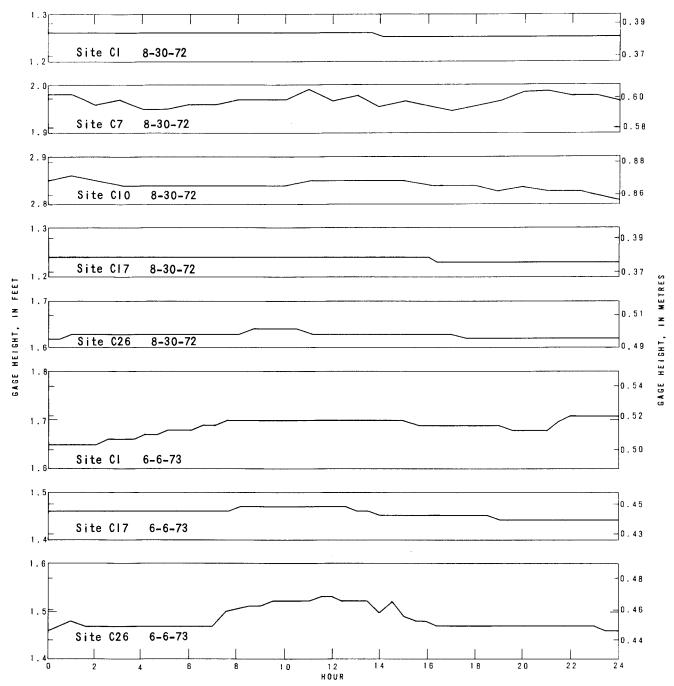
Figure 18. - Gage heights at recorders on Rocky Point Canal system.

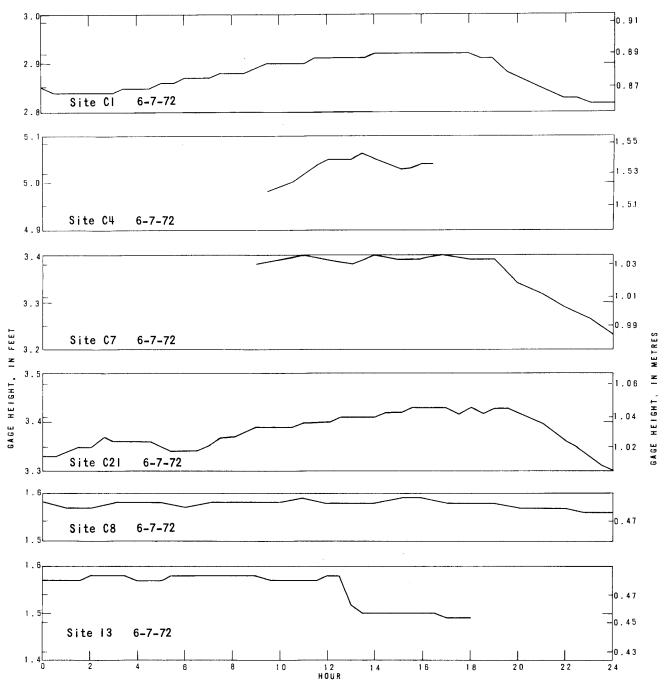
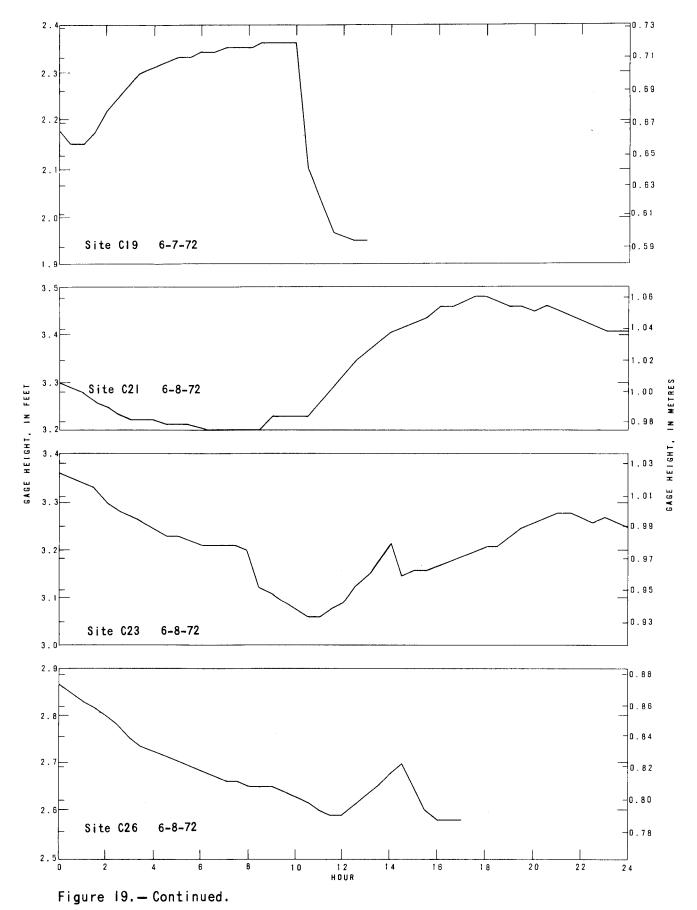
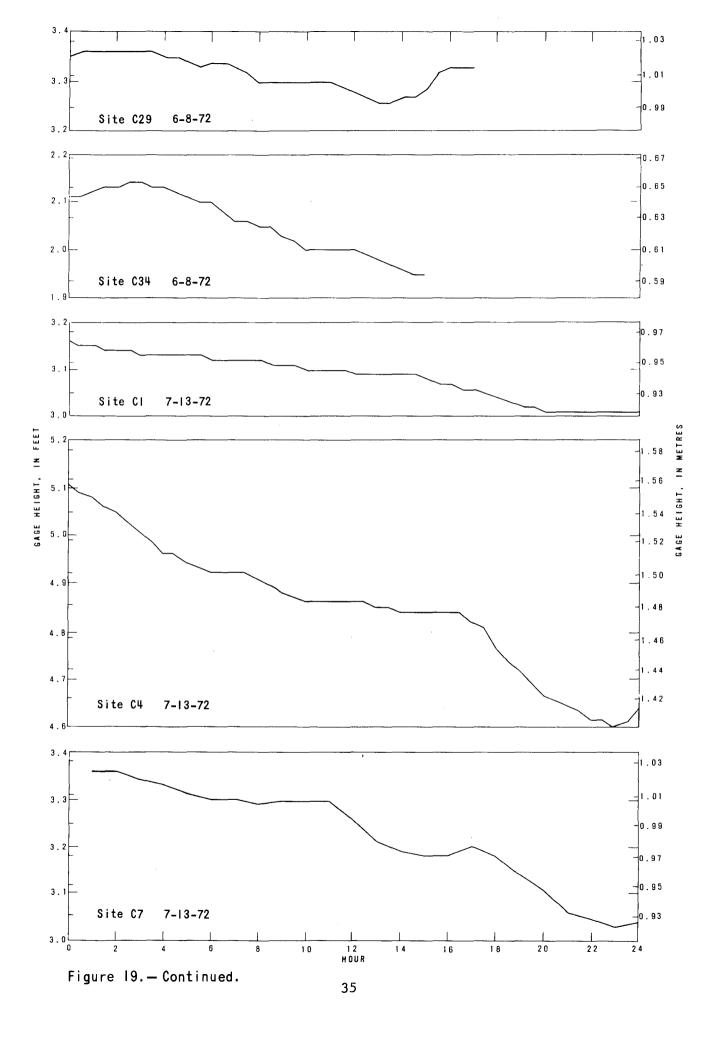
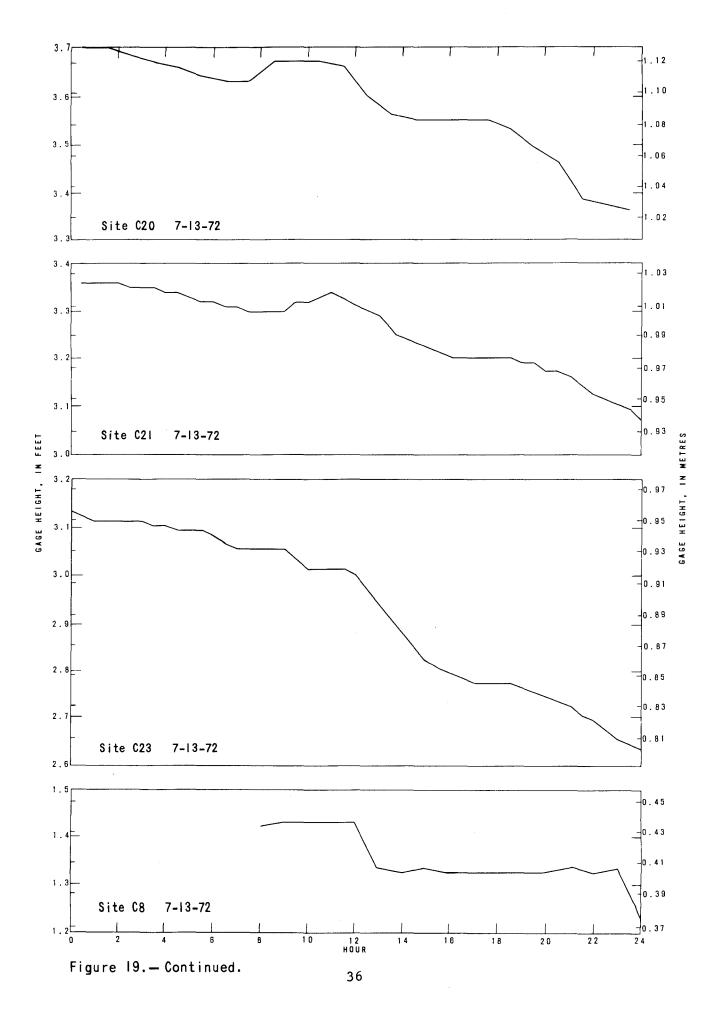
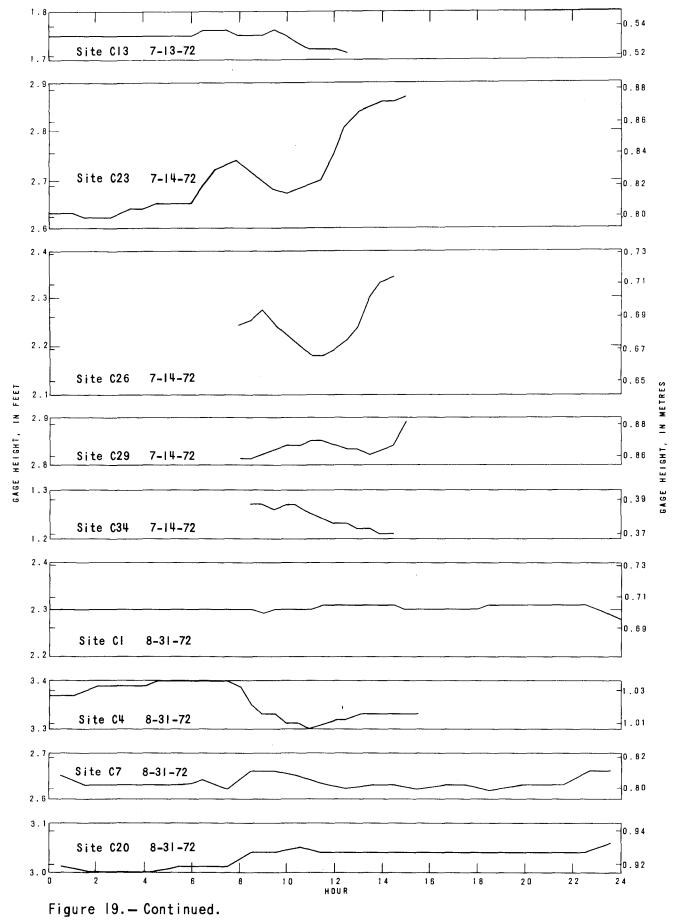
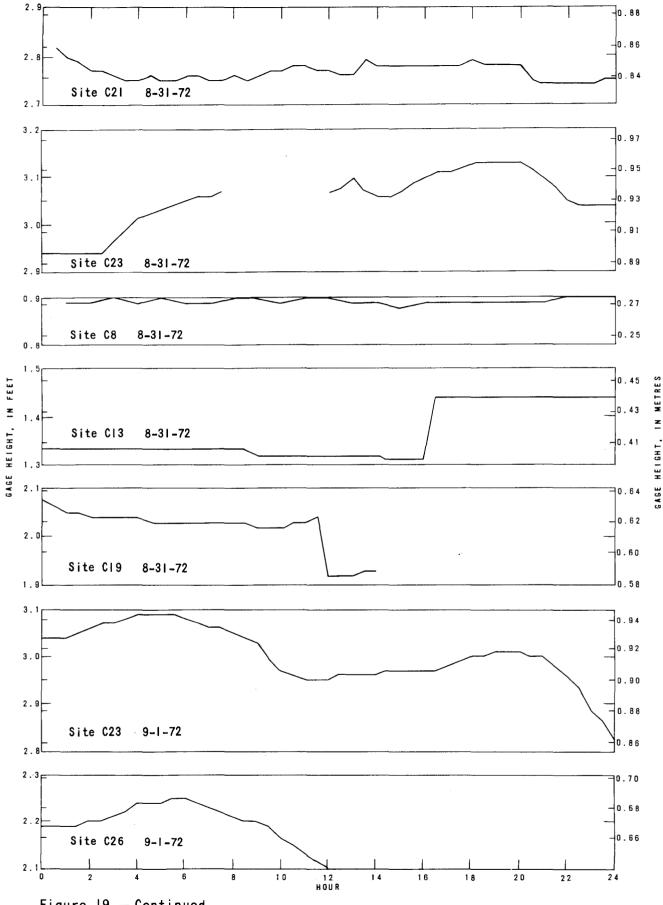
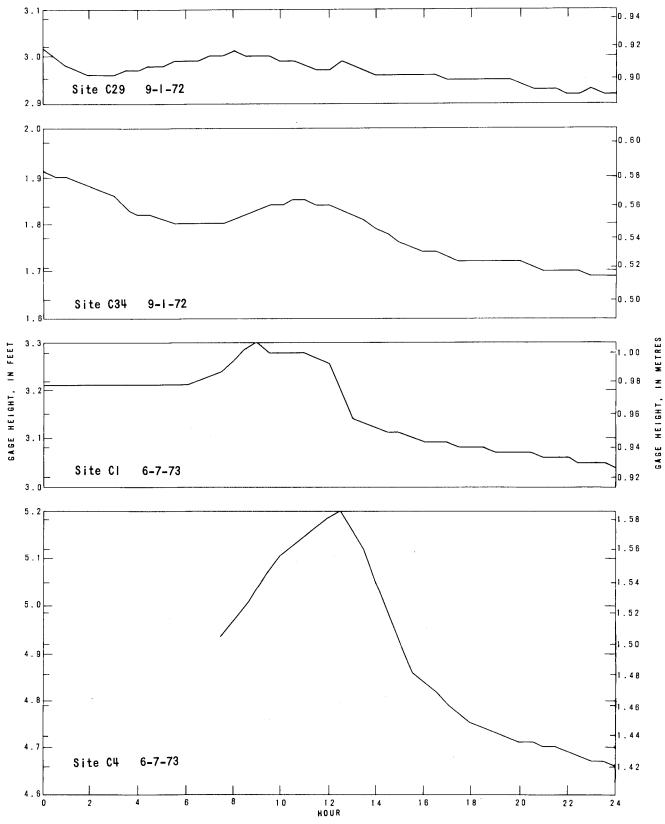
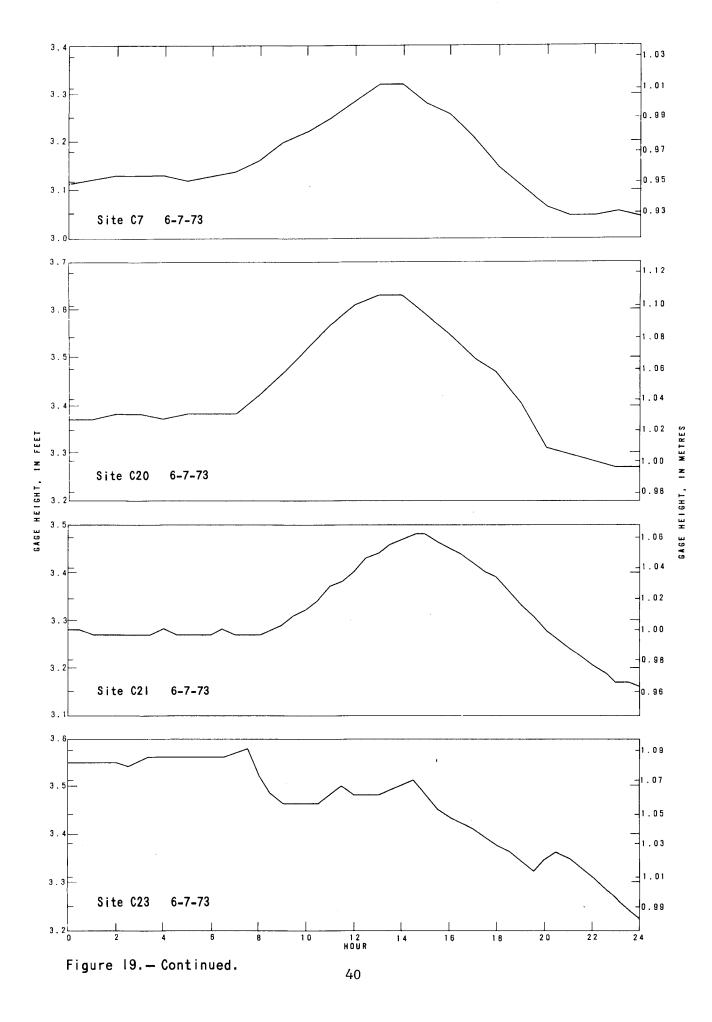
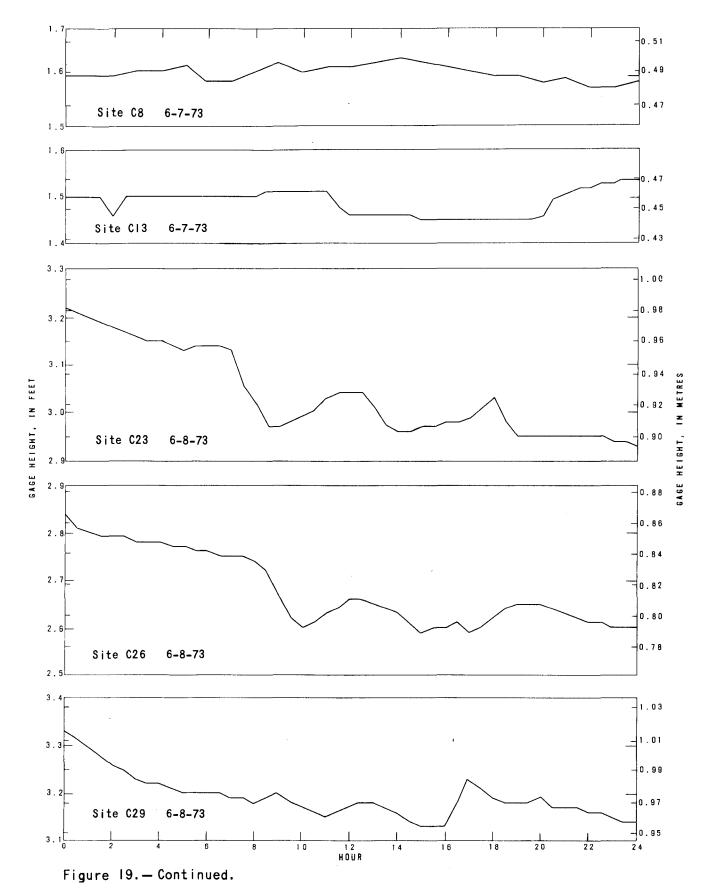
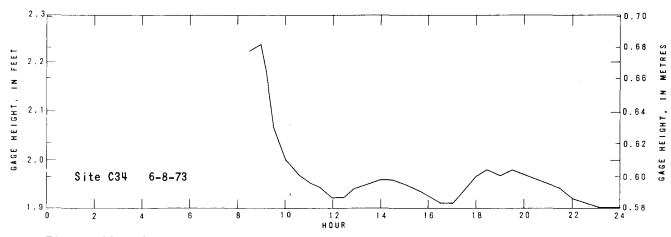
Figure 19. — Gage heights at recorders on Grey Mountain-Pleasant Valley Canal system.
