# Utah Division of Water Rights

## REVIEW OF GROUNDWATER MONITORING MOAB / SPANISH VALLEY - CENTRAL

# Moab / Spanish Valley Watershed

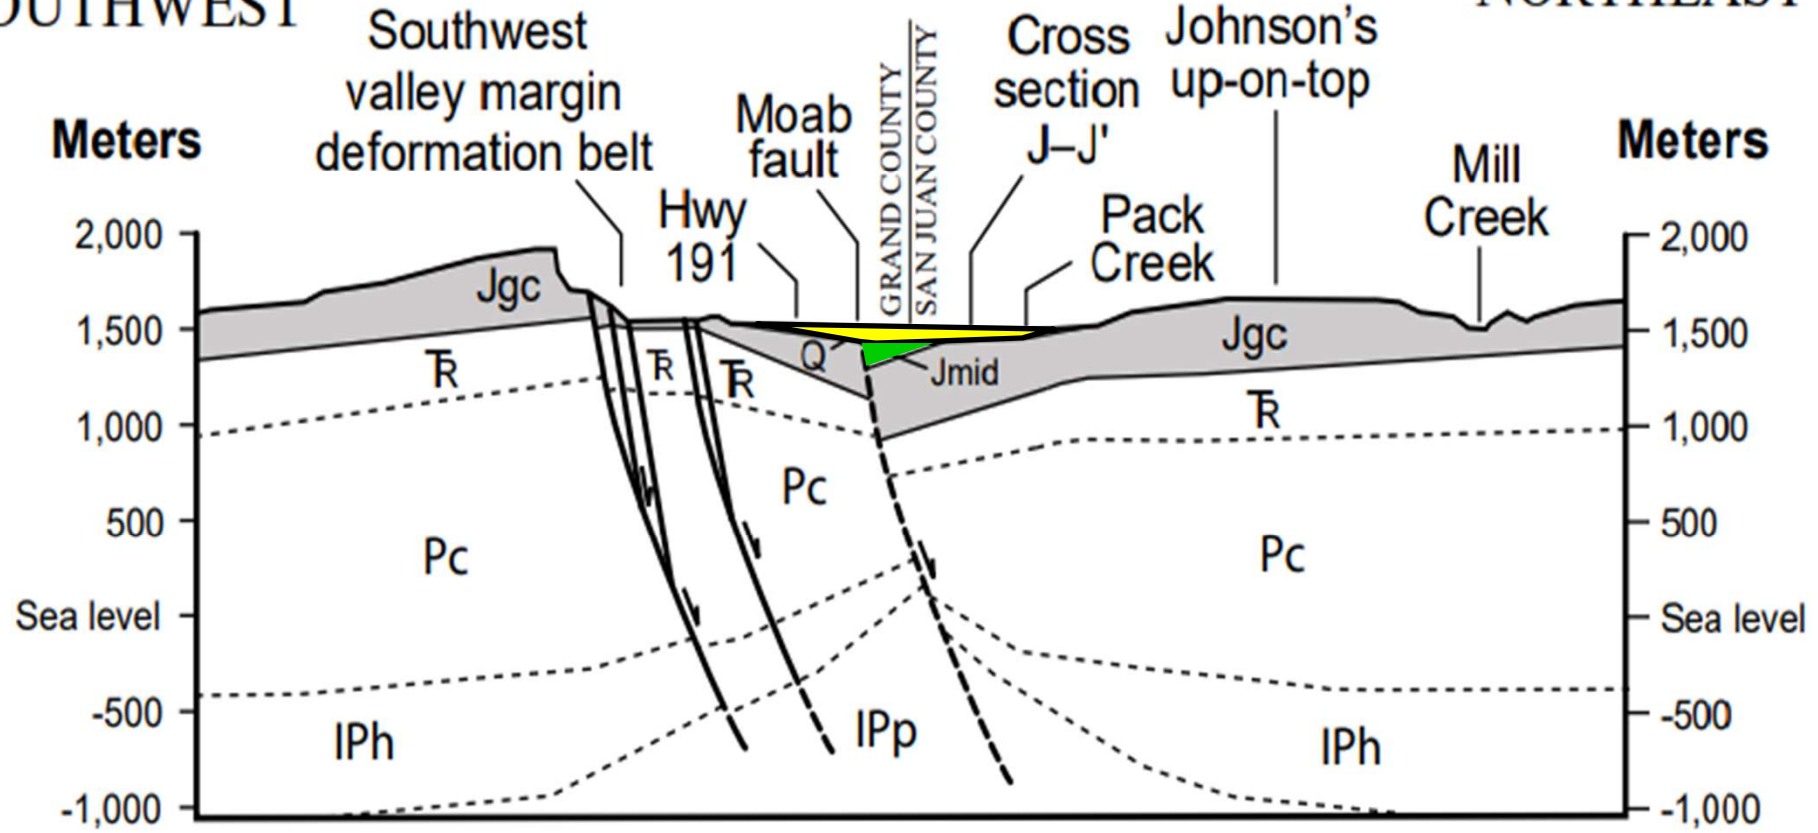
- Valley Fill – Sand / Gravel
- Carmel / Dewey Bridge

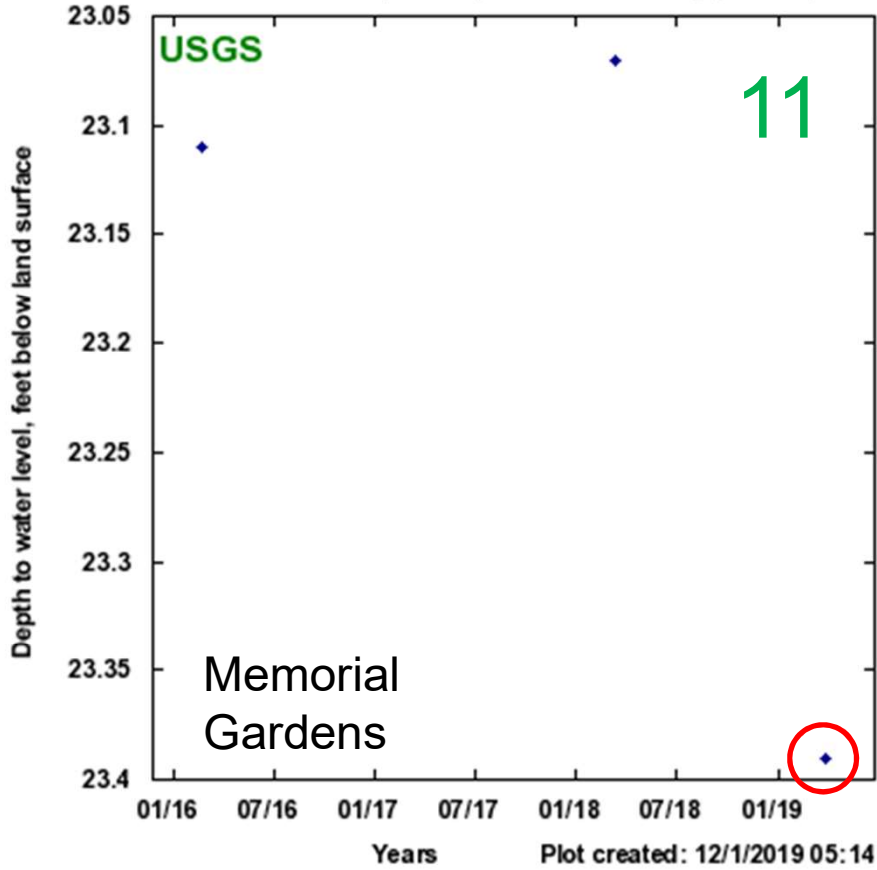
383201109295301 - (D-26-22)21aL10- 1 formerly (D-26-22)16d 05-268

- ◆ Approved water-level measurement
- ◆ Provisional water-level measurement

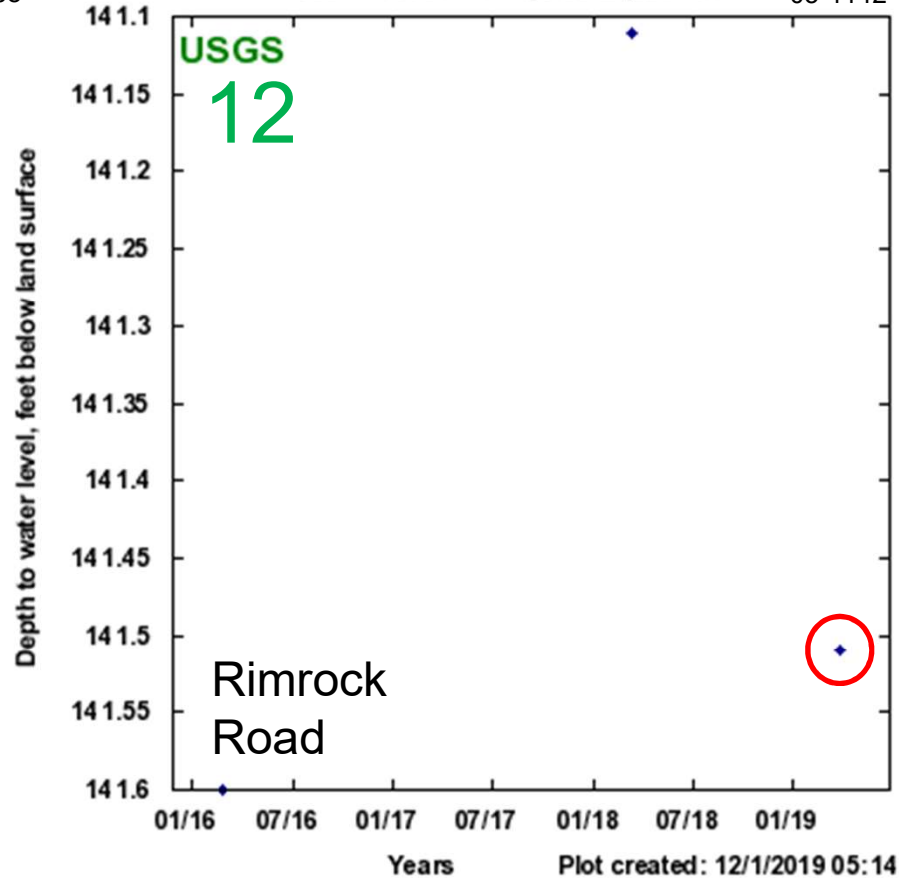
383141109304401 - (D-26-22)20dL86- 1 05-1142

No Well Log

Nearest Well: 05-486  
0 – 65' Sand / Gravel

- ◆ Approved water-level measurement
- ◆ Provisional water-level measurement

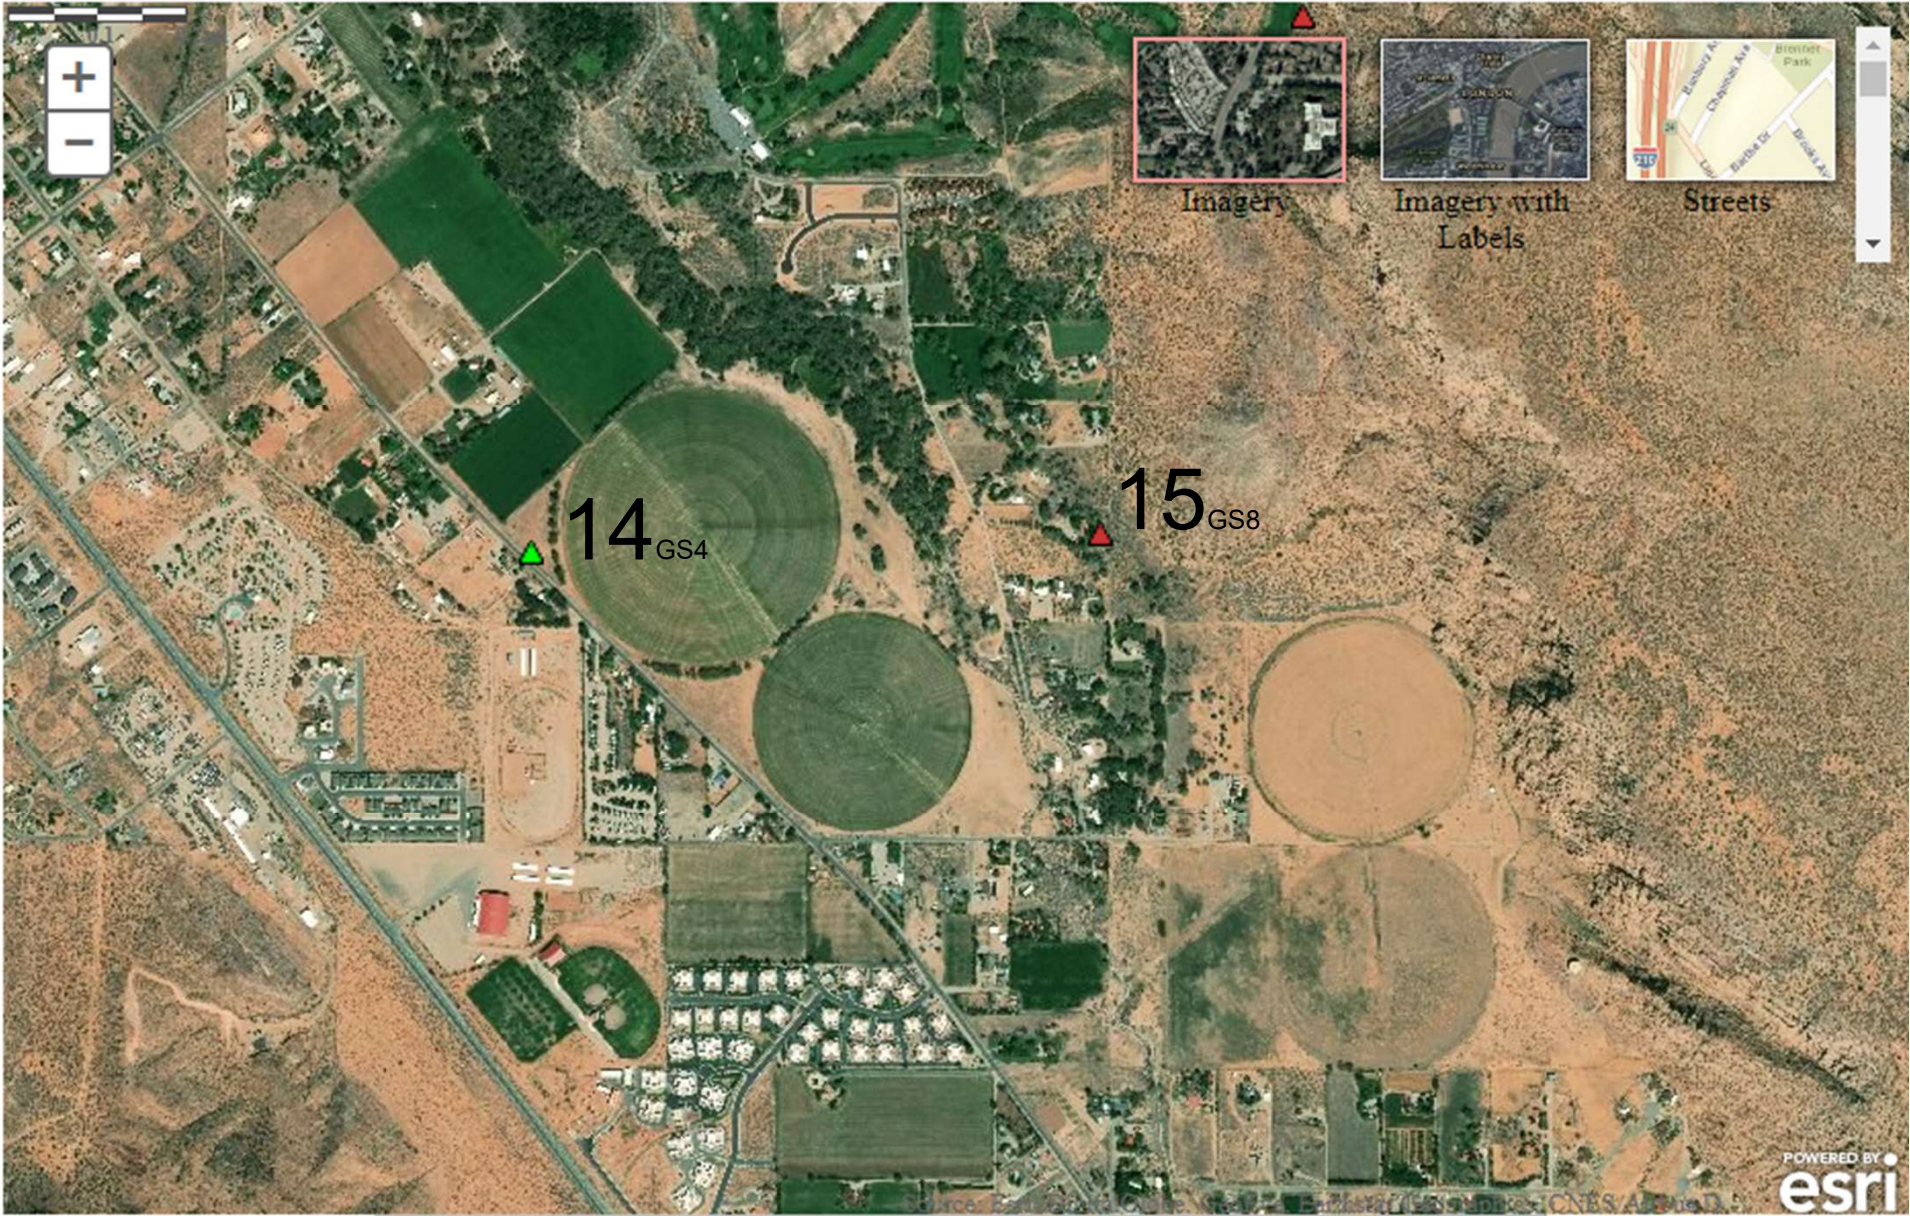
USGS "Evaluation of Groundwater Resources in the Spanish Valley Watershed, Grand and San Juan Counties, Utah" Scientific Investigations Report 2019-5062, pg. 52

USGS 383202109285101 (0-26-22)22aab- 1 05-336

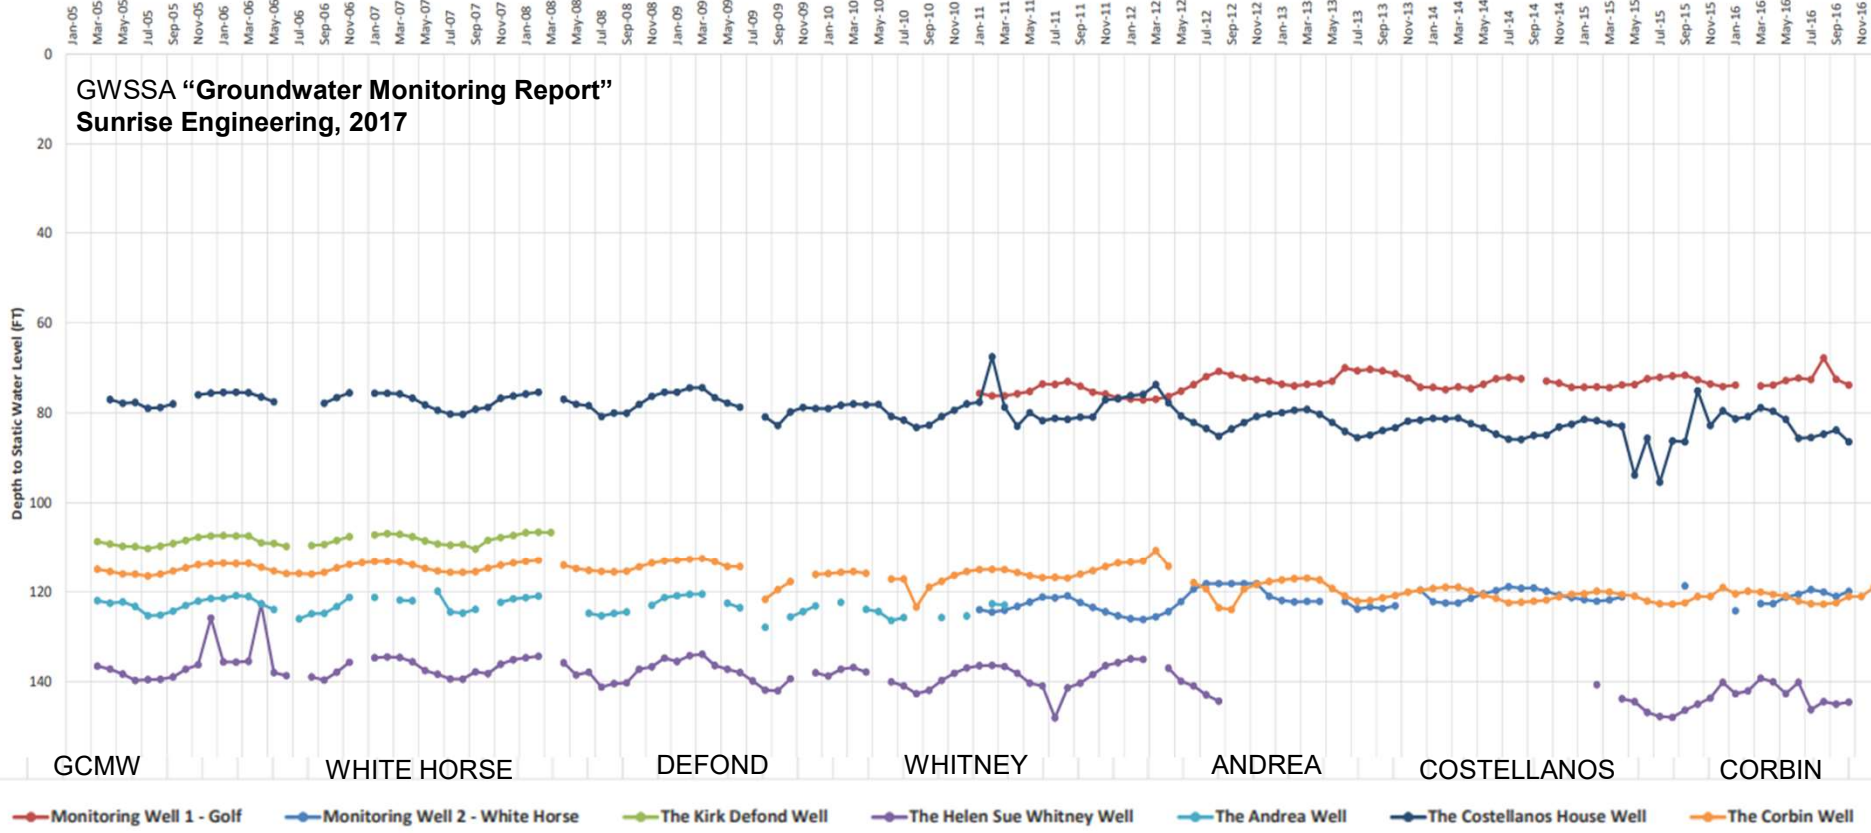
**GWSSA "Groundwater Monitoring Report"**  
**Sunrise Engineering, 2017**

Depth to Static Water Level (FT)

Monitoring Well 1 - Golf    Monitoring Well 2 - White Horse    The Kirk Defond Well    The Helen Sue Whitney Well    The Andrea Well    The Costellanos House Well    The Corbin Well

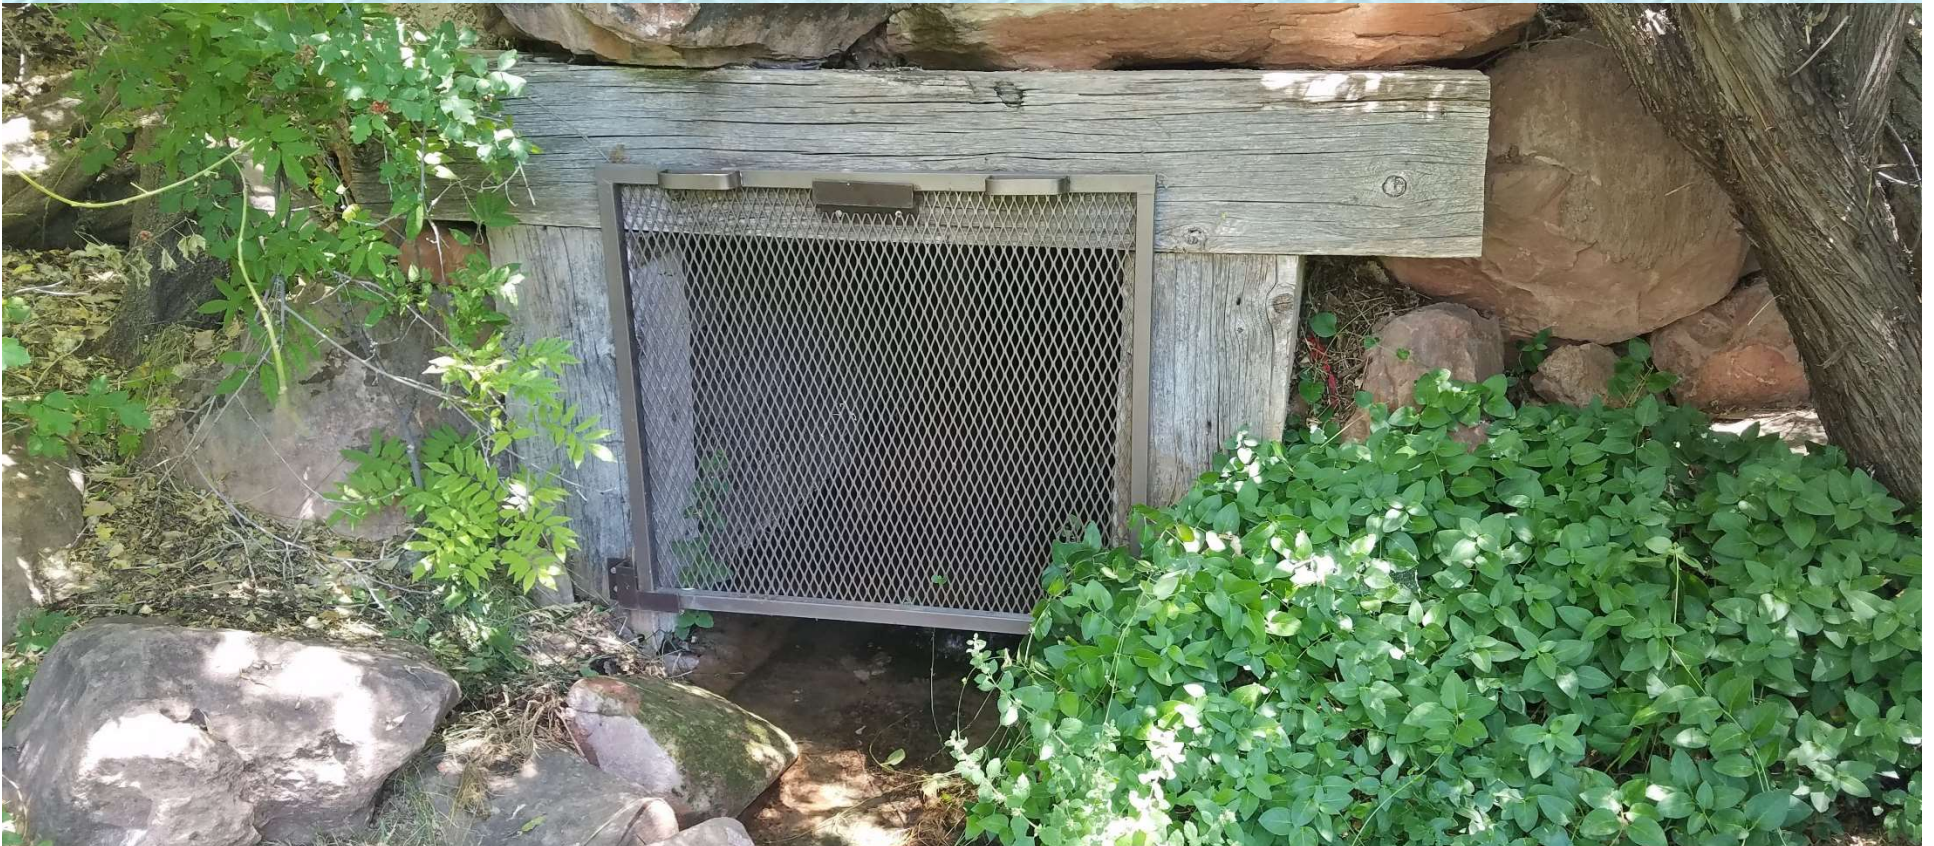
# Natural Spring Flows

- No Monitoring on any springs except for the following:
  - Moab - Sommerville Springs
  - Moab – Golf Course Springs
