SEAA 1323

**From:** Mike SILVA  
**To:** Rusty Aiken  
**Date:** 10/10/2012 1:50 PM  
**Subject:** Diversion inspection Oct 3 2012  
**Attachments:** EF Virgin 10 03 2012 028.jpg; EF Virgin 10 03 2012 023.jpg; EF Virgin 10 03 2012 024.jpg; EF Virgin 10 03 2012 025.jpg; EF Virgin 10 03 2012 026.jpg; EF Virgin 10 03 2012 027.jpg

Rusty, RE: SEAA 1323

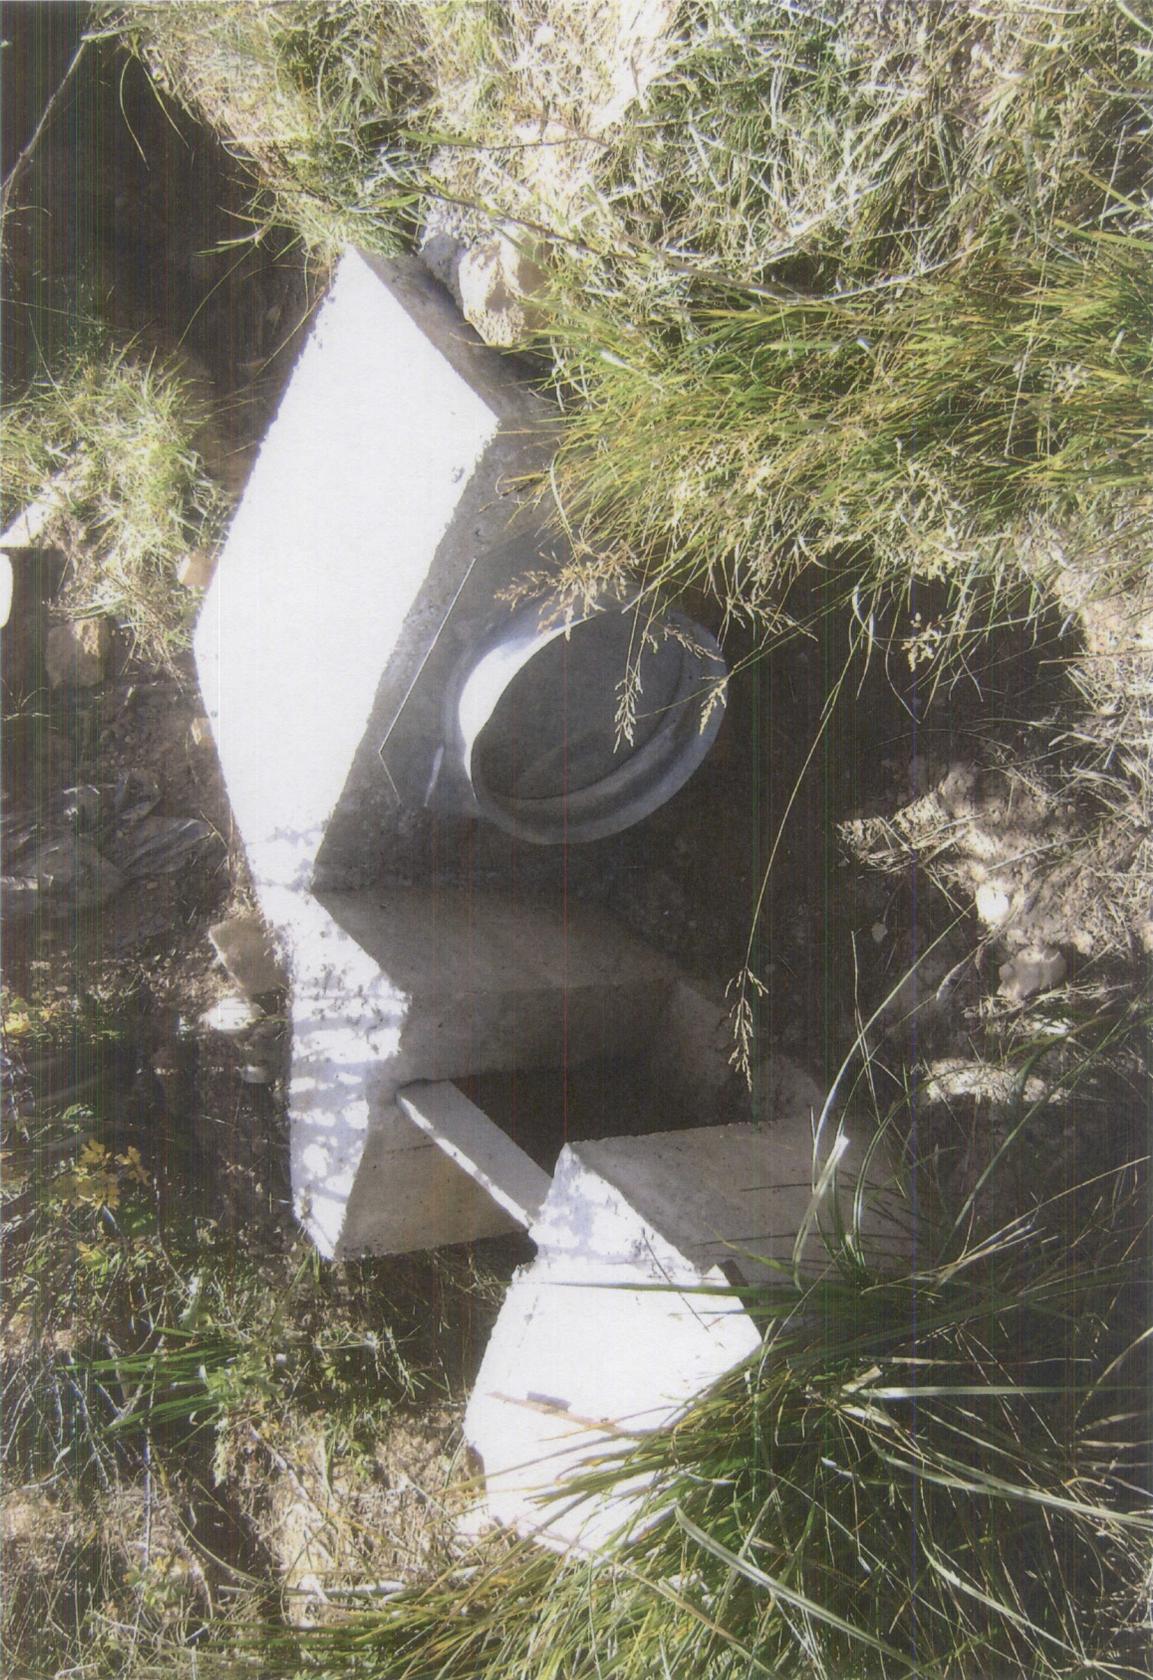
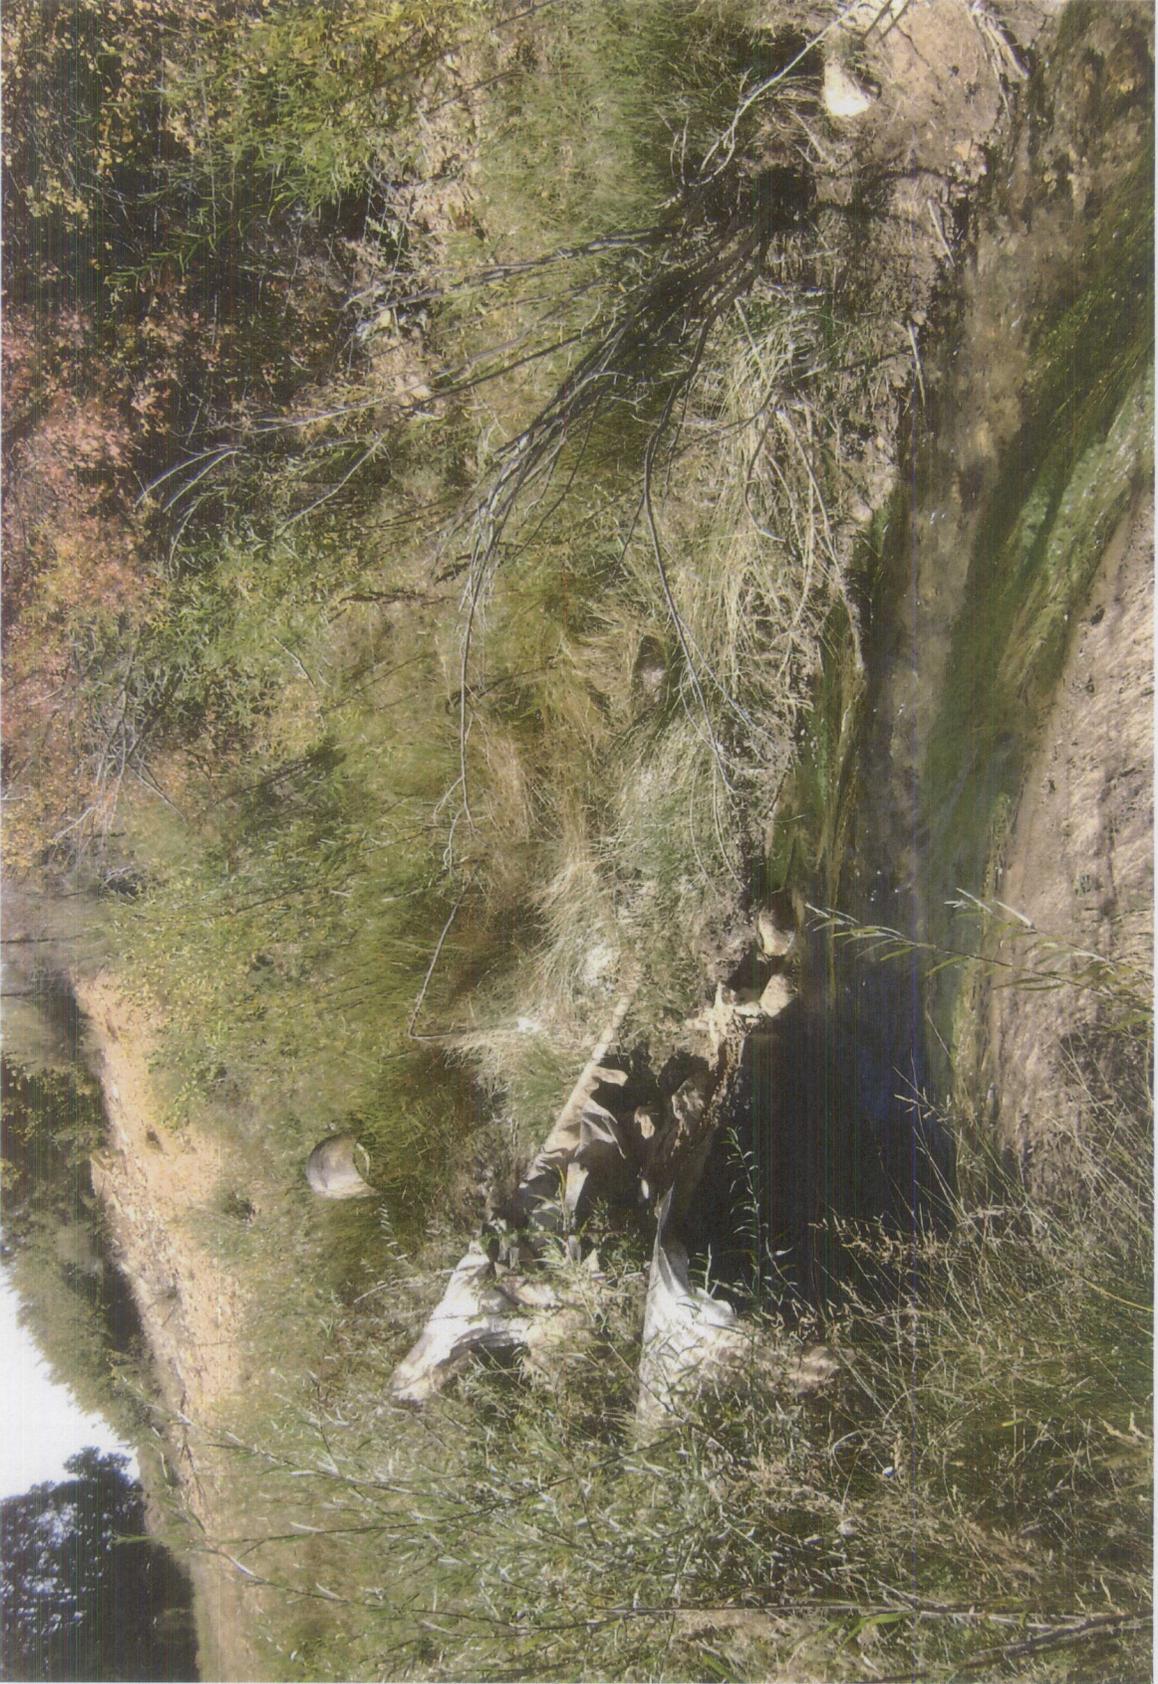
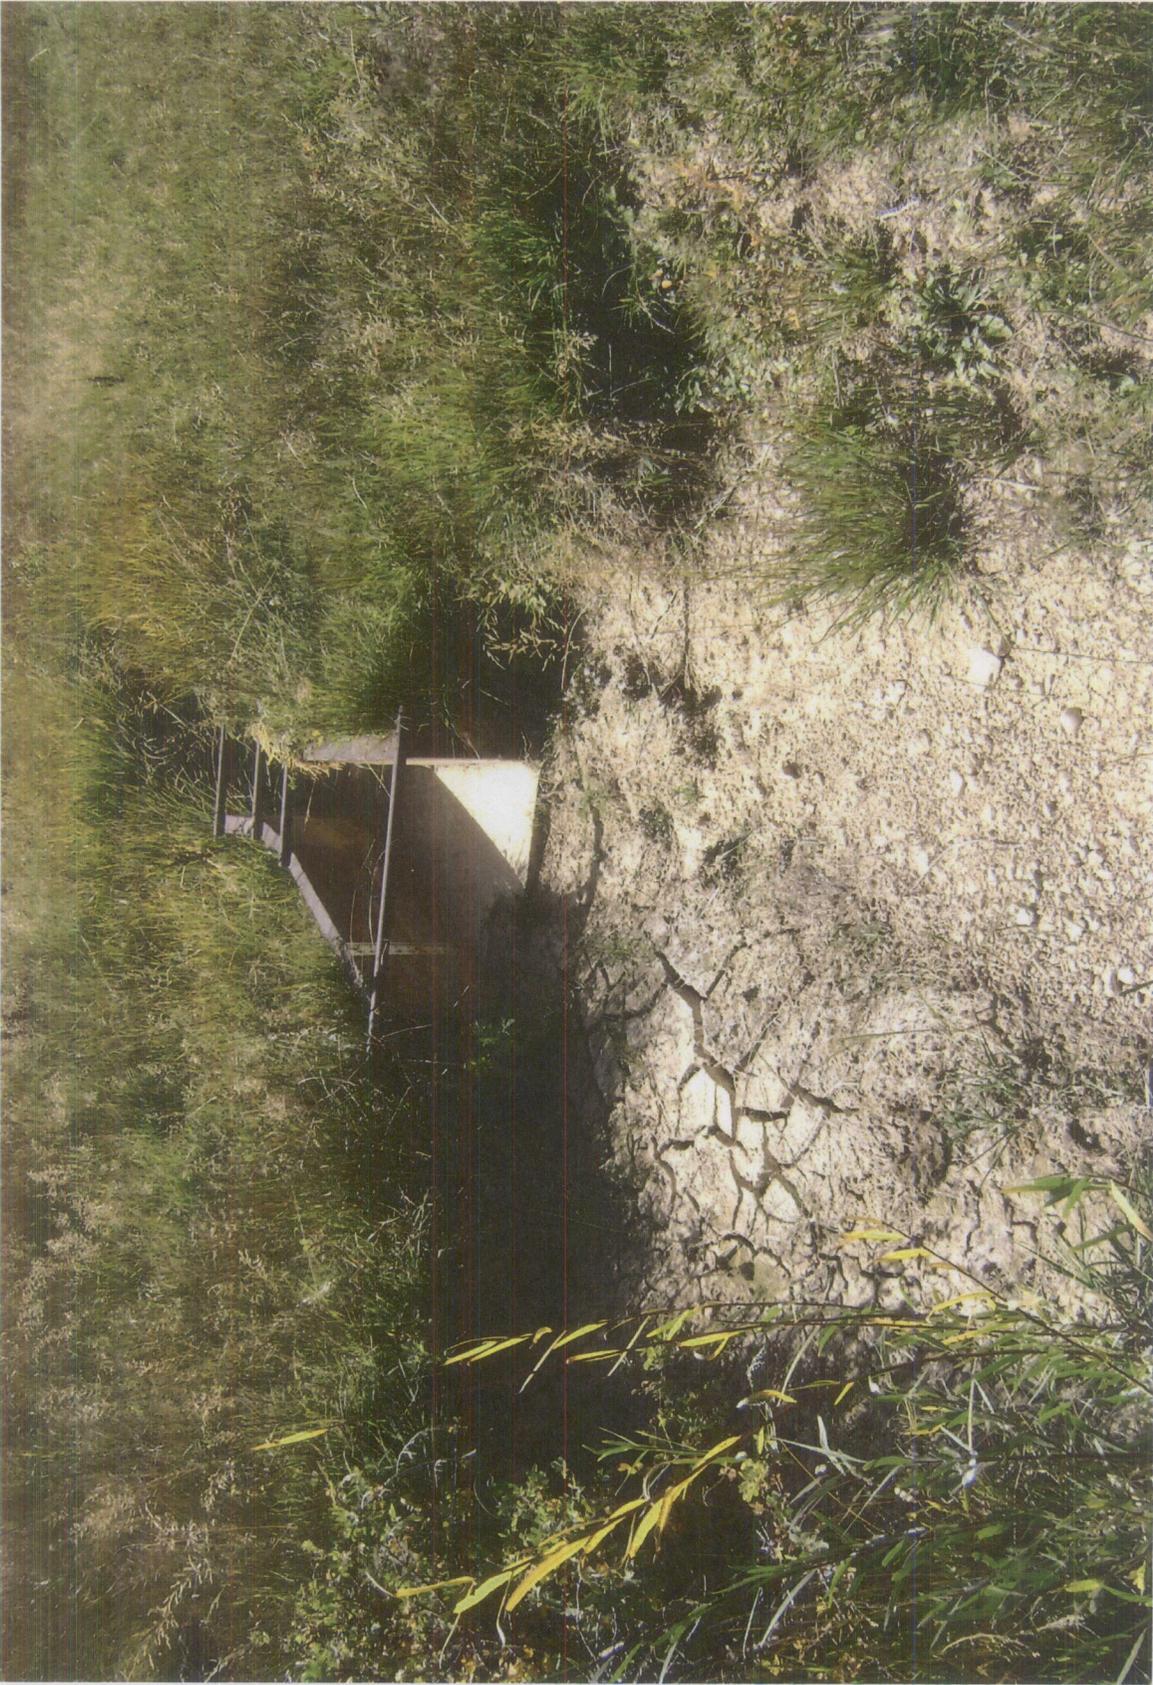
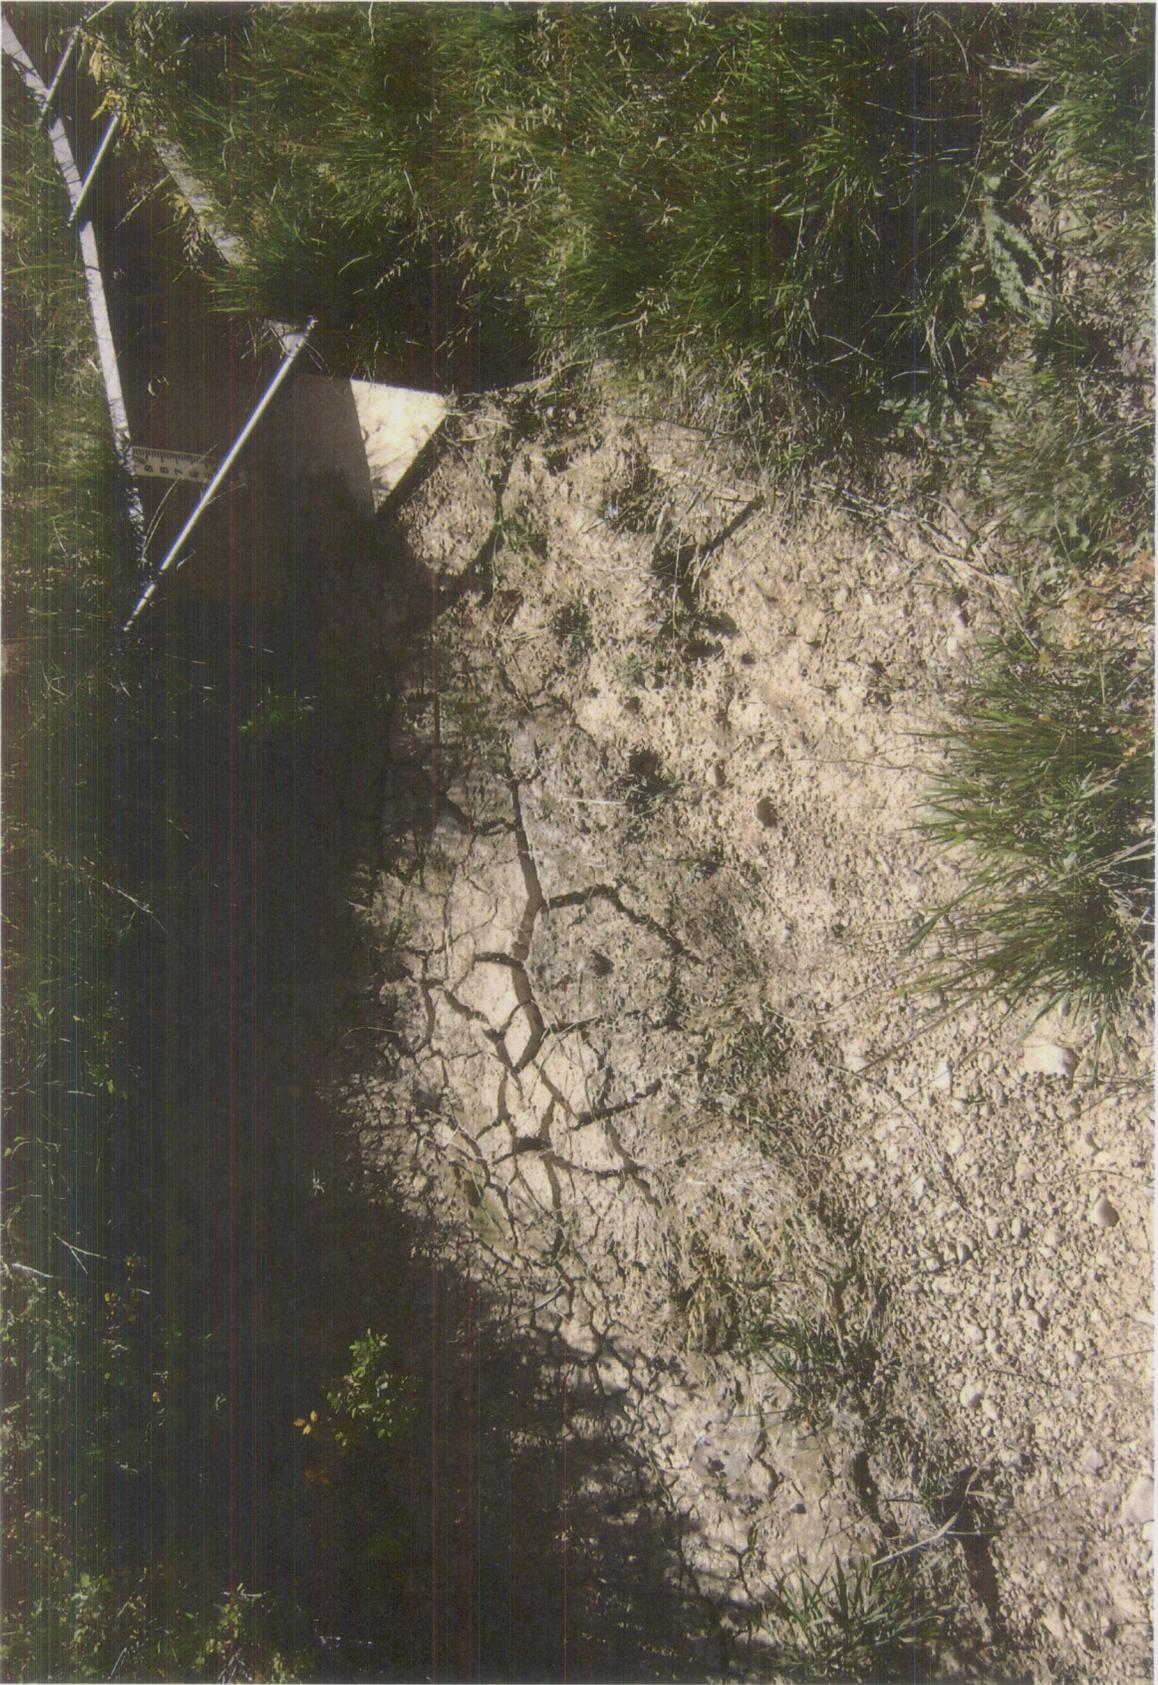
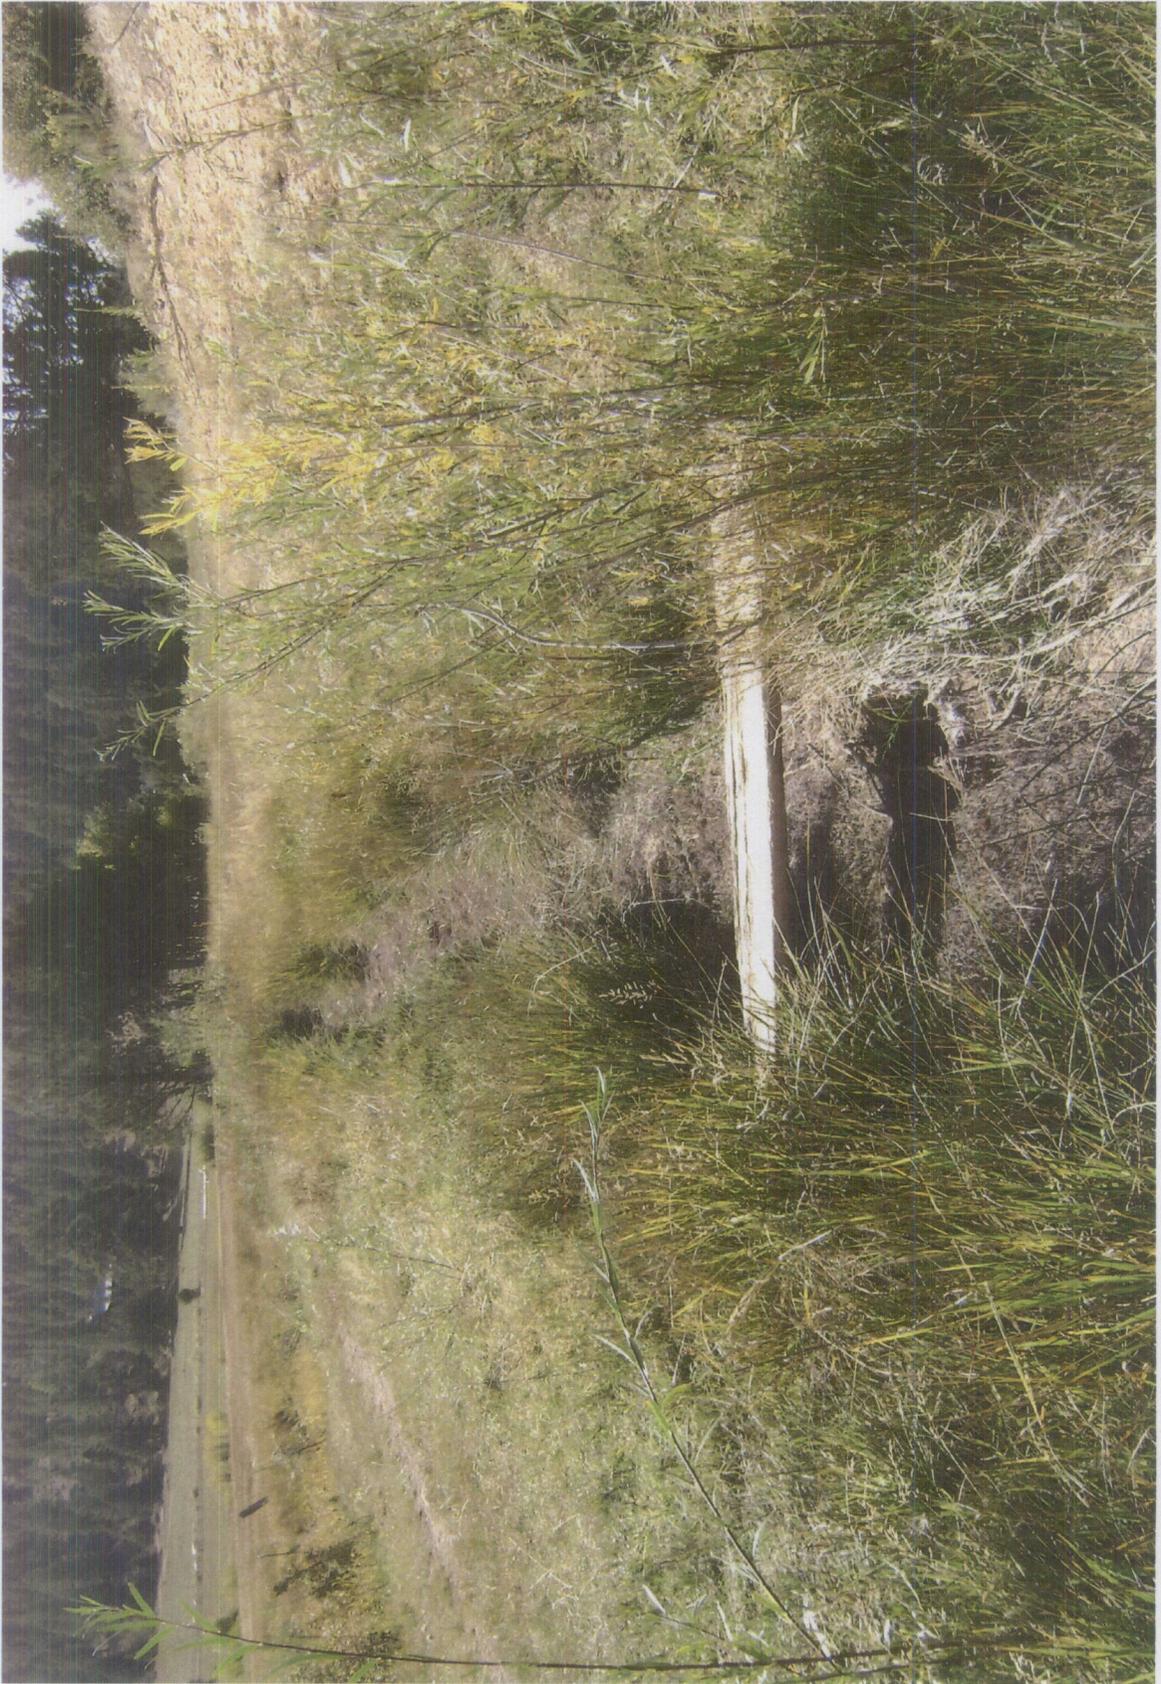
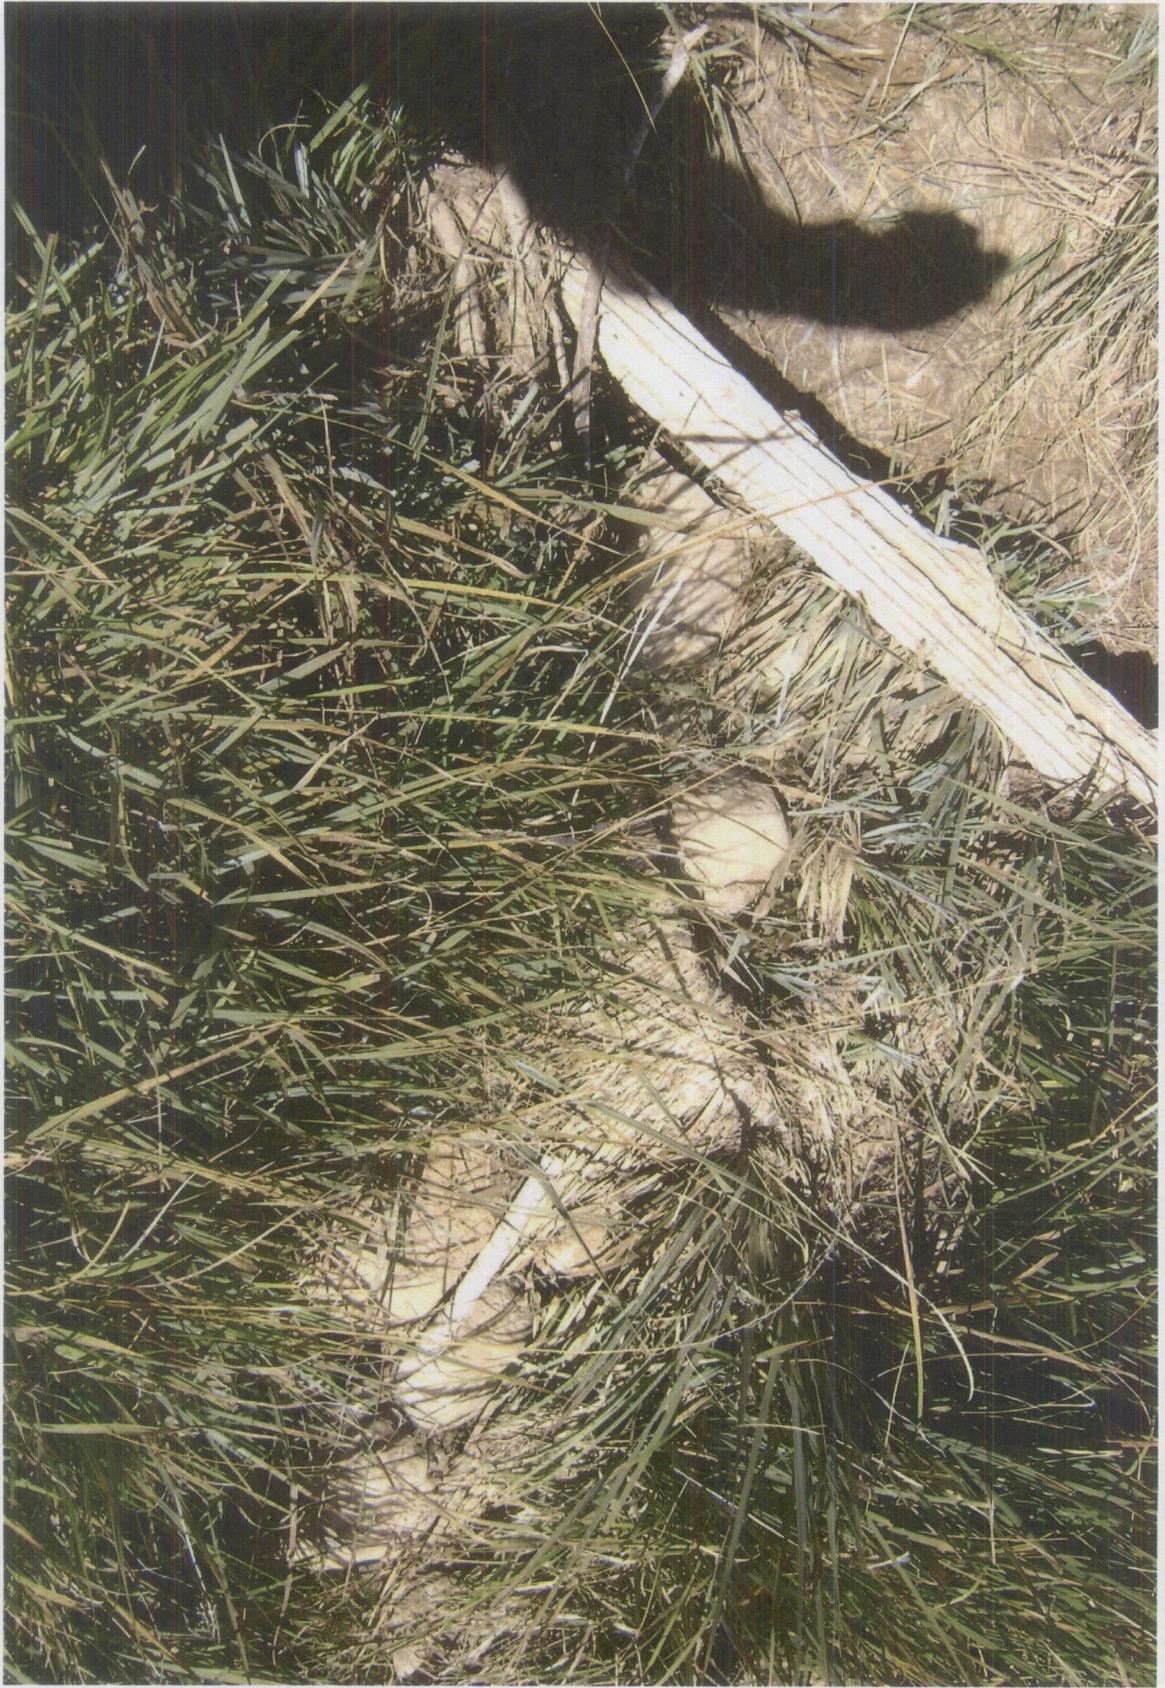
As follow up, we are noting that you have installed concrete at the return to river diversion and armoring, along with installing a new culvert in concrete with a slide- pivot at the head of your ditch above your Parshall flume measuring device.

Although we accept work completed to date, the need for a substantial diversion at the point of diversion (POD) from the main stem of the river is still needed and required by state law. The current method involves the use of a tarp and wood boards to block the river flow entering a large culvert, enough to back the river enough to enter the canal. Previous inspections with this tarp in place concealed other problems that are now evident with the tarp removed. During the latest inspection, the diversion was not active, the tarp and board arrangement to block the culvert was removed. This revealed evidence of significant erosion and water piping around both sides of the culvert. This condition is advanced enough now that it to lead to eventual failure that will occur during high flows during future diversion practices employing the same means. Water is finding alternate paths around the culvert which is compromising the culvert function as evidenced by enlargement of erosional holes.

This condition does not constitute a substantial and reliable headgate control or suitable controlling works. If continued, the culvert will wash out and release a significant amount of soil into the running stream and render your diversion inoperable. The Division does not consider the current tarp method being used as a reliable or substantial headgate diversion or turnout that is easily managed by the Water Commissioner or other water users that you share turns with. This condition is not acceptable and requires repair and a suitable long term remedy.

2) Both sides of the large culvert must be protected from further erosion and the existing erosional channels must be completely filled in and repaired so that future soil washing will not occur. Recommendation is to install concrete wing walls in conjunction with the gate requirements, and completely backfill erosional channels. Also note that concrete may not be placed in a live stream and a Stream alteration permit may be required if work in the live stream is conducted. Suggest diverting stream water around the diversion or at upstream diversion point.

4) Entrance to Parshall flume has preferential flow conditions established and sediment collection that has settled in front of culvert must be removed to insure that uniform flow conditions are maintained into the
