EVALUATION REPORT

PANGUITCH LAKE DAM

Garfield County, Utah

July 2024

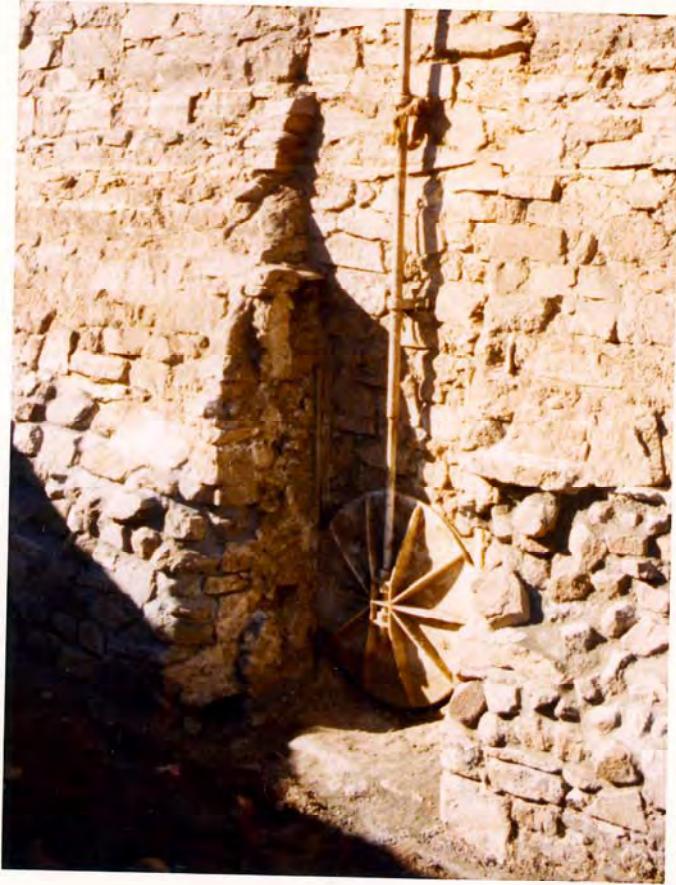
#1 Nov. 1975. Panguitch Dam, 48" dia. slide gate. Invert to crest of dam 24' - 2".

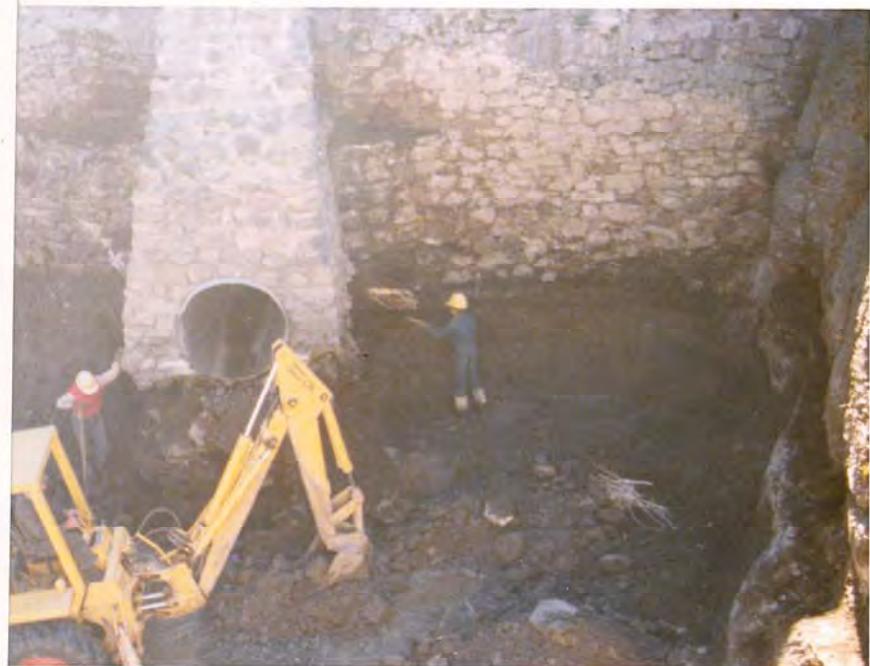
#4 Panguitch Lake Dam. Nov. 1975. Removal of existing material; downstream face.

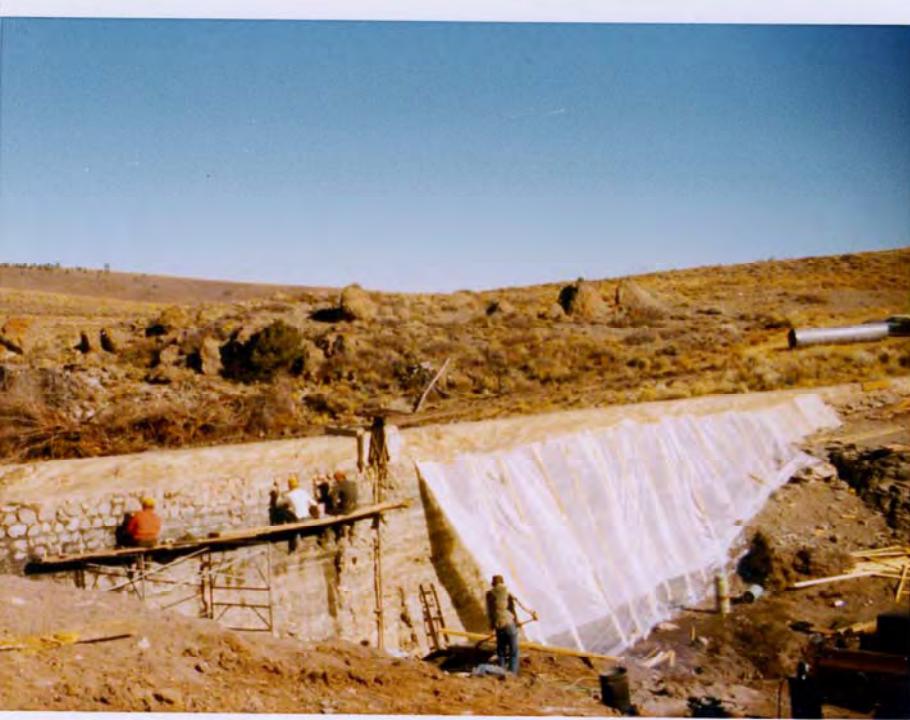
6 Nov. 1975. Panguitch Dam. Upstream mortar repair in progress.

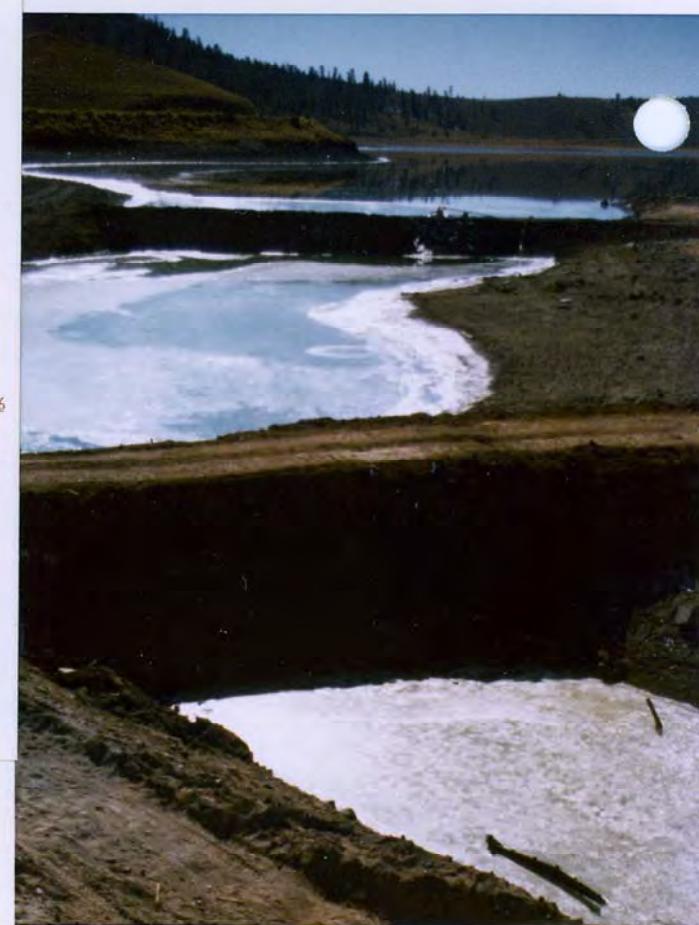
#7 Nov. 1975. Panguitch Dam. View south showing two coffer dams with pumping equipment.

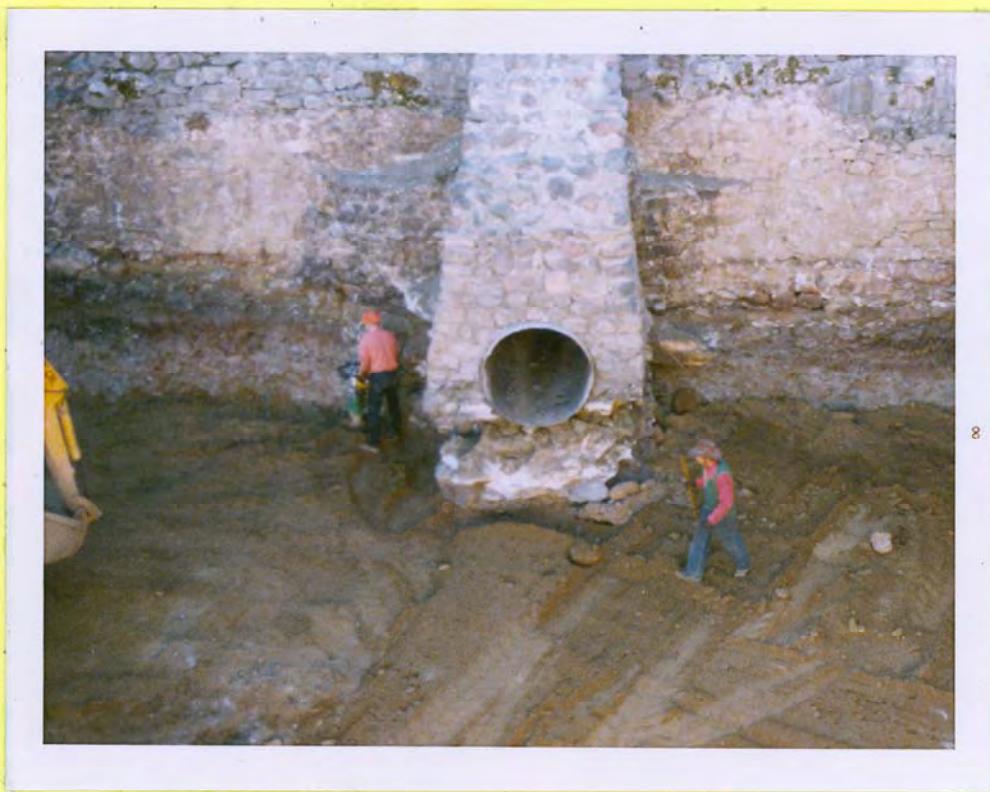
#8 Nov. 1975. Panguitch Dam. Placement of fill material downstream face.

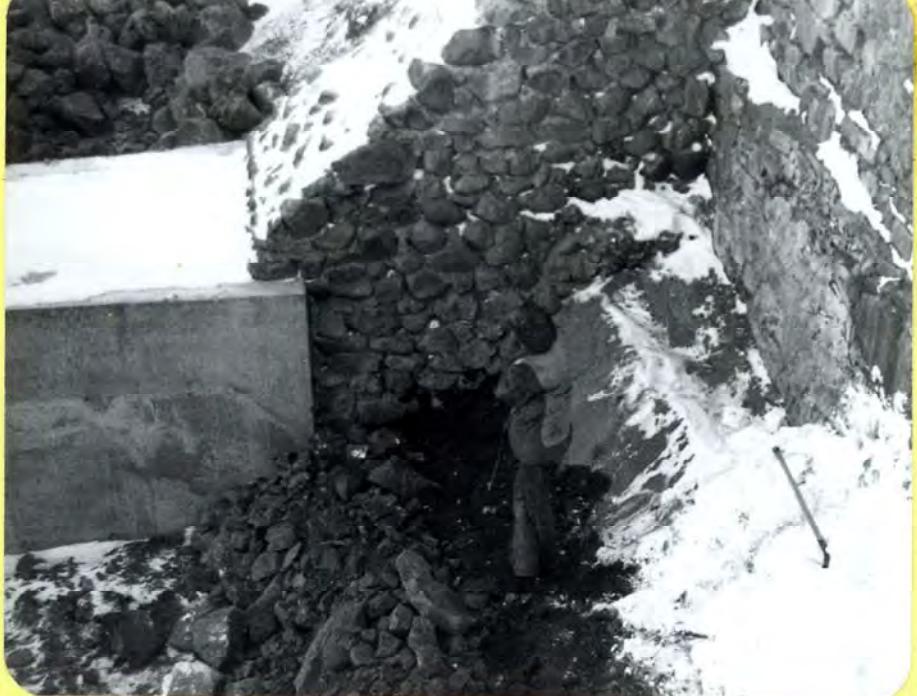
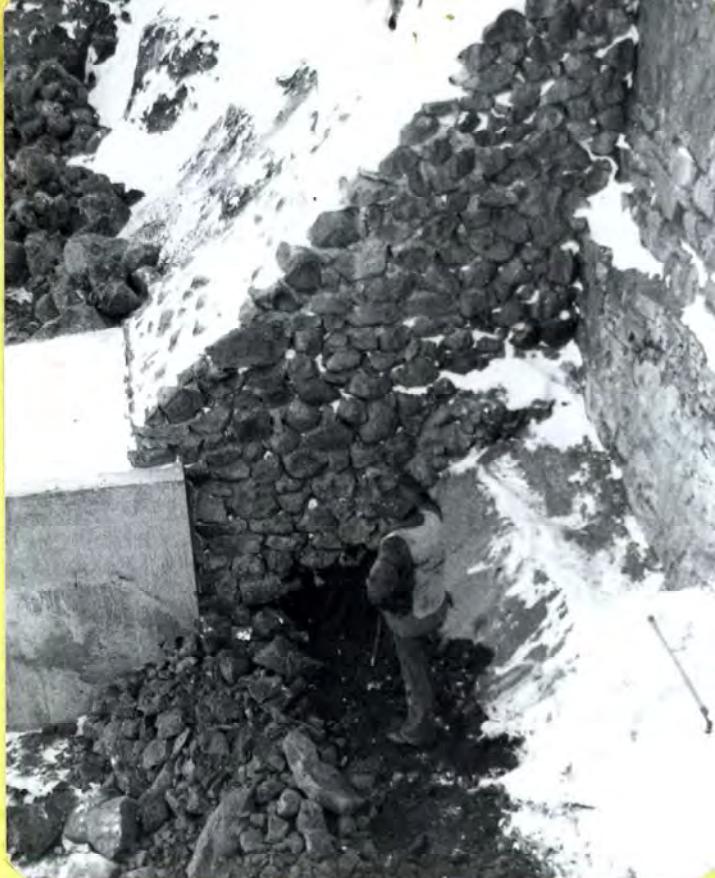
#1 and #2 Placement of fill material against downstream face of dam. Imported fill is light and natural fill is dark.

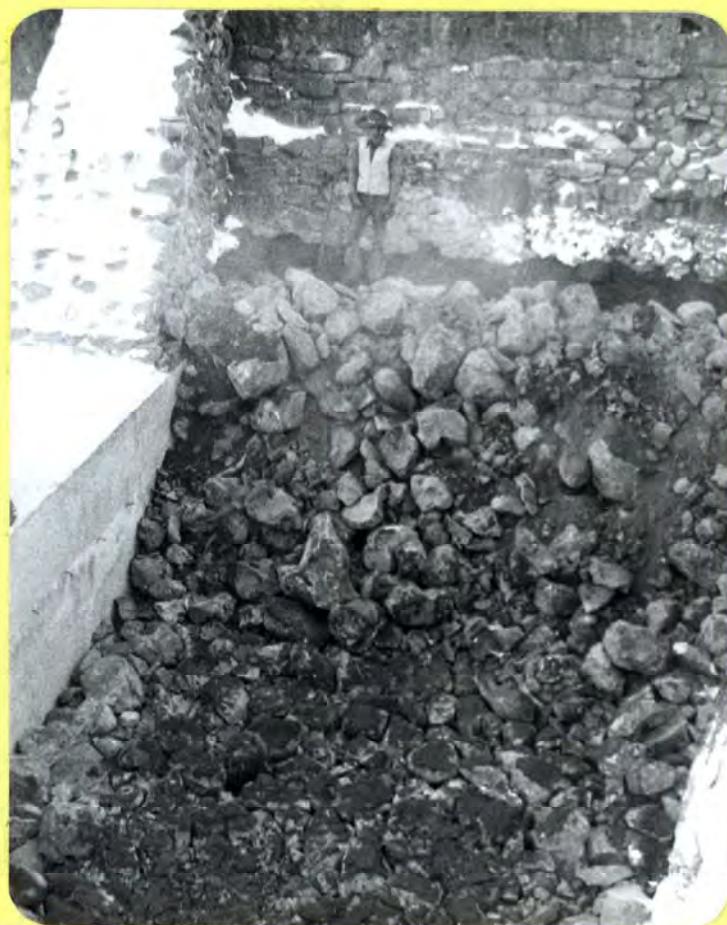
#3 Natural fill brought up and over imported fill. Rock fill started on the west side of the dam.

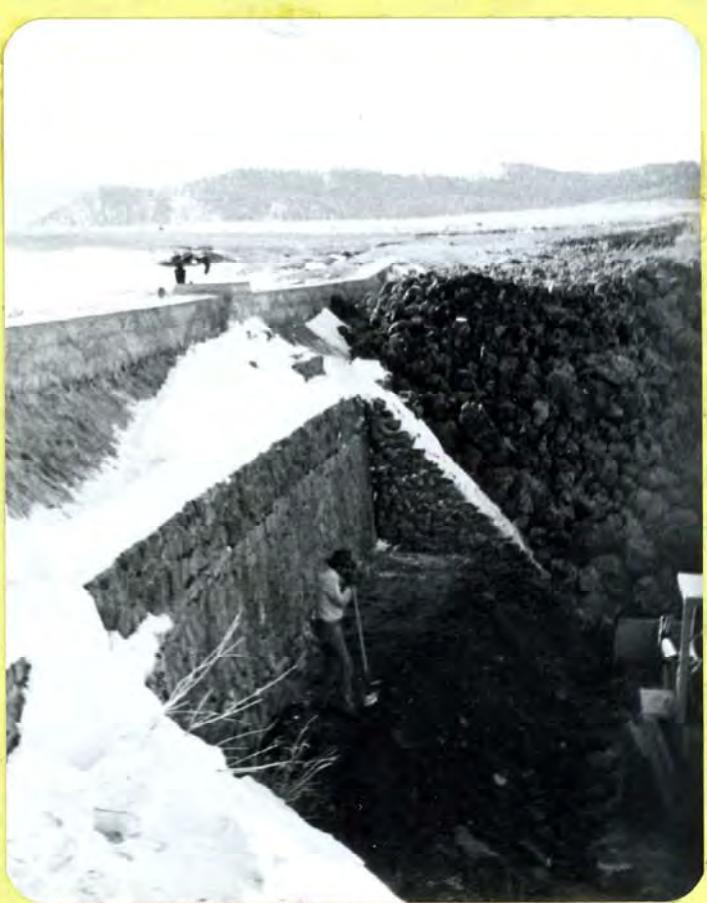
#6 Placement of natural fill against and over the imported fill material

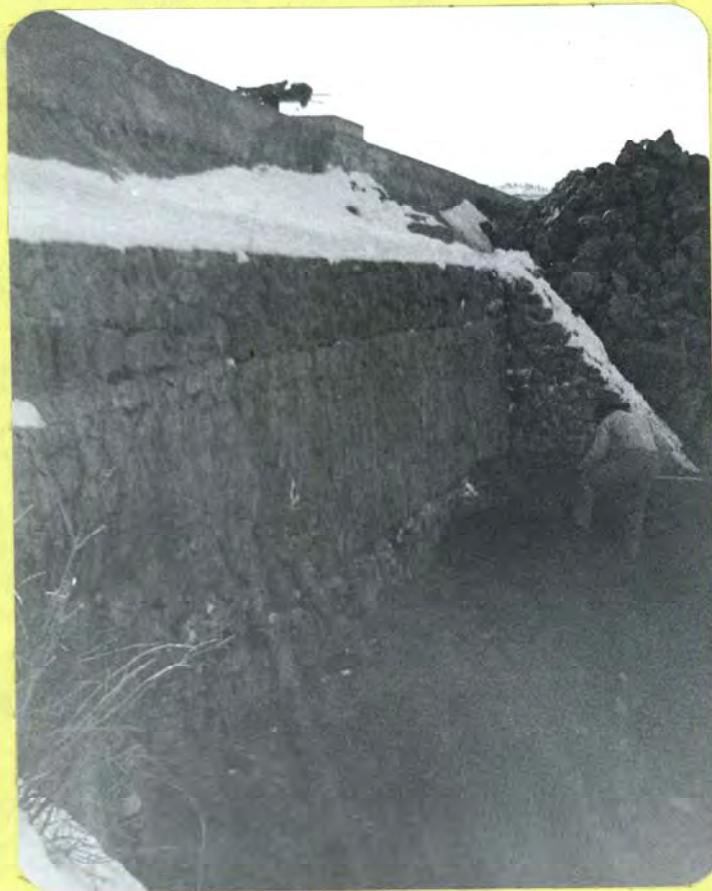
#7 Placement of natural fill material over imported fill material. (Approx. 18" in depth) east side of culvert extension.

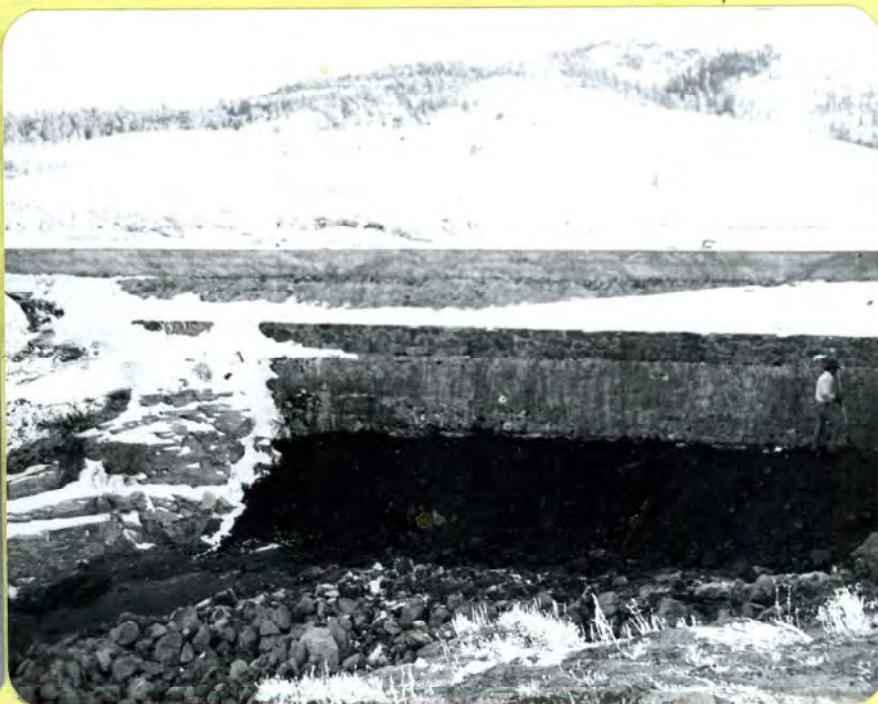
#8 Finished placement of natural fill material against and over imported fill on downstream face of Panguitch Lake Dam.

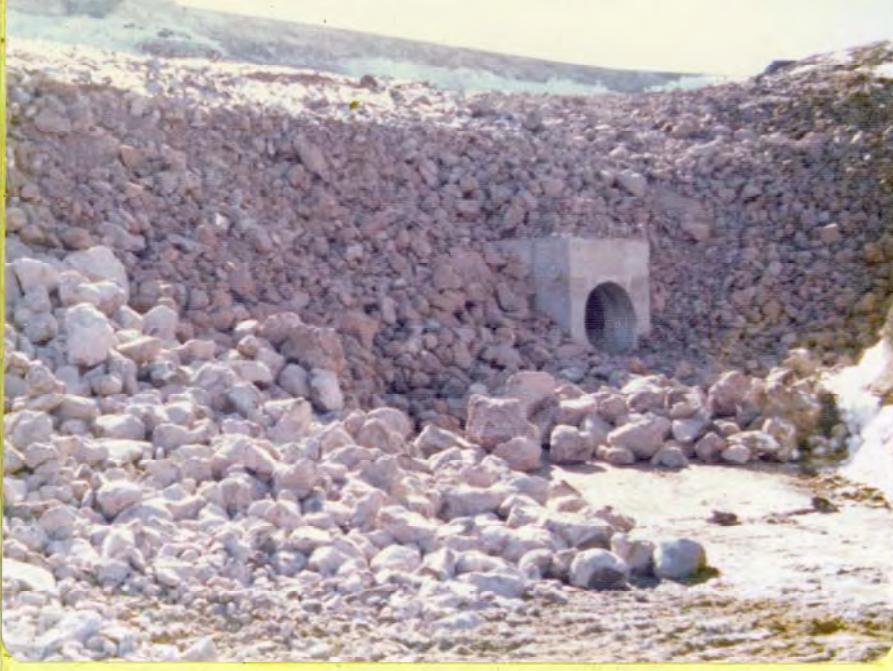
#2 Rockfill placement as of Dec. 18, 1975

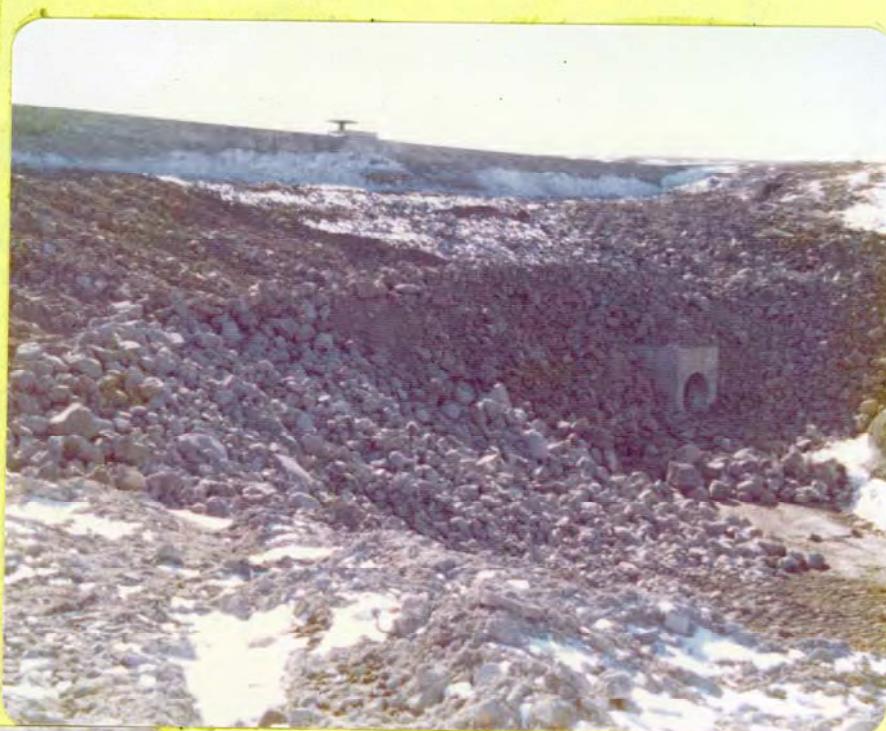
#3 Rockfill placement as of Dec. 18, 1975

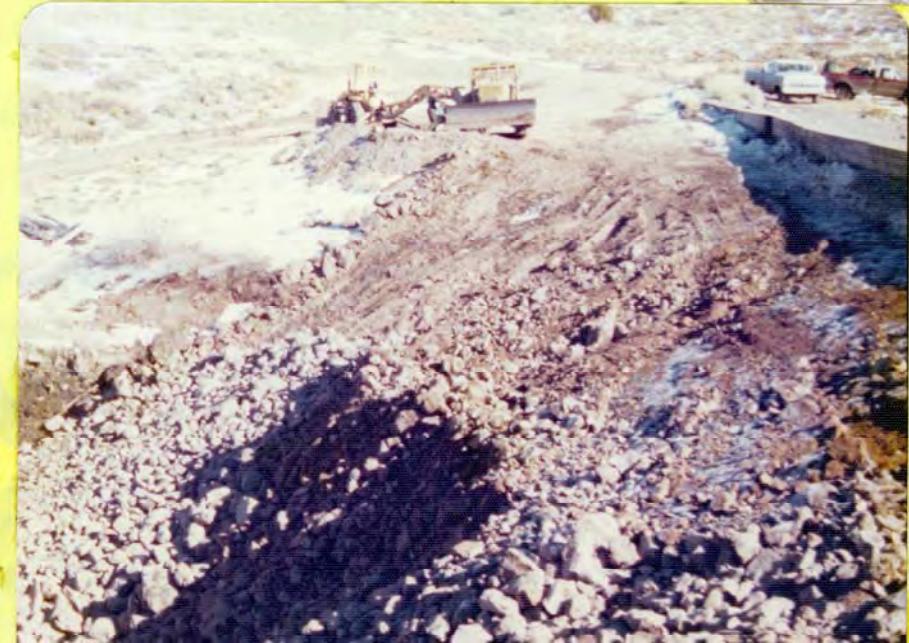
#4 Rockfill placement as of Dec. 18, 1975. East side view.

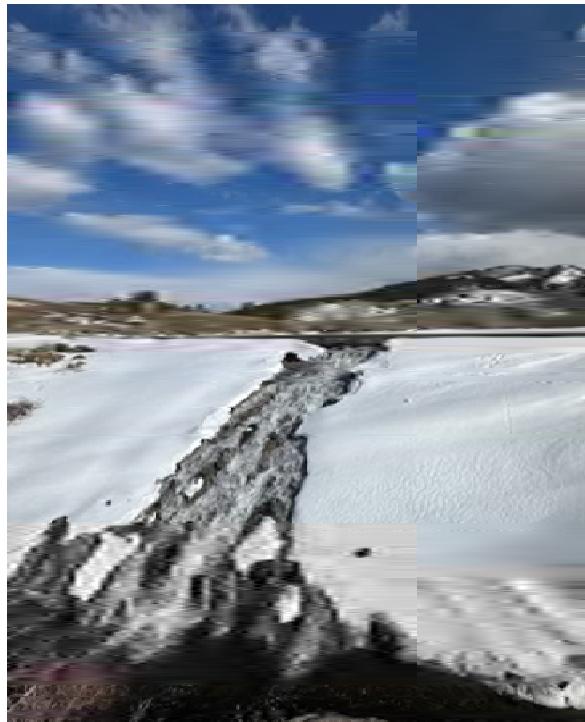
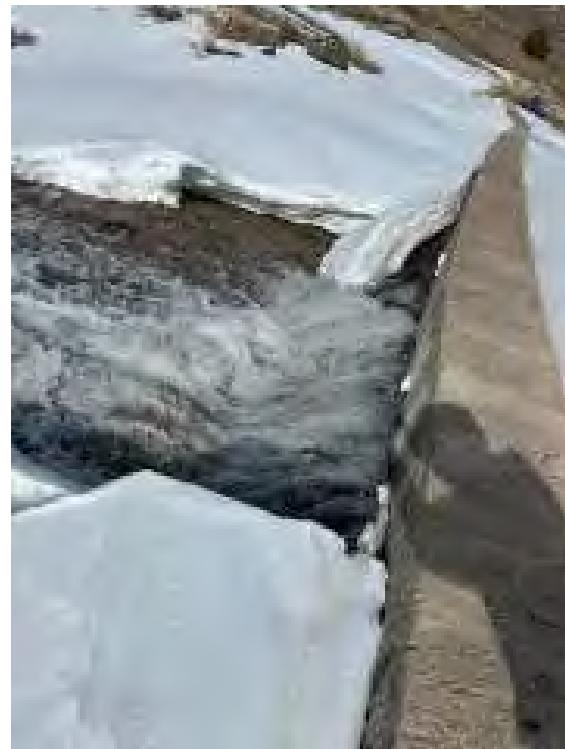
I observed conditions upon arrival with Mac Hatch and Matt Call (State Dam Safety Assist. Engineer). Water is flowing through cracks at the contact between the parapet wall and the masonry rock foundation east of the main dam. The parapet wall is about 2 foot wide and appears to be bowed in the center. The concrete wall appears to be about 2 high and sits on a masonry rock foundation. The major flow section appears to be about 25 foot wide where it has cut through

the ~2 foot of snow covering. It is likely that additional flow is occurring beneath the snow cap going to the east or right when looking at the dam from the reservoir side. I estimated the observed flow in the 20 to 25 cfs range. The total flow from the outlet works and seepage combined, as measured at the downstream weir is 160 cfs. They have a tilt meter sitting on the wall. It was reported that a 60 foot section of the wall had tilted 8 degrees downstream on Monday night and had rotated back to a 5 degree tilt during the day on Tuesday. The tilt was visually obvious. Mac said that the trencher on K-rails were scheduled to be on site at 7 am tomorrow morning. A light plant was being set up and the sheriff's department would monitor flow, measure tilt and observe conditions throughout the night. Garfield County had equipment and crews on standby to assist. They said they could begin snow removal from the downstream right abutment tonight if necessary and Mac said he could get the equipment and materials up to the site tonight if needed.

After assessing the existing conditions and history of what has transpired since the leakage was first discovered on Monday, my recommendation was to begin remedial action in the morning at daylight. My major concern was that the freezing night temperatures may cause additional wall tilting. I recommended that the sheriff's department call Mac if the tilt exceeded 8 degrees and that Mac call me so we could get up to the site. We went over our plan with Matt Call and he was in agreement with the planned course of action.

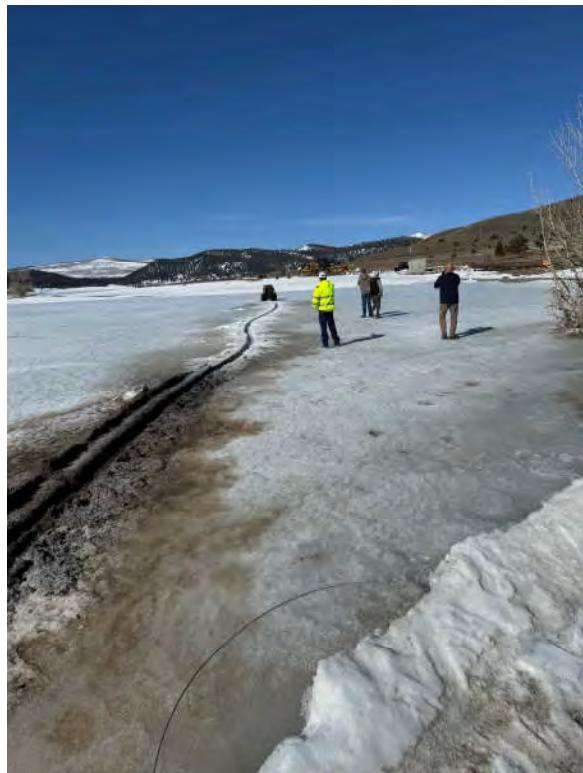
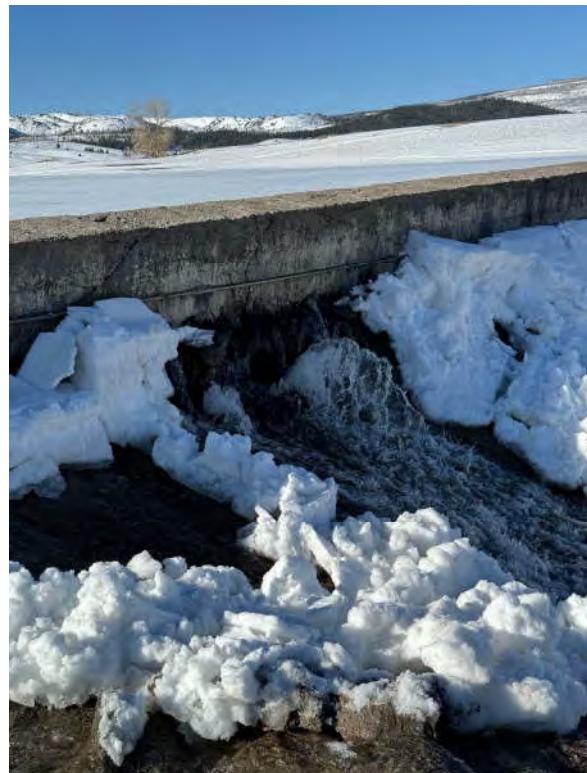
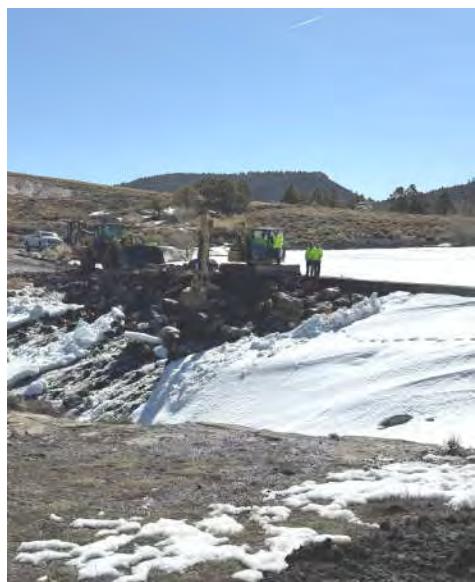
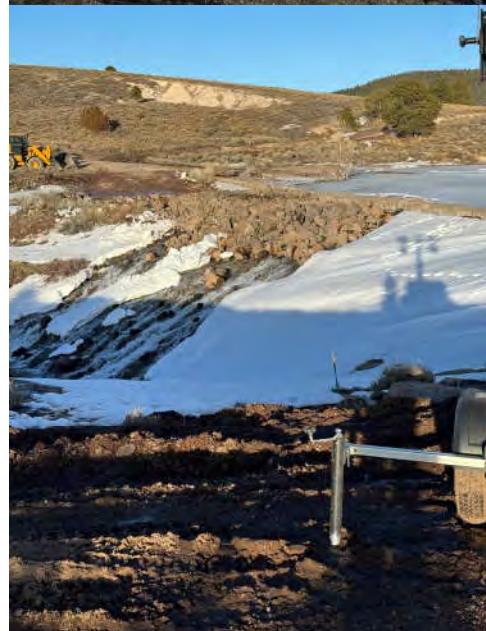
It appears that the left most crack at Sta. 1+07 is located where the natural cliff edge is. The first major flow starts at about Sta. 1+07, extending east.

On site at 7 am. Garfield County crews began with rockfill at 7:15. Everett Taylor was on site from ~7:30 until 8:15. We discussed finalizing the emergency repair, agreeing to extend at least 10 feet west of the first major crack which is at Sta. 1+07. He asked Austin to continue opening the gate at about 10 cfs increase intervals today. We also discussed work going forward. Mac asked about draping a liner across the ramp to keep overflow from entering the rock during spring runoff. Our desire is to continue lowering the reservoir to store without overtopping. I like the idea of removing the wall on the right (west) end and creating a spillway around the end. In that light, I asked Mac to have them pothole on the downstream right abutment to verify that it is rock.

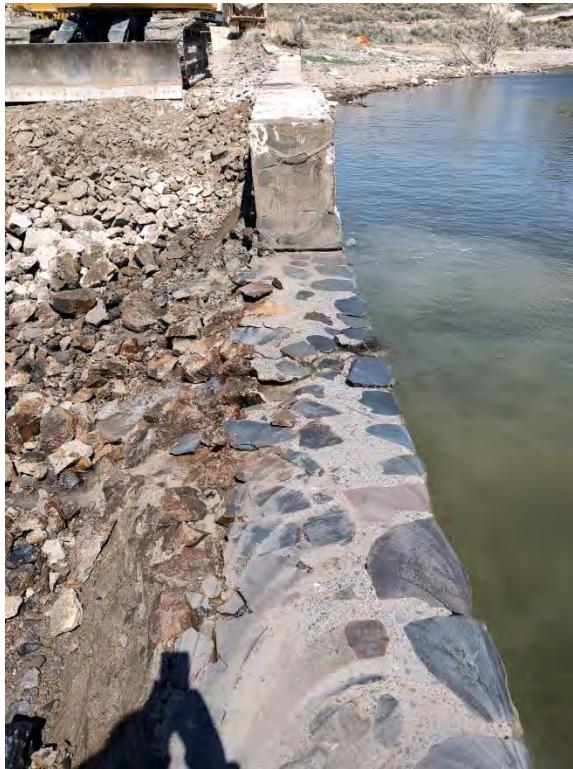
Right side of temporary spillway
(Photo taken by M. Hatch)

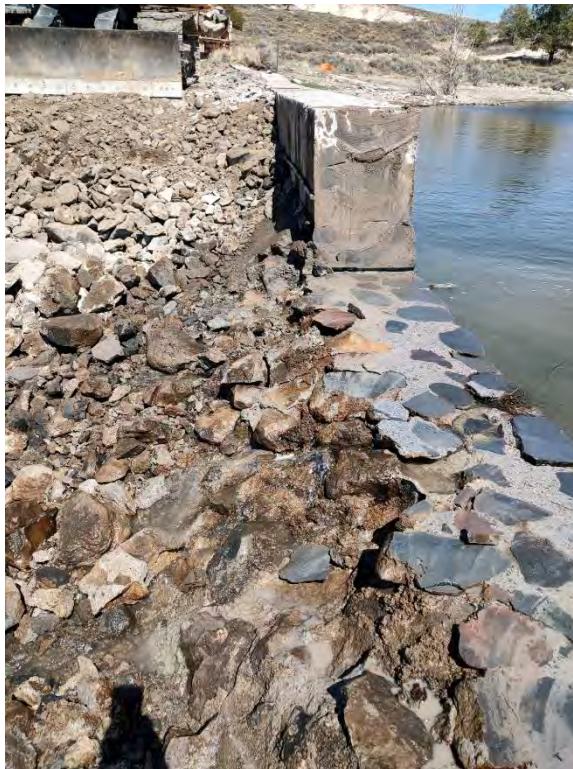
Right side of temporary spillway
(Photo taken by M. Hatch)
